# Measuring the progress of a recovery process after an earthquake: The case of L'Aquila, Italy

After the earthquake in 2009, L'Aquila (Italy) began a recovery process characterized by a delay in the reconstruction of the city center. Between 2010 and 2014 a recovery index was formulated based on spatial indicators, such as building condition and building use, to measure the progress of the recovery process in L'Aquila. Eight years after the earthquake, the work presented in this paper was used to update the recovery index, not only by measuring the progress of the recovery in L'Aquila but also by validating the usefulness of the proposed recovery index. To achieve this objective, the current research considered the same set of spatial indicators that were used to determine the progress of the recovery in L'Aquila by 2010, 2012, and 2014 in the revaluation of the expert criteria. It was found that in 2016 the number of reconstructed buildings and buildings under ongoing construction had significantly increased and the number of buildings with residential and commercial use had increased along the main roads. While progress was observed in the overall building condition, there was

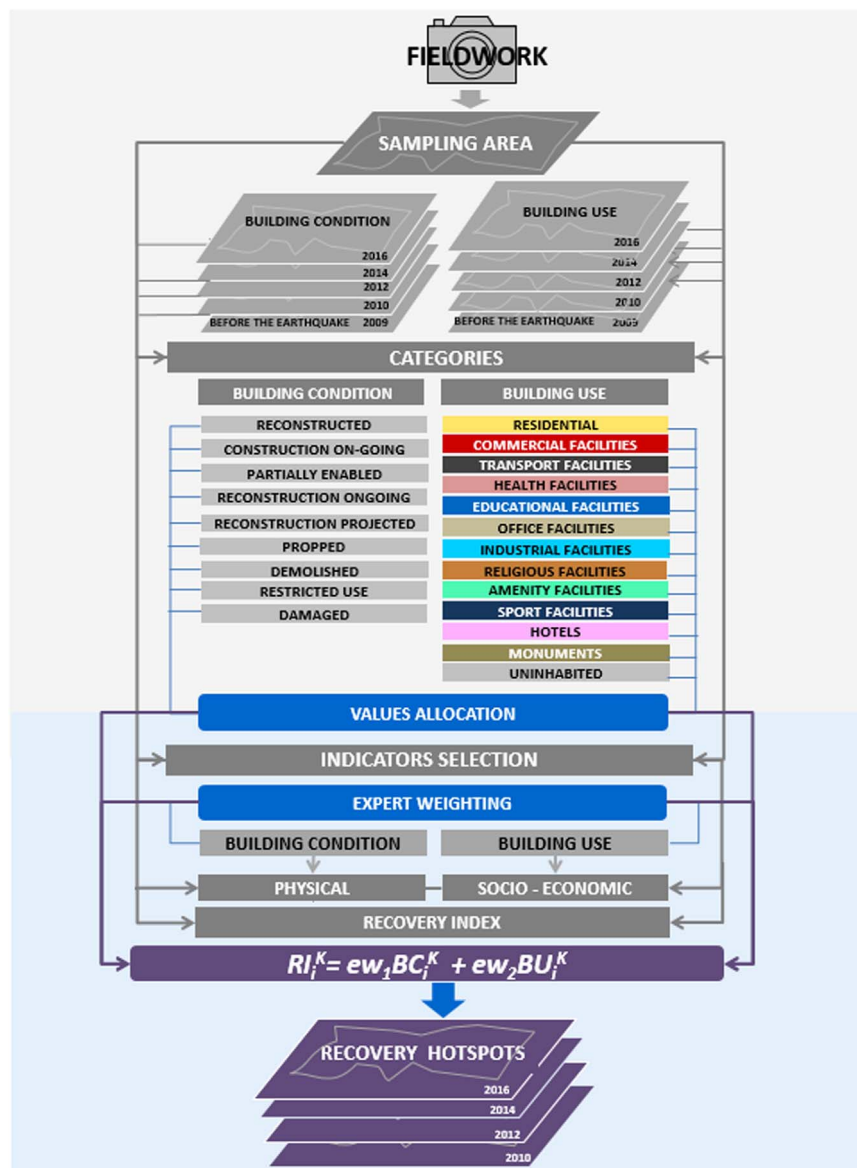
Fig. 2. Revised methodology.

The methodology of this research entails five steps: 1) data collection 2) data processing; 3) identification of categories and indicators 4) allocation of weights by experts to each spatial category and indicators to form a recovery index; and 5) determining the hotspots of recovery in L'Aquila. The sequence of the methodology is portrayed in Fig. 2. The building use before the earthquake is based on the observation of the store names and the photographs taken during the fieldwork campaigns, and information extracted from photographs available in *Google maps* and the 3D model of the city of L'Aquila in *Google Earth*.

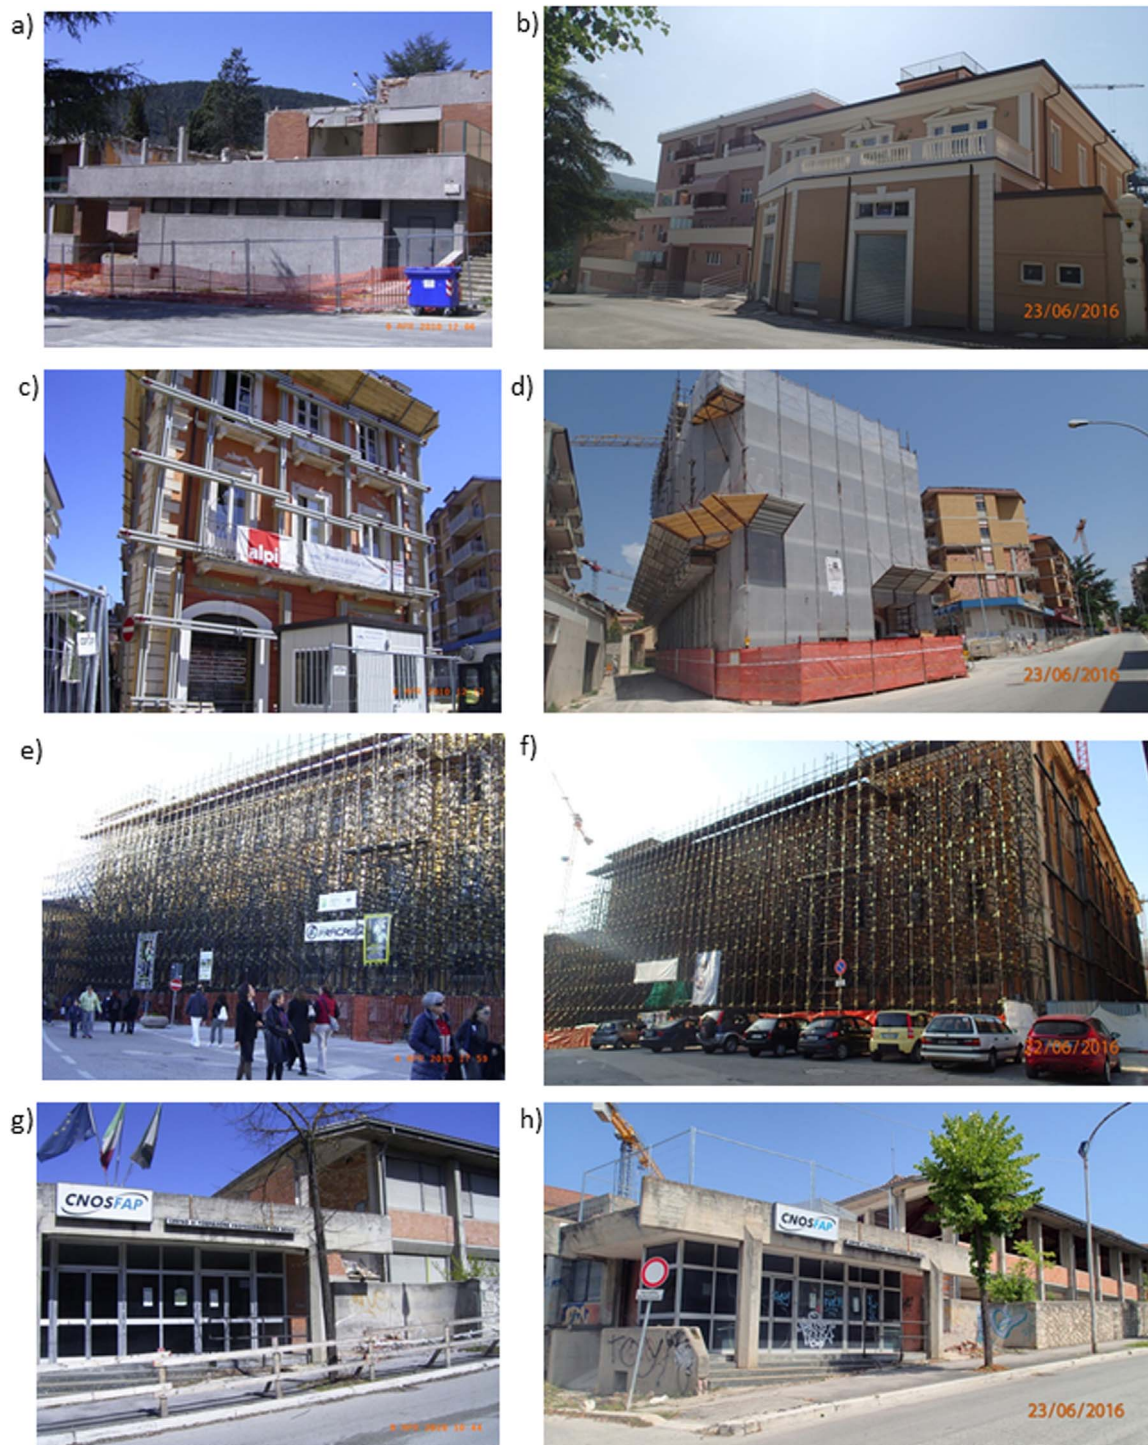
**Fig. 3.** Changes in L'Aquila (Italy) between 2010 and 2016. A) House located in front of the cross between the streets Strada Statale 17 and Via XXIV Maggio (2010); b) House located in front of the cross between the streets Strada Statale 17 and Via XXIV Maggio (2016); c) Building located over the Via XX Settembre between Via Orto Agrario and via delle Bone Novelle (2016); d) Building located over the Via XX Settembre between Via Orto Agrario and via delle Bone Novelle (2010); e) Building located between Via S. Bernardino and Piazza del Teatro and between Via S. Giovanni da Capestrano and Via S. Giacomo della Marca (2010); f) Building located between Via S. Bernardino and Piazza del Teatro and between Via S. Giovanni da Capestrano and Via S. Giacomo della Marca (2016); g) Center of Professional Training "Don Bosco" (2010) and h) Center of Professional Training "Don Bosco" (2016). Photos by Diana M. Contreras M.

In 2016, newly reconstructed buildings could be observed in L'Aquila (see Fig. 3a and b). Buildings that had been classified as being

in reconstruction projected over six years were finally in reconstruction ongoing (see Fig. 3c and d). Meanwhile, other buildings remained propped (see Fig. 3e and f) or were still awaiting a decision (damaged) (see Fig. 3g and h). The changes in the buildings' conditions between 2010 and 2016 are illustrated in Fig. 3.

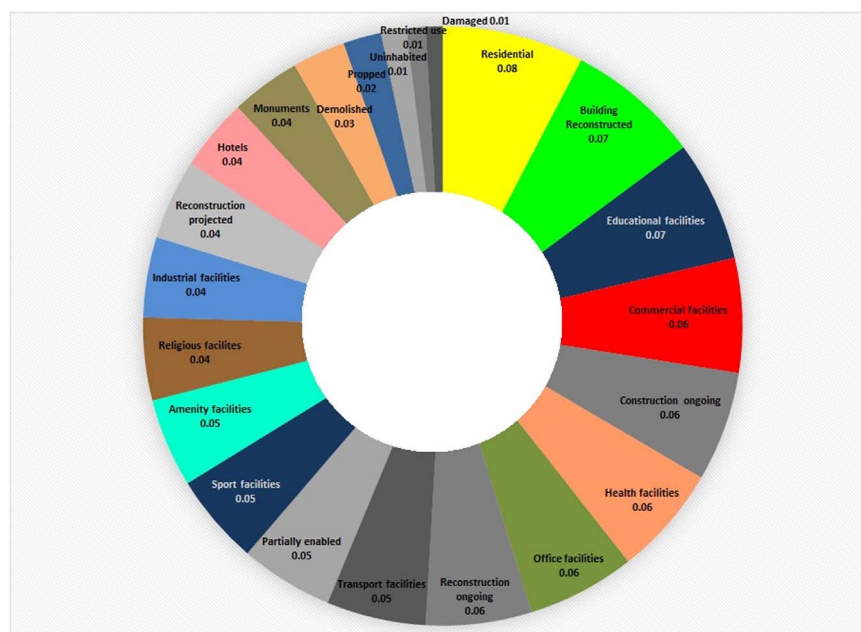
**Fig. 4.** Results of experts weighting allocation process.

*reconstructed*, and *educational facilities*. Contrarily, *damaged*, *restricted use*, and *uninhabited* were perceived as the categories that contribute less to the progress of the recovery after an earthquake. The result of the weightings for all considered variables is portrayed in Fig. 4.

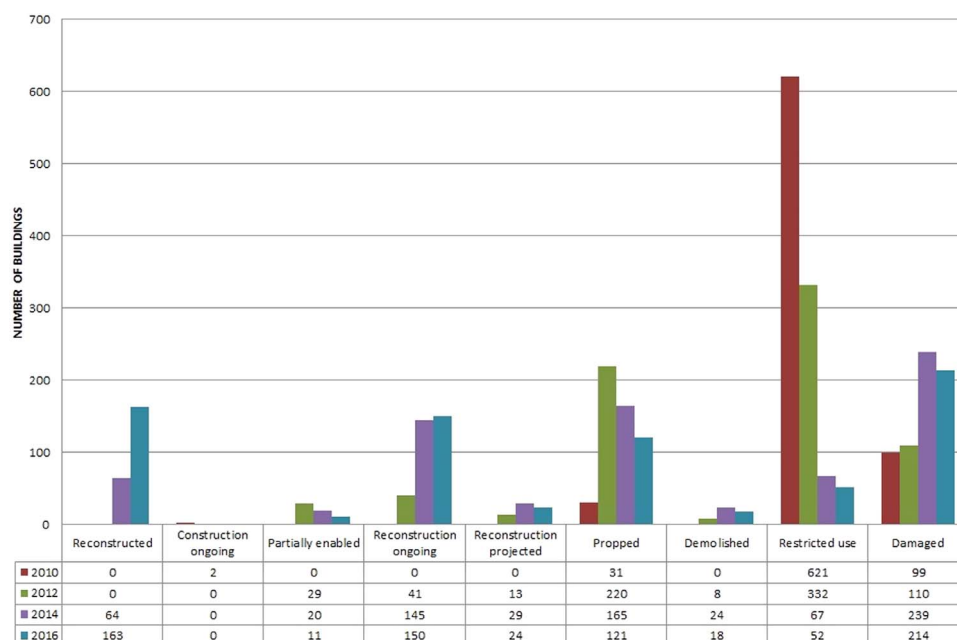
Fig. 5. Comparison of the changes in the building condition in L'Aquila after the earthquake between 2010 and 2016.

The sampling area of the historic center of L'Aquila included 753 buildings. It was found that the percentage of buildings that were classified as *partially enabled* has decreased by over 4% (29) to 1% (11) between 2010 and 2016. The percentage of buildings *reconstructed* increased from just 5% (41) in 2010 to over 20% (150) in 2016. The percentage of buildings with *reconstruction projected* (announced on a billboard) rose from 2% (13) in 2012 to 4% (29%) in 2014 but slightly fell to 3% (24) in 2016. The percentage of *propped* buildings (still requiring structural support) increased significantly from just 4% (31) in 2010 to over 29% (220) in 2012. However, the percentage of *propped* buildings dropped by over 22% (165) in 2014 and to 16% (121) in 2016. The percentage of *inhabited* buildings reached a record of 15% (110) in 2012, from 13% (99) in 2010; but afterwards, the percentage of *inhabited* buildings continued to decrease from 9% (65) in 2014 to 8% (62) in 2016. The percentage of buildings with *restricted use* (uninhabited) steadily decreased from 82% (621) in 2010 to 44% (332) in 2012, to 9% (67) in 2014 and to 7% (52) in 2016, which is another sign of progress in the recovery process. The percentage of buildings *demolished* reached 3% (24) in 2014, from just over 1% (8) in 2012, but this number decreased again to 2% (18) in 2016. The percentage of *damaged* buildings in the sampling area in the city center of L'Aquila remained high at 23% (174) in 2014 [14] and decreased slightly to 20% (152) in 2016. These results are plotted in Table 4 and Figs. 5 and 6.

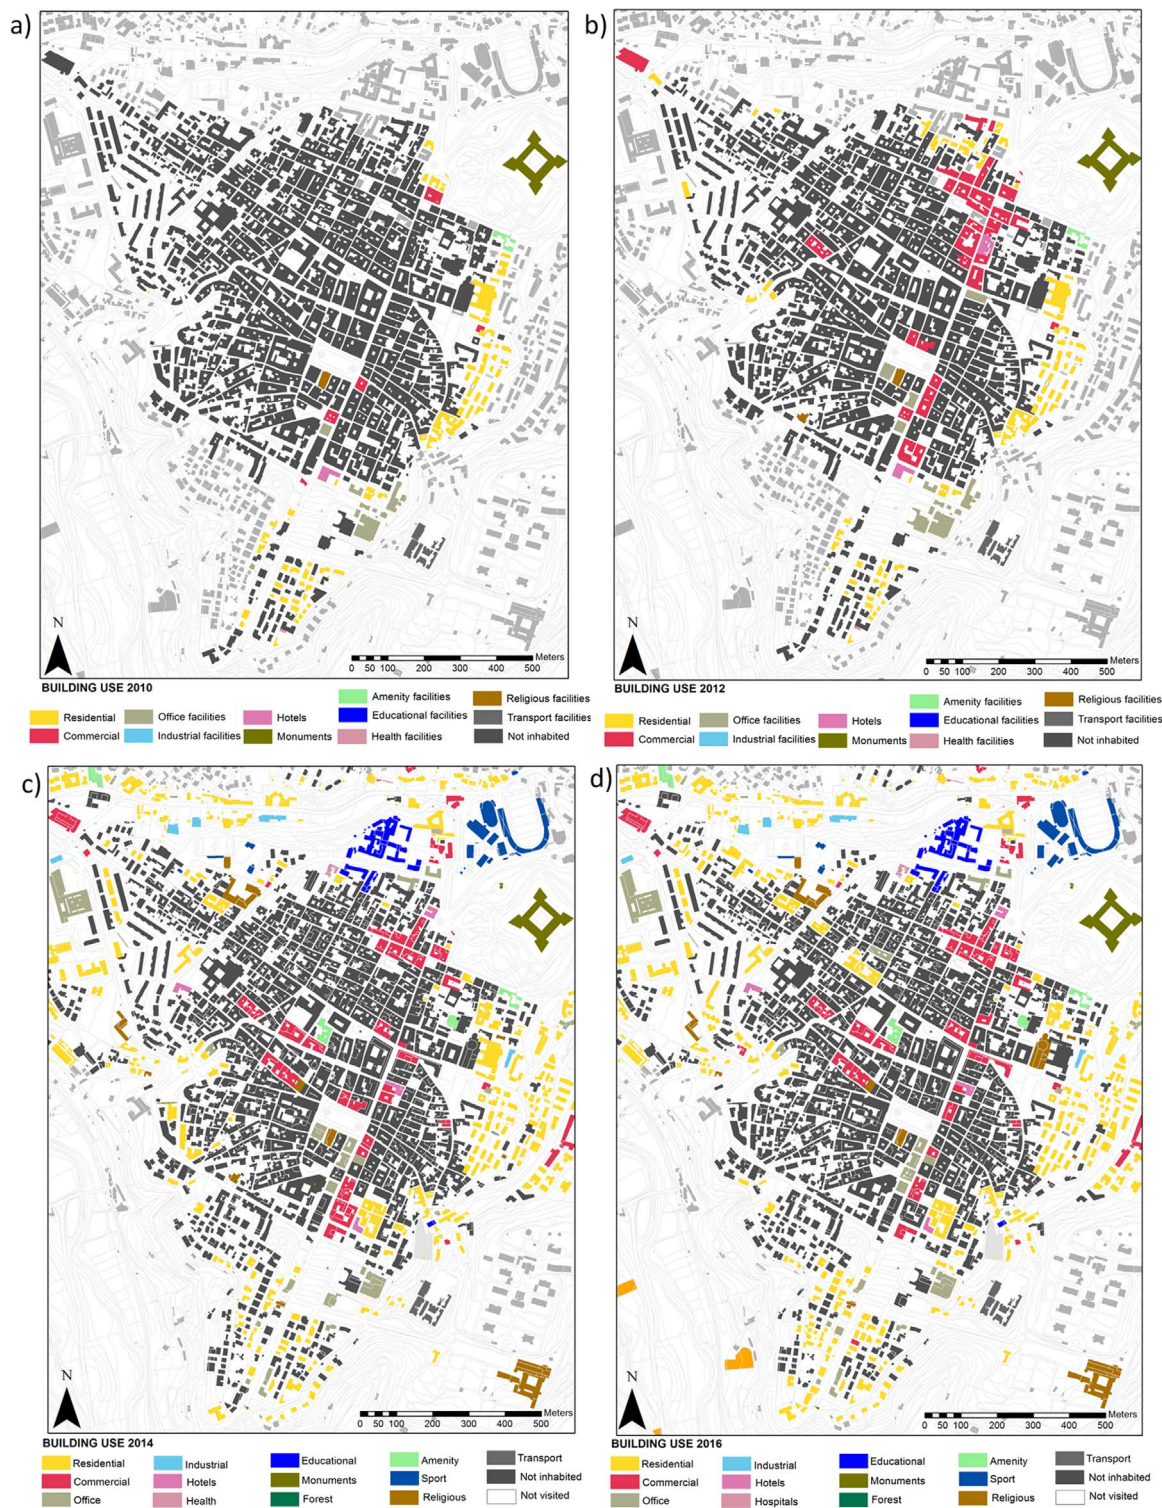
Fig. 6. Building condition in L'Aquila after the earthquake in a) 2010, b) 2012, c) 2014 and d) 2016.

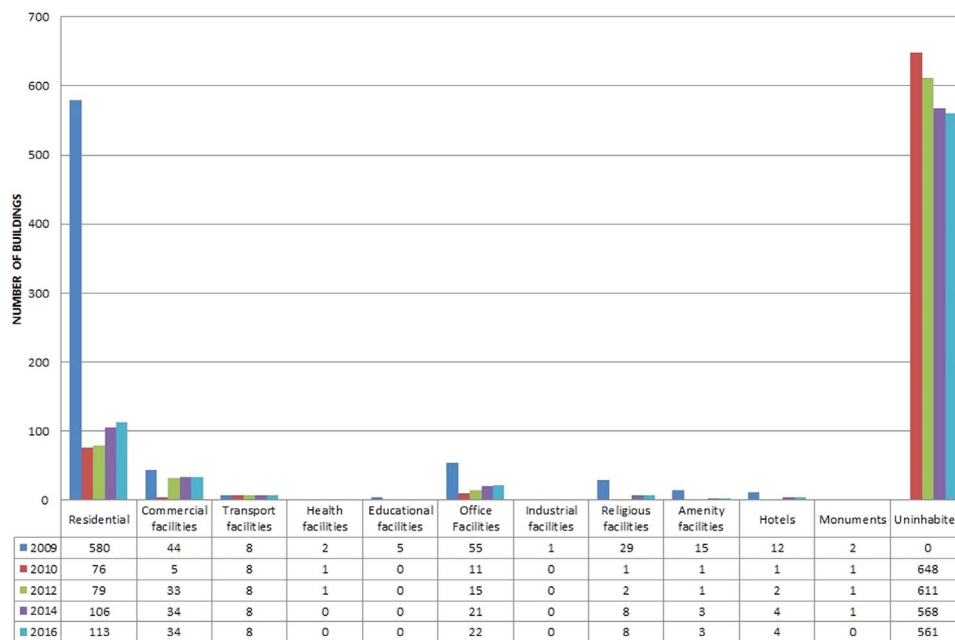
Fig. 7. Comparison of the changes in the building use in L'Aquila after the earthquake between 2010 and 2016.

before the earthquake), and 28% (29 *religious facilities* before the earthquake). There was an increase of 1% (22) in the number of *office facilities* available in the sampling zone in 2016 compared to 2014. There was no increase in the number of *hotels* or *religious facilities* available by 2016. The number of *residential buildings* (580 before the earthquake) has been steadily increasing from 76 (10% of the buildings in the sampling zone) in 2010, to 79 (10%) in 2012, to 106 (14%) in 2014 and 113 (15%) in 2016. These results are depicted in Table 5 and Figs. 7 and 8.

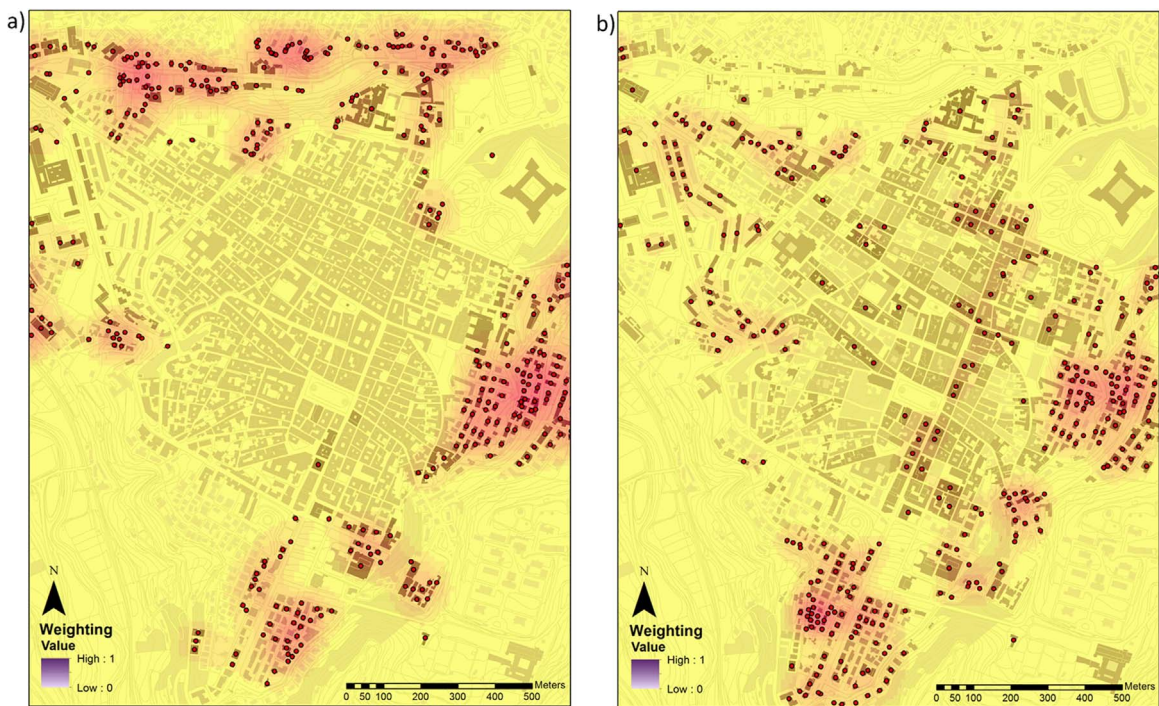
Fig. 9. Hotspots of recovery in L'Aquila in a) 2010 and b) 2016.

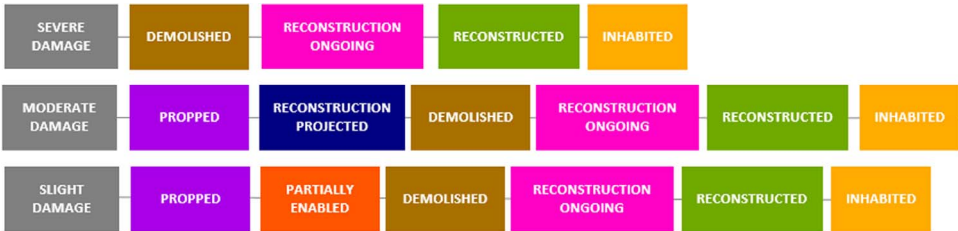
Fig. 10. Transitions in building condition in L'Aquila between 2009 and 2016.

found inhabited in the past fieldwork visits and are now in restoration. Transitions in building condition in L'Aquila between 2009 and 2016 are depicted in Fig. 10 and they are similar to the limit state event tree to assess building-level recovery developed by [9].

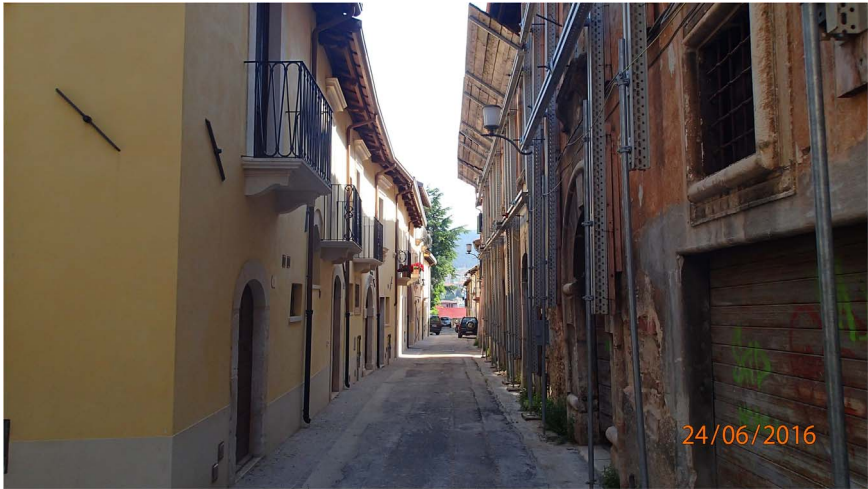
Fig. 11. Contrasts in the recovery process of the city center in L'Aquila.

Furthermore, there are many facilities, such as schools and offices, which need to be rebuilt to contribute to a functional living environment in the HC of L'Aquila. Before the earthquake, this HC was also the location of offices and private shared accommodation for students. This means that some householders were not physically living in those houses. The contrast between building conditions along the streets in the recovery process of L'Aquila can be observed in Fig. 11.
