Silicon Microstrip Sensors for SiD:

R&D Review and Future Plans

M. Breidenbach, C. Kenney, T. Nelson, A. Tomada

SLAC National Accelerator Laboratory

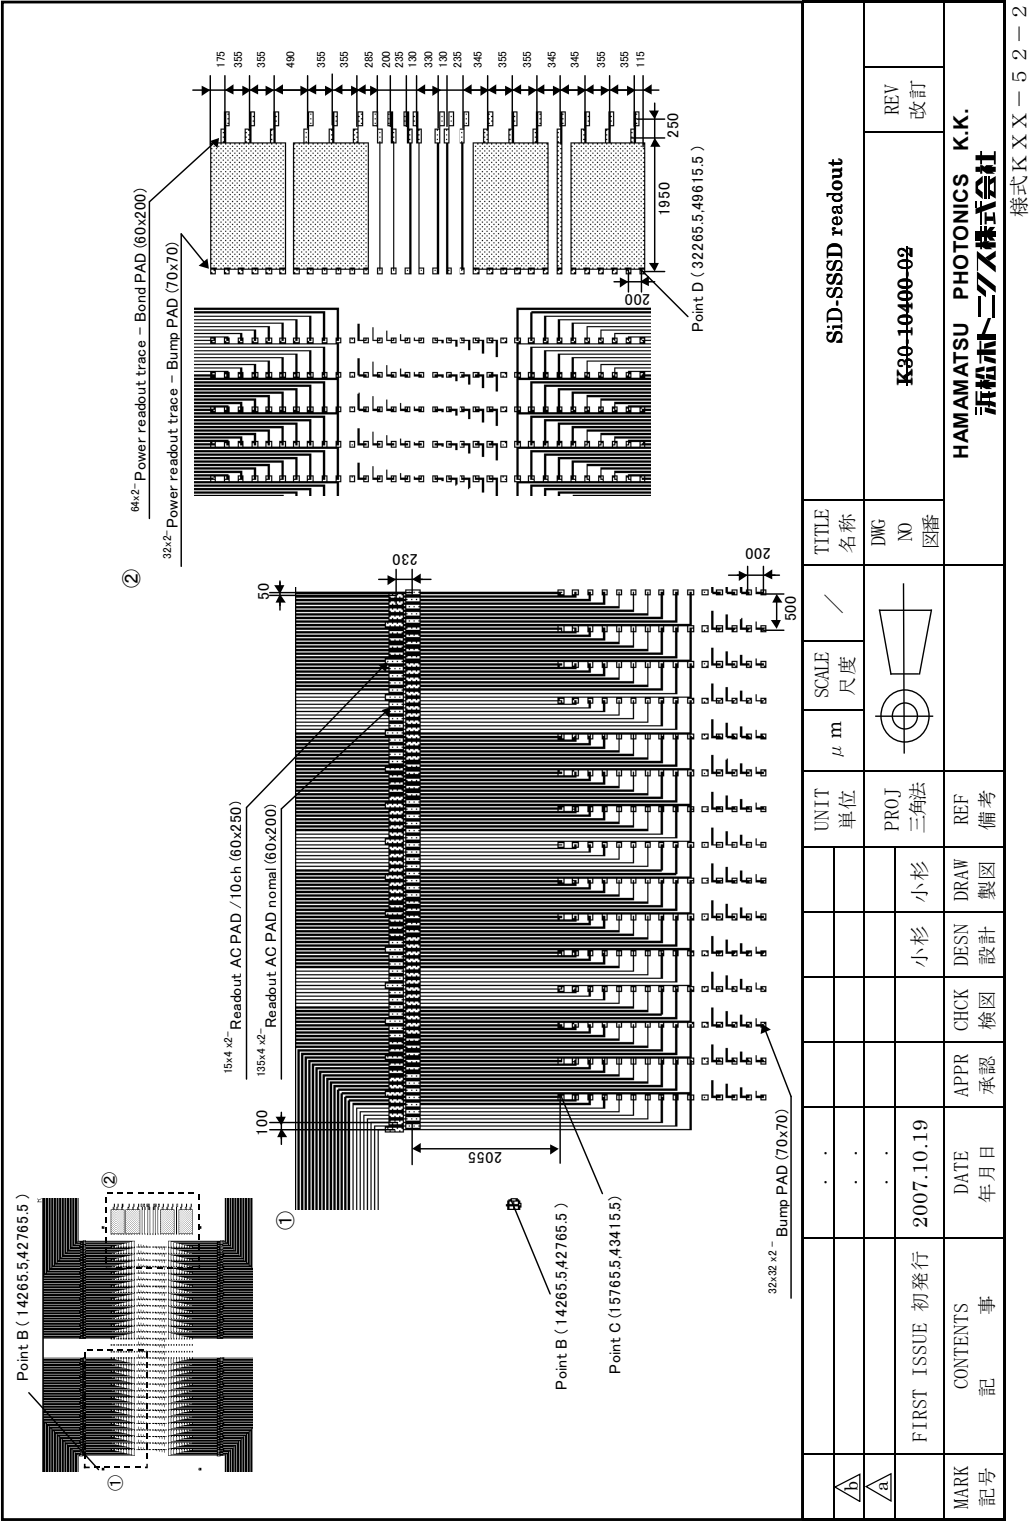
FIG. 7: The Hamamatsu drawing for the tracker sensor prototypes showing the KPiX and cable bonding region in detail. The wirebonding pads are along the right edge of the drawing.

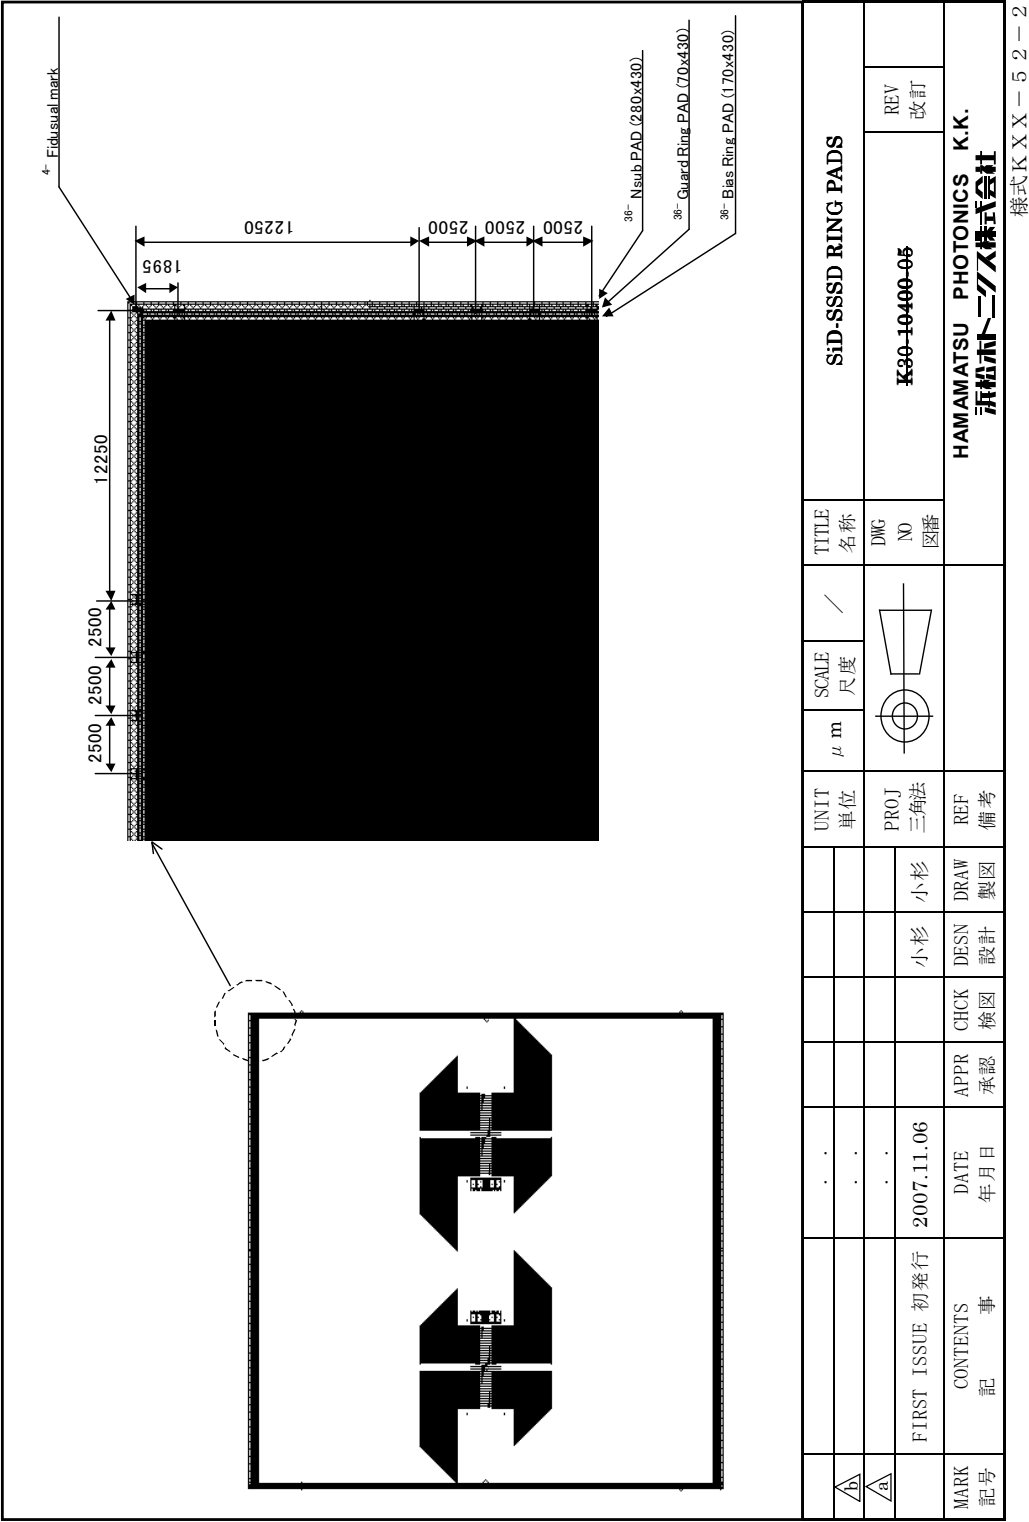
FIG. 8: The Hamamatsu drawing for the tracker sensor prototypes showing the bias ring and pads in detail.
