# Silicon Microstrip Sensors for SiD:

## R&D Review and Future Plans

M. Breidenbach, C. Kenney, T. Nelson, A. Tomada

*SLAC National Accelerator Laboratory*

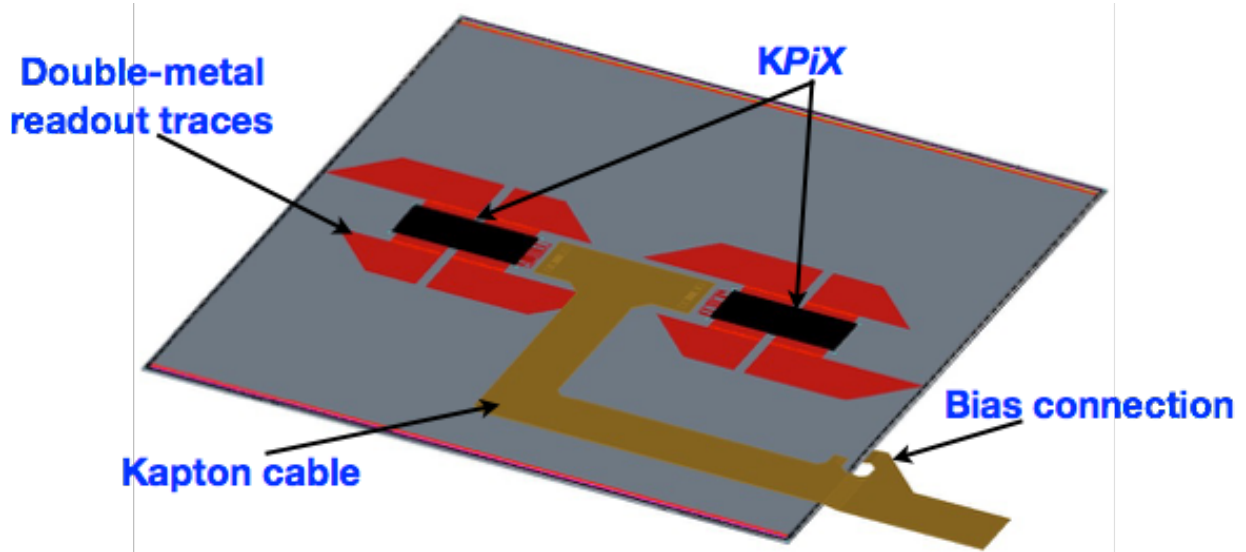
FIG. 1: The module concept for the SiD outer tracker. Each sensor is read out by a pair of KPiX readout ASICs via a polyimide flex cable, which also provides bias to the sensor.

KPiX to the external DAQ and power supply, as well as providing bias to the sensor. As shown in Figure 1, the design calls for each sensor to be read out by a pair of 1024-channel bump-bonded KPiX, which are controlled and read out by a single cable which attaches to the sensor between the two readout chips. In early 2008, after extensive development of the

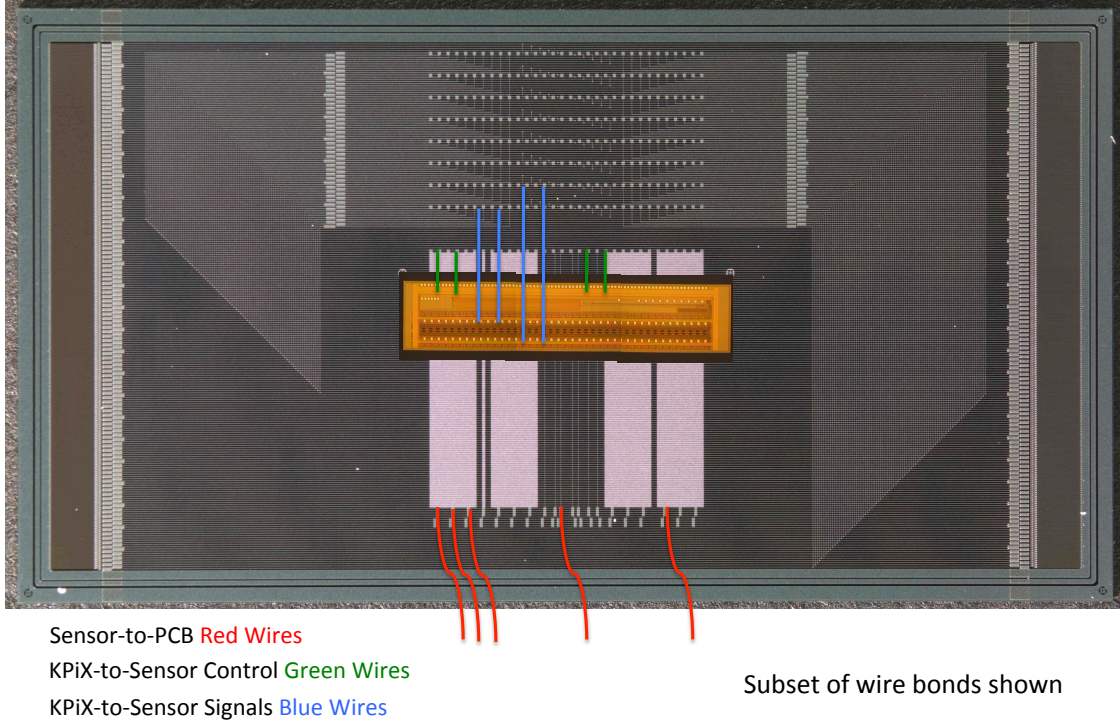
FIG. 2: The layout for initial testing with a 64-channel KPiX readout ASIC and double-metal test sensor. The KPiX is glued to the face of the sensor with bump bond pads facing up to allow wirebonding of KPiX to both the power/control traces (second metal) and the readout traces (first metal) of the sensor. For this test, the other end of the power/control traces were bonded to an underlying PCB instead of a polyimide flex cable.

a 64-channel KPiX prototype upside-down (with bump bond pads facing upwards) to allow wirebonding to the test sensor. The primary purpose of this test was to assess crosstalk from KPiX clock traces that are routed on the second metal layer to the underlying sense traces. The wirebonding layout for this test is shown in Figure 2. This wirebonding was

performed by Amtech Microelectronics Inc., the packaging and SMT vendor used by SLAC for all contract assembly and wirebonding. Although the wirebonds on this prototype appeared successful, testing revealed that the wirebonds on the sensor had shorted the second metal layer to the first-metal readout traces. A second attempt was made with the same vendor with the same results. In order to have more control over the wirebonding process, further prototypes were sent to colleagues at UC Santa Cruz and wirebonded there on their Hesse&Knipps BJ820 by an experienced technician. The results of this effort were similar and, in general, the rate of punch-through during bonding appears to be at least 10%. Table I summarizes the measured resistance between the second metal clock trace and the

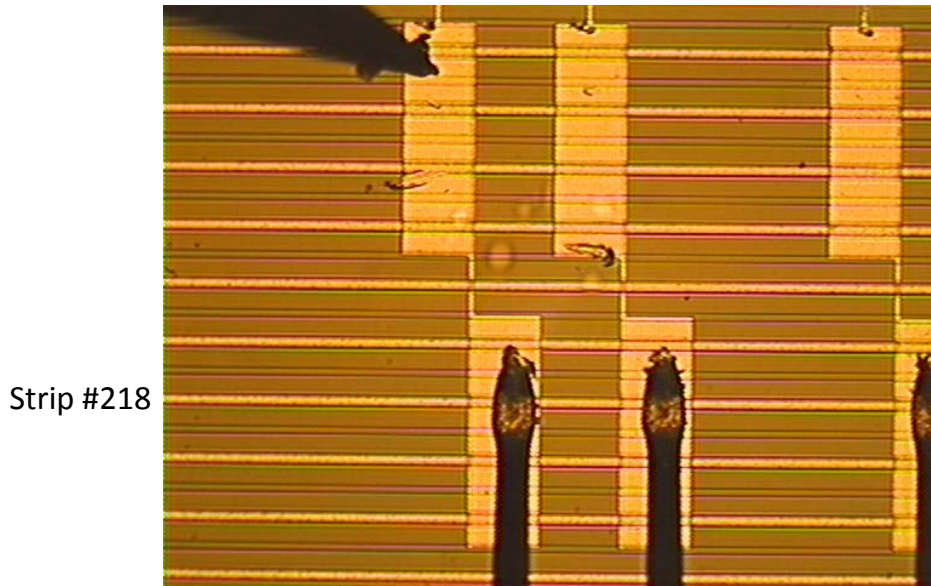
FIG. 3: The setup for measuring the resistance between the clock trace, shown being probed at the spare wirebonding pad, and the underlying readout traces. As indicated strip 218 lies underneath the pad where the wirebond was made to the PCB.

first metal readout traces that lie underneath the bonding pads on one of these prototypes. Figure 3 shows a closeup image of the wirebond pad that was found to have only  $70\Omega$  resistance to the underlying readout trace. Since then, the same technician using the same

Strip Number	Resistance to Clock Pad
215	$>10\text{M}\Omega$
216	$>10\text{M}\Omega$
217	$>10\text{M}\Omega$
218	$<70\Omega$
219	$2\text{M}\Omega$
220	$2\text{M}\Omega$
221	$2\text{M}\Omega$

TABLE I: The resistance between the clock trace (second metal) and the underlying readout traces (first metal) after wirebonding. Strip 218 is underneath the wirebond pad for bonding the clock trace to the PCB.

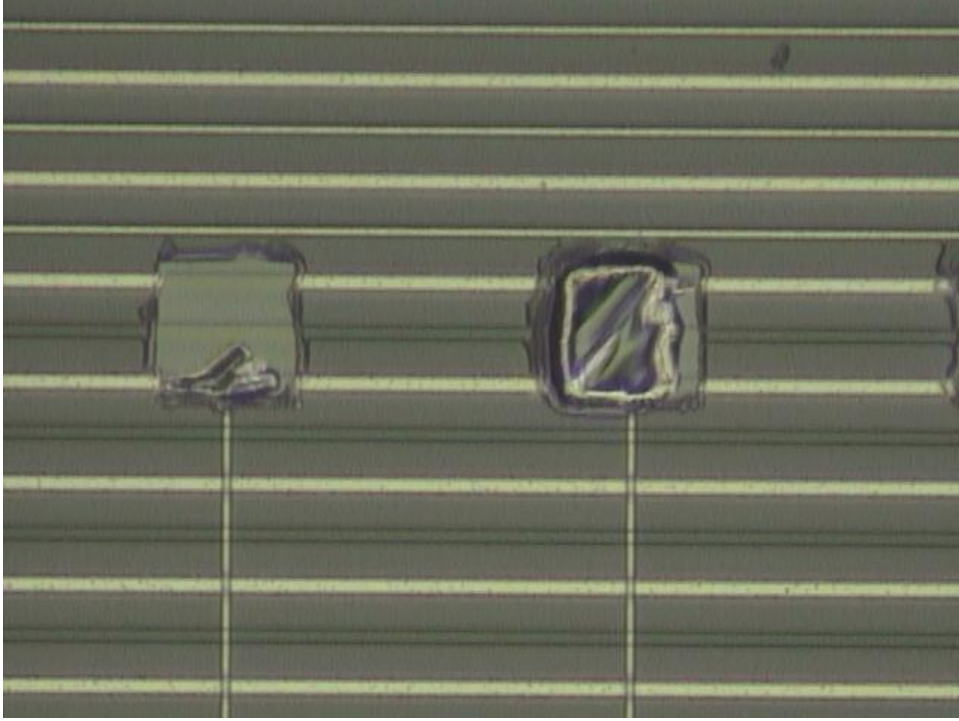
layers were lifted by the bumps on KPiX leaving measurable craters, approximately  $10\ \mu\text{m}$  deep, in the sensor. This failure mode would seem to indicate a processing failure of some kind in the layers of the sensors.

FIG. 4: Tracker sensor bump bonding pads after failure. Note the pad on the left where the sensor layers have been removed leaving a hole all the way down to the silicon substrate.

Assembly of the tracker prototype recommenced with sending full-sized tracker sensors to IZM Fraunhofer for the same UBM and bump bonding of KPiX that was performed successfully for the ECal sensors. Although the KPiX bonding at IZM appeared to be successful, testing showed poor and inconsistent electrical connectivity, and during probing the ASICs spontaneously detached from the sensors. Careful examination revealed that the bump bonds themselves had not failed, but rather that the substrate underneath the bonding pads on the sensor had failed. As shown in Figure 4, pieces of the sensor pads and underlying

After exhaustive attempts to produce and test prototypes of the SiD tracker modules using sensors procured from Hamamatsu for this purpose, it appears that some defect of design and/or fabrication has resulted in an oxide layer that can withstand neither wirebonding nor bump bonding using industry standard processes. Meanwhile, the need to complete this R&D has become more urgent, as the SiD detector concept has matured and the proposals to build a new  $e^+e^-$  collider have gained momentum due to the discovery of the Higgs boson at CERN. Therefore, we now must obtain replacement sensors that will allow us to complete the R&D as originally intended. While it is not obvious what change must be made in order to ensure successful fabrication of this design, it is clear that double-metal readout designs

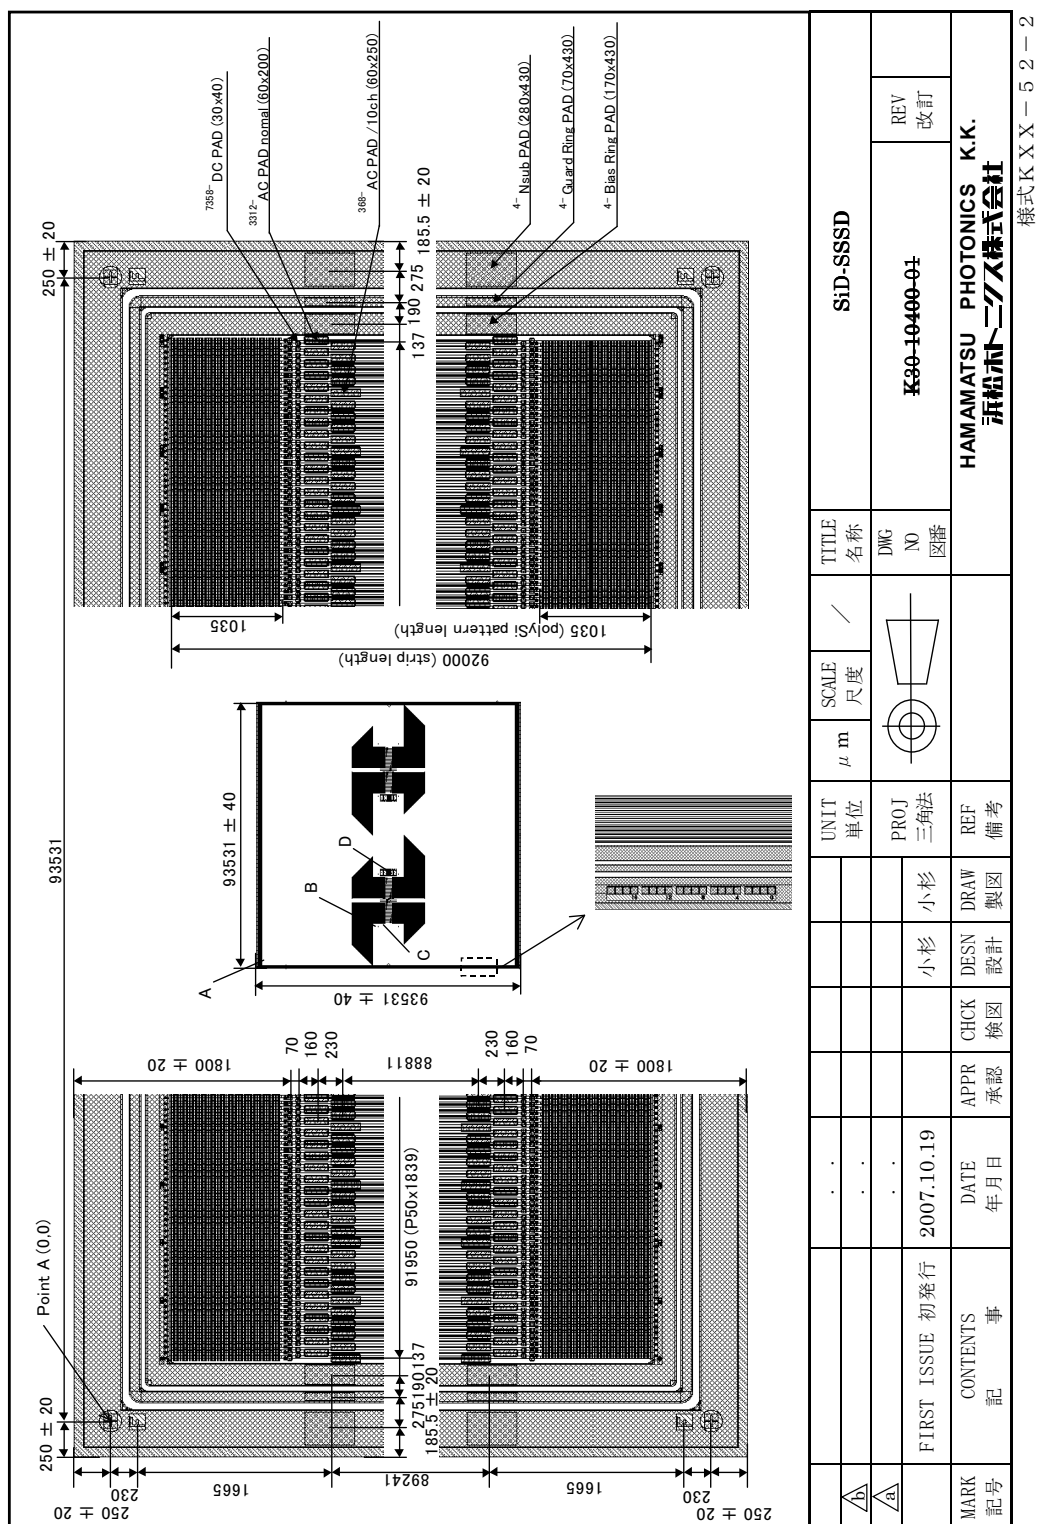
FIG. 6: The Hamamatsu overview drawing for the tracker sensor prototypes.

The specifications for the sensors are shown in Figure 5. The drawings for the full-sized sensors are shown in Figures 6, 7 and 8. The drawing for the test sensors is shown in Figure 9.

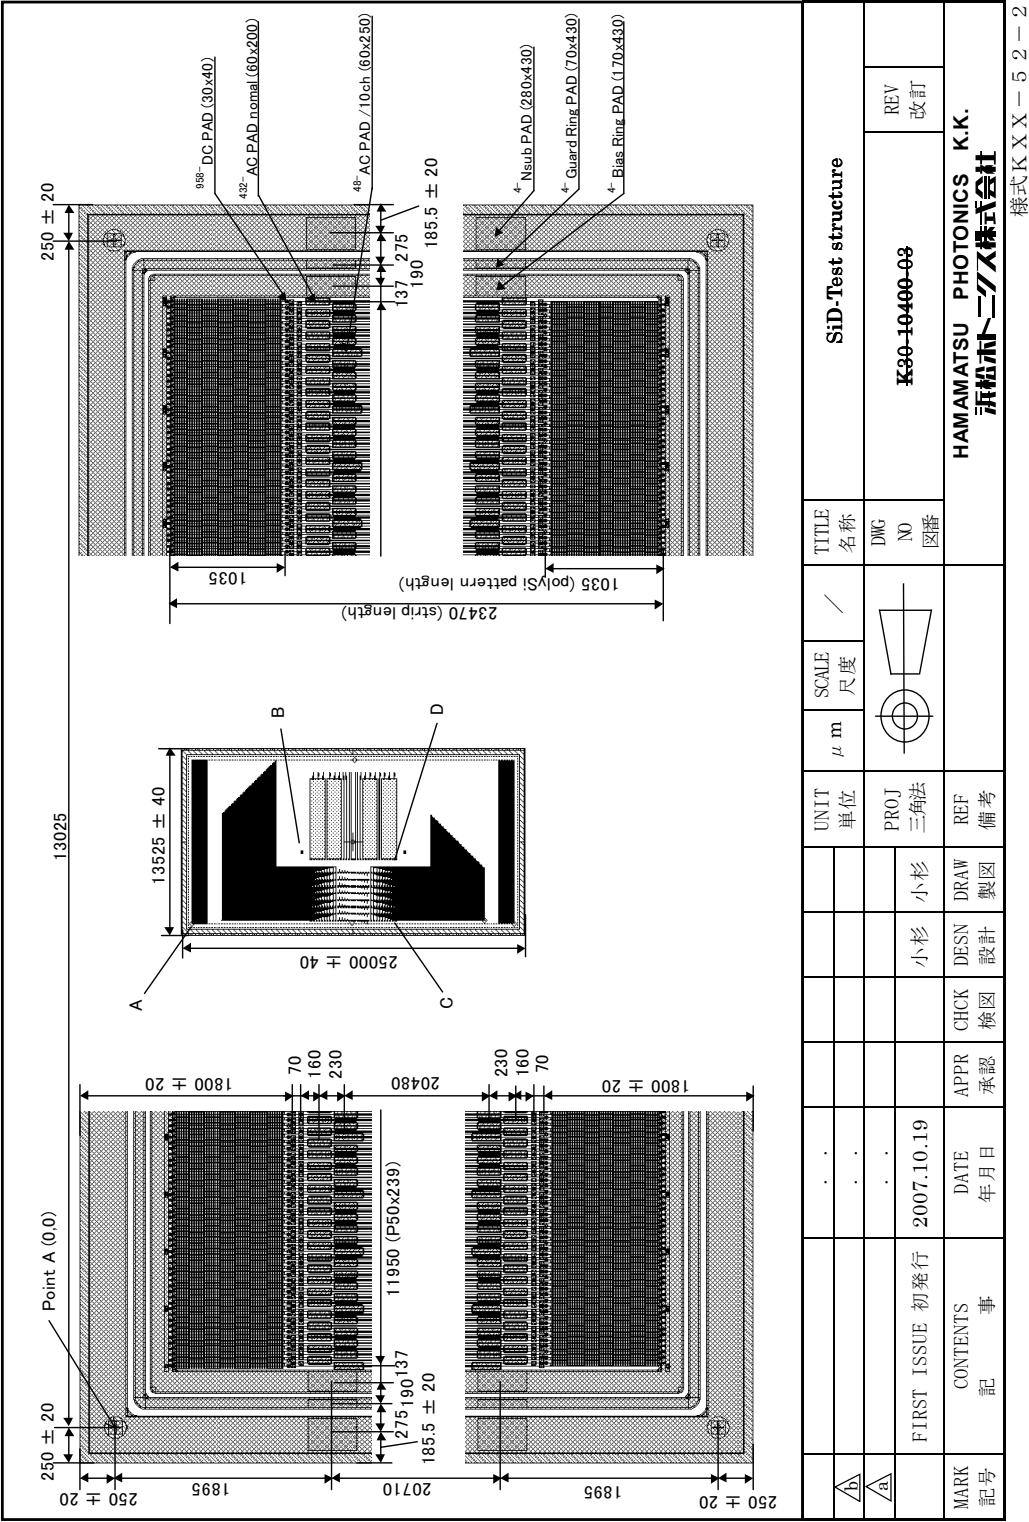
FIG. 9: The Hamamatsu drawing for the test sensors fabricated on the same wafers.
