Silicon Microstrip Sensors for SiD:

R&D Review and Future Plans

M. Breidenbach, C. Kenney, T. Nelson, A. Tomada

SLAC National Accelerator Laboratory

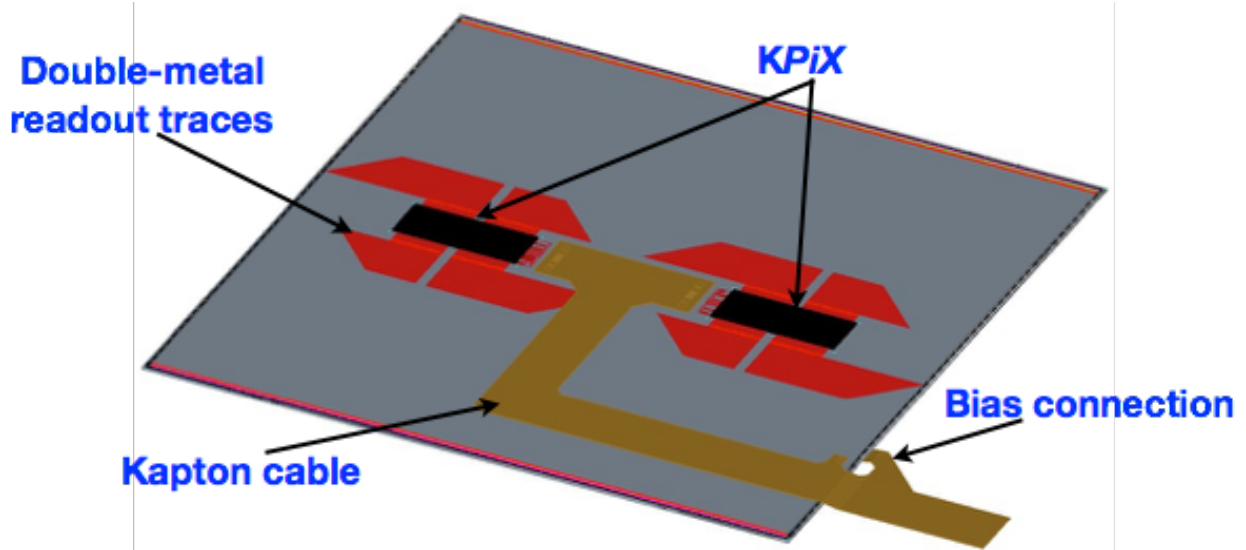
FIG. 1: The module concept for the SiD outer tracker. Each sensor is read out by a pair of KP*i*X readout ASICs via a polyimide flex cable, which also provides bias to the sensor.

shown in Figure 1, the design calls for each sensor to be read out by a pair of 1024-channel bump-bonded KP*i*X, which are controlled and read out by a single cable which attaches to the sensor between the two readout chips. In early 2008, after extensive development of the

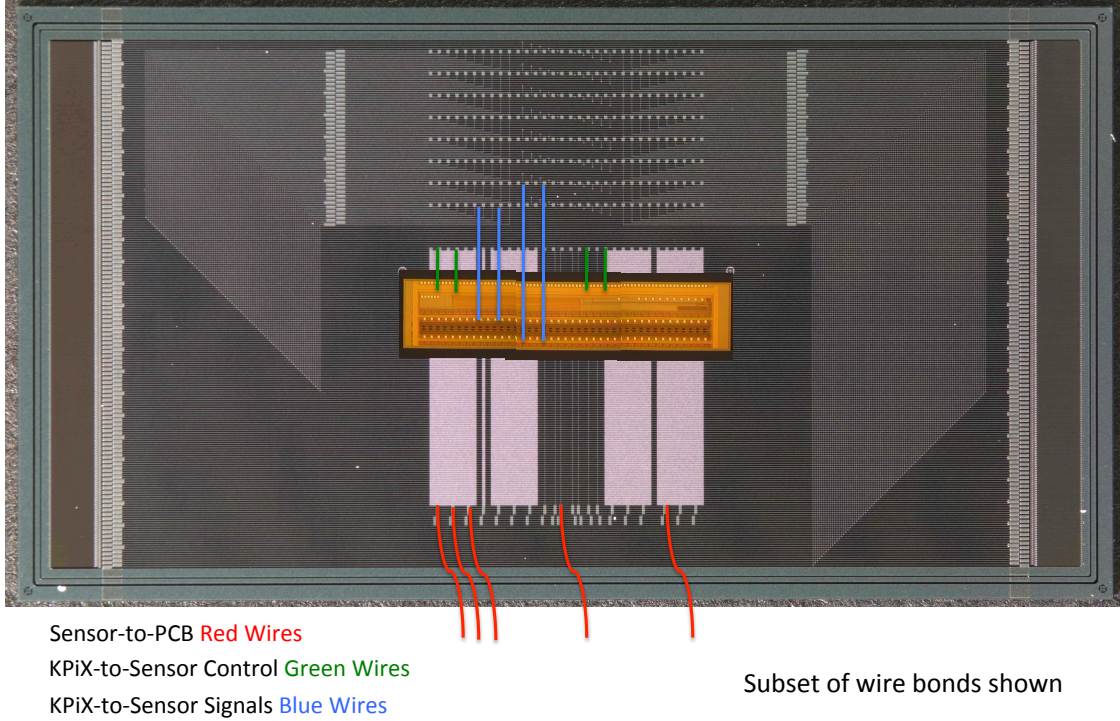
FIG. 2: The layout for initial testing with a 64-channel KPiX readout ASIC and double-metal test sensor. The KPiX is glued to the face of the sensor with bump bond pads facing up to allow wirebonding of KPiX to both the power/control traces (second metal) and the readout traces (first metal) of the sensor. For this test, the other end of the power/control traces were bonded to an underlying PCB instead of a polyimide flex cable.

wirebonding to the test sensor. The primary purpose of this test was to assess crosstalk from KPiX clock traces that are routed on the second metal layer to the underlying sense traces. The wirebonding layout for this test is shown in Figure 2. This wirebonding was

performed by Amtech Microelectronics Inc., the packaging and SMT vendor used by SLAC for all contract assembly and wirebonding. Although the wirebonds on this prototype appeared successful, testing revealed that the wirebonds on the sensor had shorted the second metal layer to the first-metal readout traces. A second attempt was made with the same vendor with the same results. In order to have more control over the wirebonding process, further prototypes were sent to colleagues at UC Santa Cruz and wirebonded there on their Hesse&Knipps BJ820 by an experienced technician. The results of this effort were similar and, in general, the rate of punch-through during bonding appears to be at least 10%. Table I summarizes the measured resistance between the second metal clock trace and the first metal readout traces that lie underneath the bonding pads on one of these prototypes.

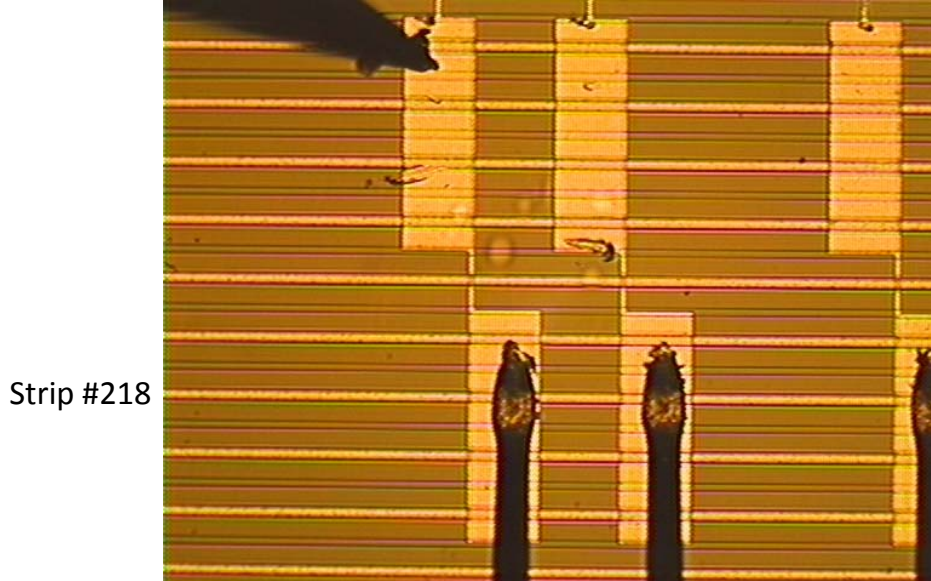
Figure 3 shows a closeup image of the wirebond pad that was found to have only 70Ω resistance to the underlying readout trace. Since then, the same technician using the same

FIG. 3: The setup for measuring the resistance between the clock trace, shown being probed at the spare wirebonding pad, and the underlying readout traces. As indicated strip 218 lies underneath the pad where the wirebond was made to the PCB.

Strip Number	Resistance to Clock Pad
215	$>10\text{M}\Omega$
216	$>10\text{M}\Omega$
217	$>10\text{M}\Omega$
218	$<70\Omega$
219	$2\text{M}\Omega$
220	$2\text{M}\Omega$
221	$2\text{M}\Omega$

TABLE I: The resistance between the clock trace (second metal) and the underlying readout traces (first metal) after wirebonding. Strip 218 is underneath the wirebond pad for bonding the clock trace to the PCB.

machine performed approximately 50000 wirebonds to Hamamatsu sensors fabricated for the DØ Run IIb upgrade in producing sensor modules for the HPS experiment without a single failure, resulting in a completed detector with a bad channel rate of less than 0.01%. Therefore, it has become clear that the oxide layer between the first and second metal layers

on these prototype sensors are, for an unknown reason, simply not robust enough to allow wirebonding.

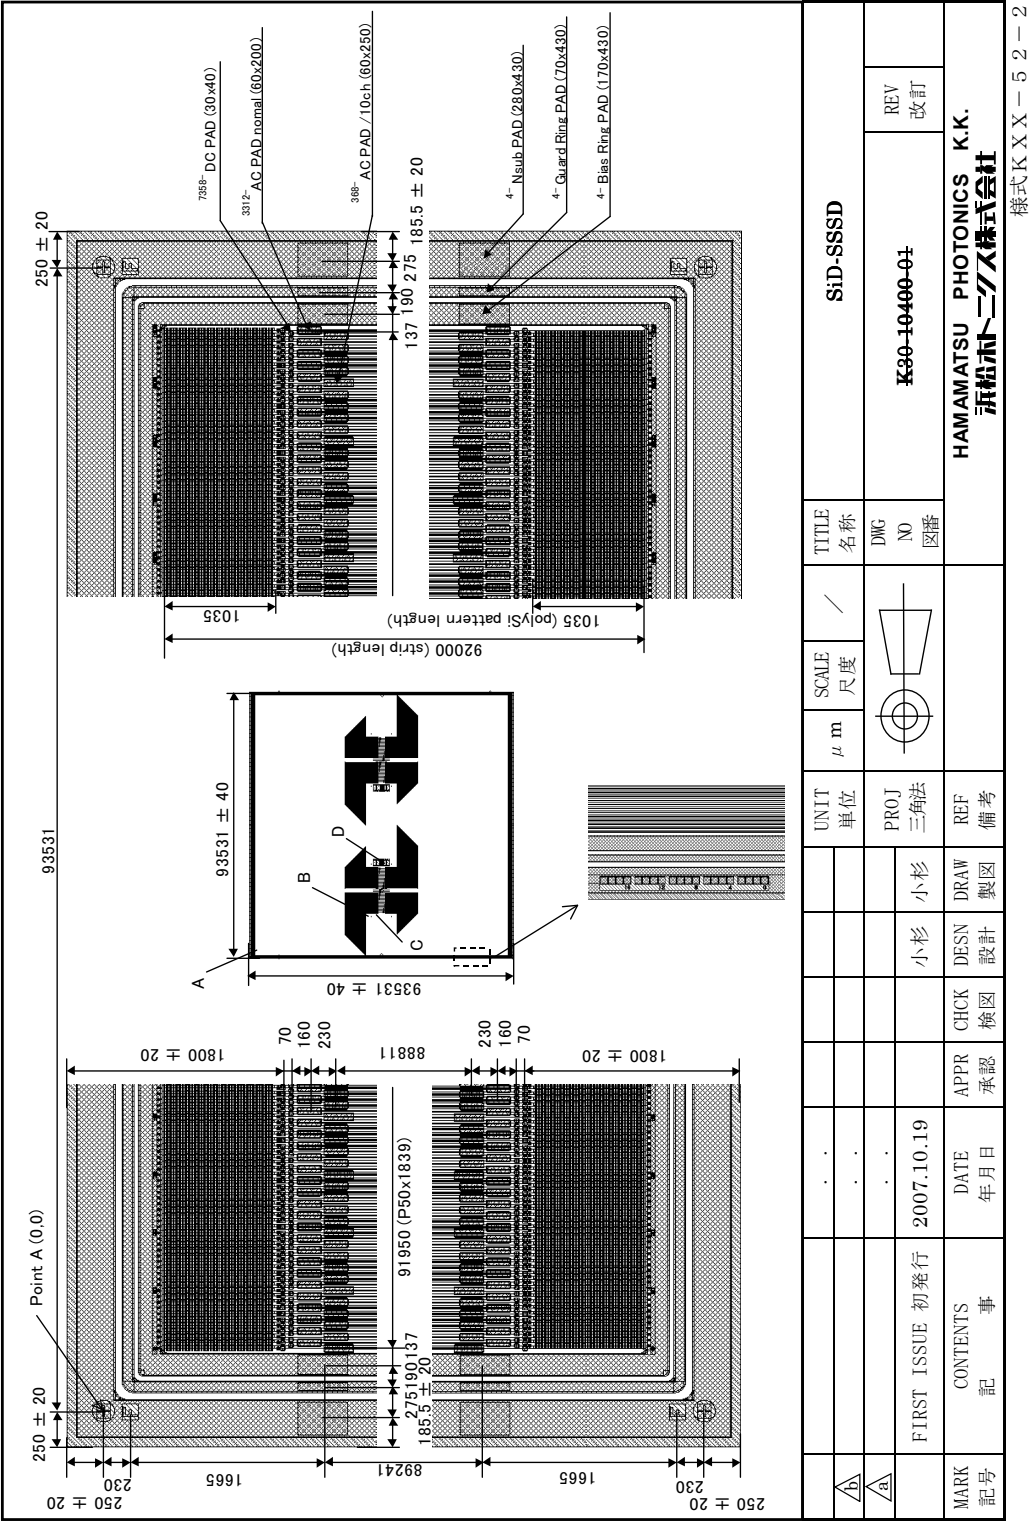
FIG. 5: The Hamamatsu overview drawing for the tracker sensor prototypes.

The specifications for the sensors are shown in Figure 4. The drawings for the full-sized sensors are shown in Figures 5, 6 and 7. The drawing for the test sensors is shown in Figure 8.

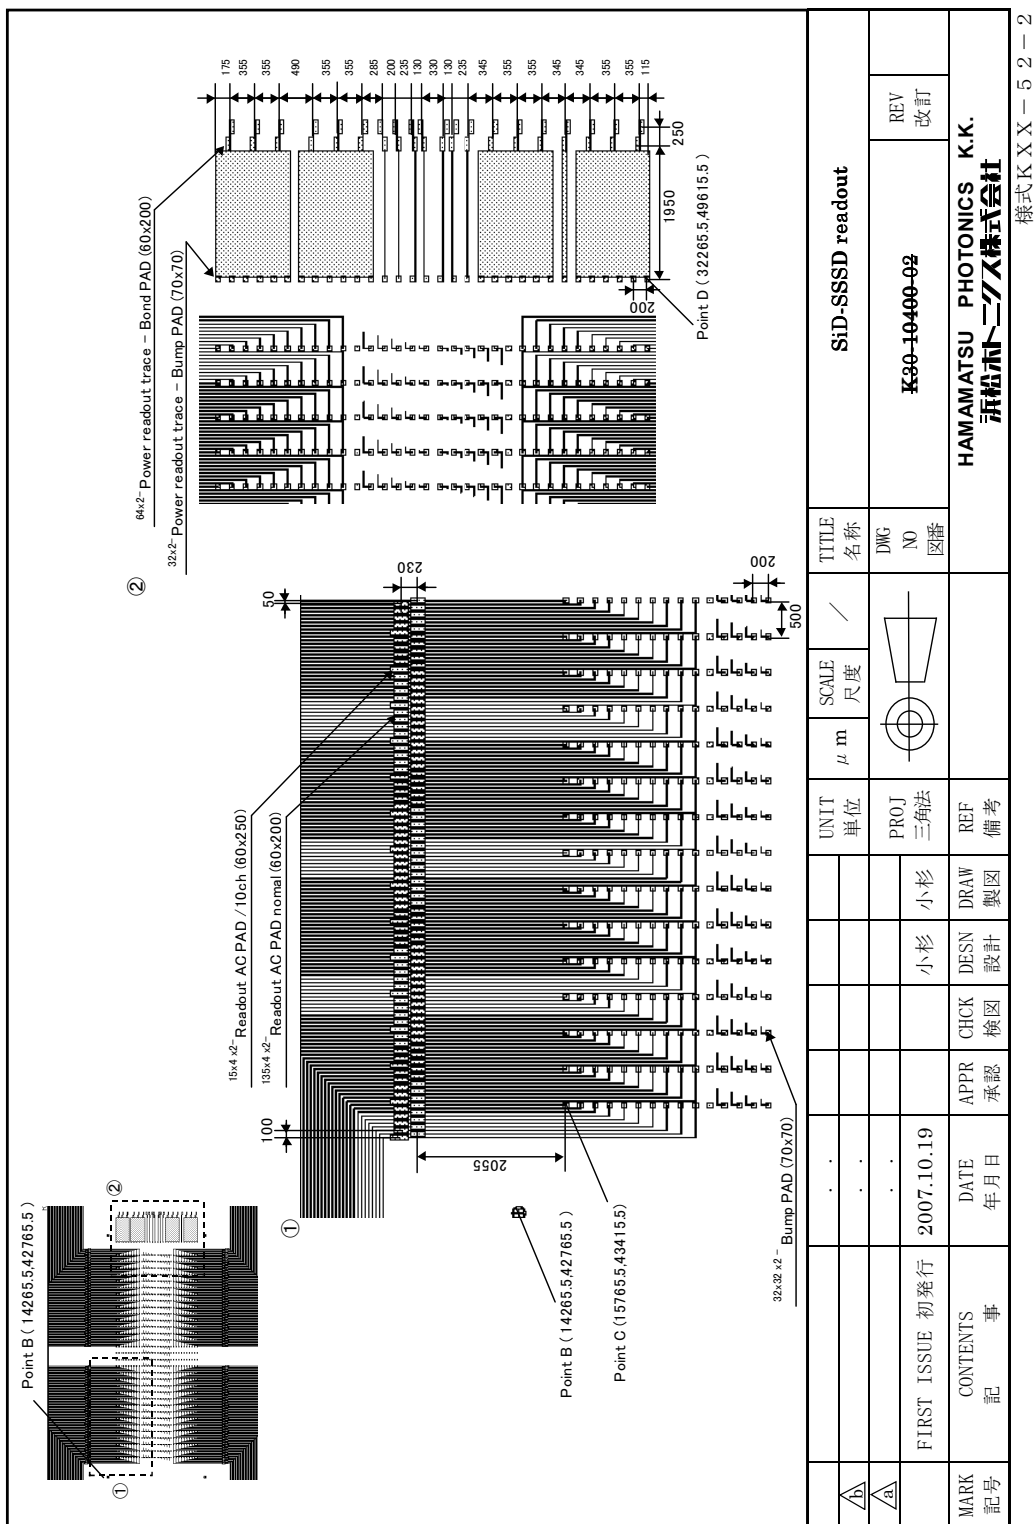
FIG. 6: The Hamamatsu drawing for the tracker sensor prototypes showing the KPiX and cable bonding region in detail. The wirebonding pads are along the right edge of the drawing.
