Home Inspection Report

2000 Hunnington #151, PLano, TX 75075

Mark Leitch, TREC# 21044

PROPERTY INSPECTION REPORT

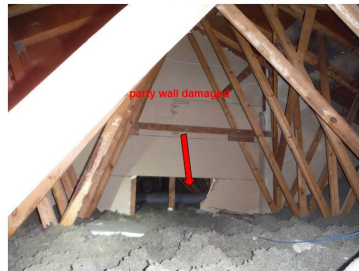
- **LIFE SAFETY ISSUE-** party wall between units has been compromised, recommend repairing holes with fire rated sheetrock and perform work to City of Plano building codes and standards

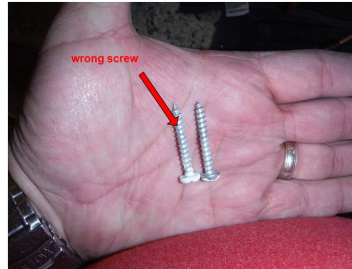
- panel contains no ARC fault breakers- safety device that is required in today's panel installs
- panel has wrong screws for cover, should be blunt tipped- left two out of panel on kitchen counter

DEFICIENCIES: Recommend licensed electrician evaluate the following for repairs

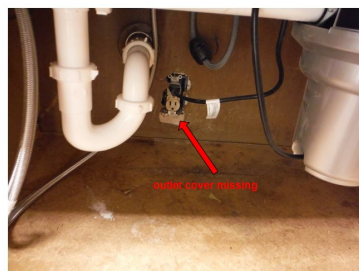
- outlet cover missing in kitchen at disposal
- lights not working at rear patio, living area
- light cover missing in kitchen

DEFICIENCIES: Recommend licensed electrician evaluate the following for repairs

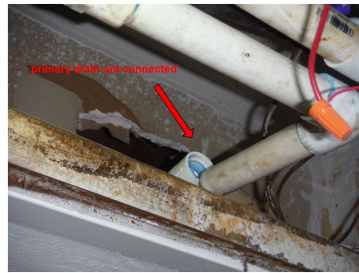
- primary drain line disconnected in the attic above tub- MUST CONNECT BEFORE USING A/C
- latches for furnace cover do not latch well and drywall screws were used to insure the cover wouldn't come open
- temperature differential on single unit is 14 degrees- normal is 16-21 degrees, recommend service
- blower wheel/motor is extremely dirty, this will restrict airflow and pass contaminants into ductwork- needs to be cleaned

DEFICIENCIES: Recommend licensed HVAC technician evaluate the following for repairs

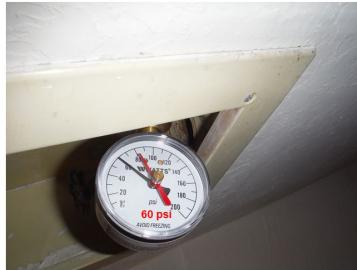
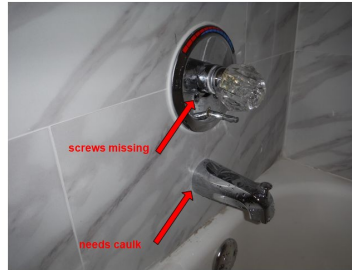
- hall bath
 - caulk shower valve trim
 - caulk all tubs spouts and trims
 - drain stopper lever at lavatory hard to operate
- master bath/ shower
 - caulk all tubs spouts and trims
 - trim screws missing for shower valve chrome trim
 - shower valve leaking behind handle

DEFICIENCIES: Recommend licensed Plumber evaluate the following for repairs

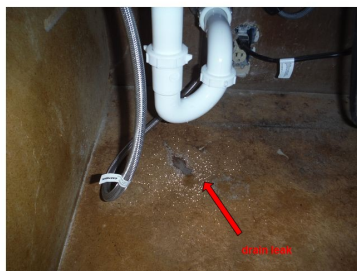
- drain fittings leaking at kitchen sink
- slow drain at master tub, master lavatory

DEFICIENCIES: Recommend licensed Plumber evaluate the following for repairs

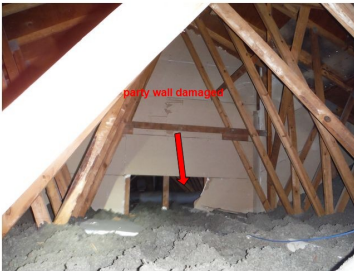
- **LIFE SAFETY ISSUE-** party wall between units has been compromised, recommend repairing holes with fire rated sheetrock and perform work to City of Plano building codes and standards

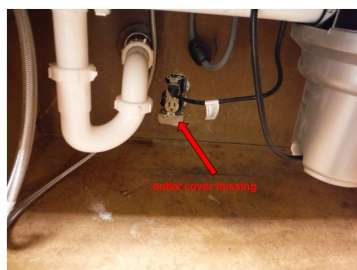
BRANCH CIRCUITS, CONNECTED DEVICES, AND FIXTURES

- outlet cover missing in kitchen at disposal
- lights not working at rear patio, living area
- light cover missing in kitchen

DEFICIENCIES: Recommend licensed electrician evaluate the following for repairs

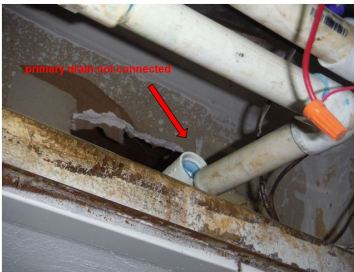
COOLING EQUIPMENT

- primary drain line disconnected in the attic above tub- **MUST CONNECT BEFORE USING A/C**
- latches for furnace cover do not latch well and drywall screws were used to insure the cover wouldn't come open
- temperature differential on single unit is 14 degrees- normal is 16-21 degrees, recommend service
- blower wheel/motor is extremely dirty, this will restrict airflow and pass contaminants into ductwork- needs to be cleaned

DEFICIENCIES: Recommend licensed HVAC technician evaluate the following for repairs

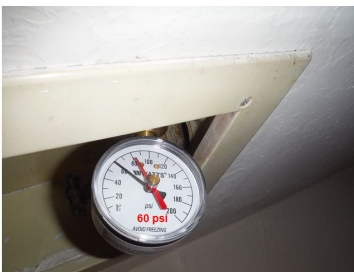
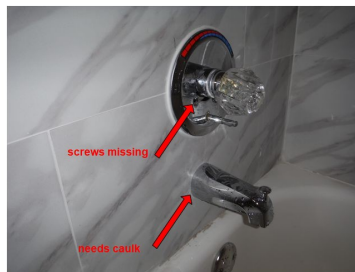
PLUMBING SUPPLY, DISTRIBUTION SYSTEMS AND FIXTURES

- hall bath
 - caulk shower valve trim
 - caulk all tubs spouts and trims
 - drain stopper lever at lavatory hard to operate
- master bath/ shower
 - caulk all tubs spouts and trims
 - trim screws missing for shower valve chrome trim
 - shower valve leaking behind handle

DEFICIENCIES: Recommend licensed Plumber evaluate the following for repairs

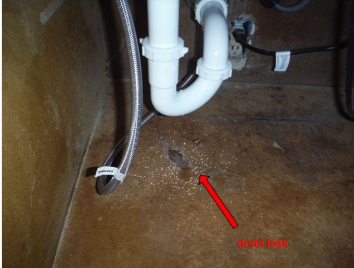
DRAINS, WASTES, AND VENTS

- drain fittings leaking at kitchen sink
- slow drain at master tub, master lavatory

DEFICIENCIES: Recommend licensed Plumber evaluate the following for repairs
