# Asbestos Refurbishment Survey

Saint Mary Somerset Tower, 5 Lambeth Hill, London, EC4V 4AG

<b>Client:</b>	Saint Mary Somerset Tower
<b>Job Reference:</b>	S-01137
<b>Report Date:</b>	01/04/2015
<b>Property Address:</b>	Saint Mary Somerset Tower 5 Lambeth Hill London EC4V 4AG
<b>Date of Survey:</b>	27/03/2015
<b>Survey Type:</b>	Asbestos Refurbishment Survey
<b>Surveyor Name:</b>	Mohammed Waheed
<b>Surveyor Signature:</b>

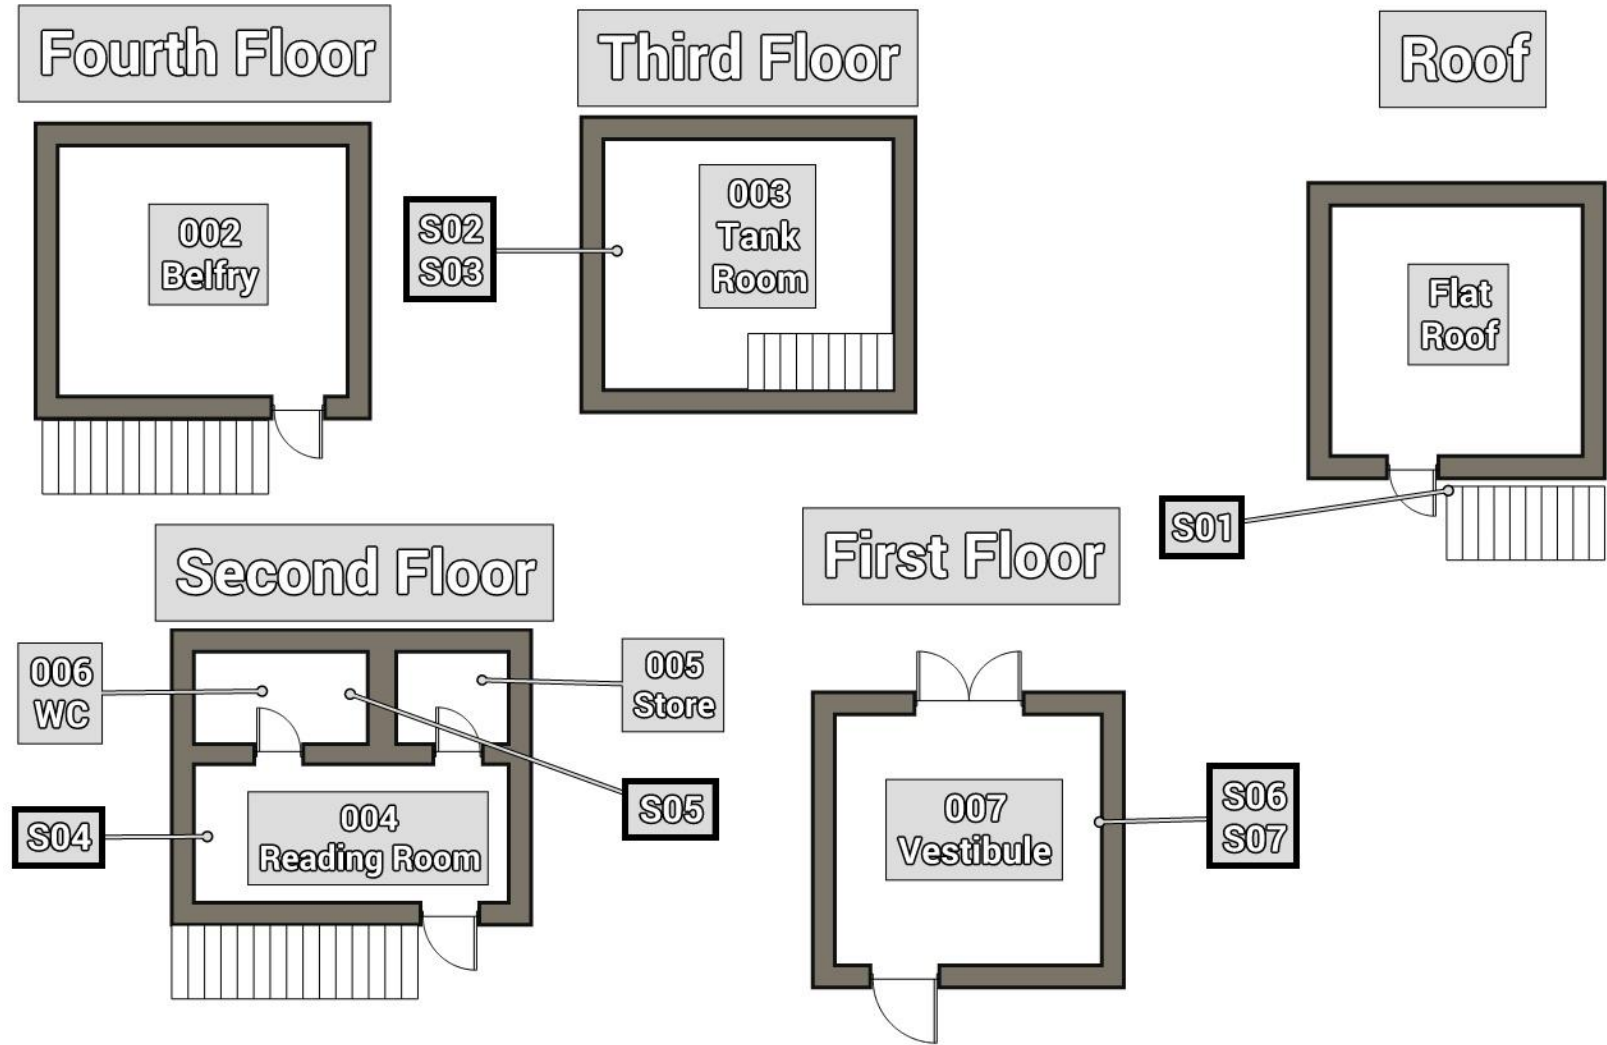
## Site Floor Plans

SITE PLAN	THIS SITE PLAN SHOULD BE READ IN CONJUNCTION WITH THE FULL ASBESTOS SURVEY REPORT	KEY	Sample Numbers	 	Unit 28, Essex Technology & Innovation Centre, The Gables, Fyfield Road, Ongar, CM5 0GA	NOT TO SCALE	<p><b>Limitations of reported information</b></p> <p>The information contained within this report which identifies the locations of asbestos containing materials (ACMs) should not be treated as either exhaustive or definitive. It should always be assumed that there may be other ACMs present, hidden or undetected within the fabric of the building. Further investigations may be necessary when carrying out works likely to disturb the fabric of the building.</p>
		 	Negative Sample Number				
		 	Positive Sample Number
