ELEC 340

APPLIED ELECTROMAGNETICS AND PHOTONICS

Lab 3 - Normal Incidence and Reflection Transmission

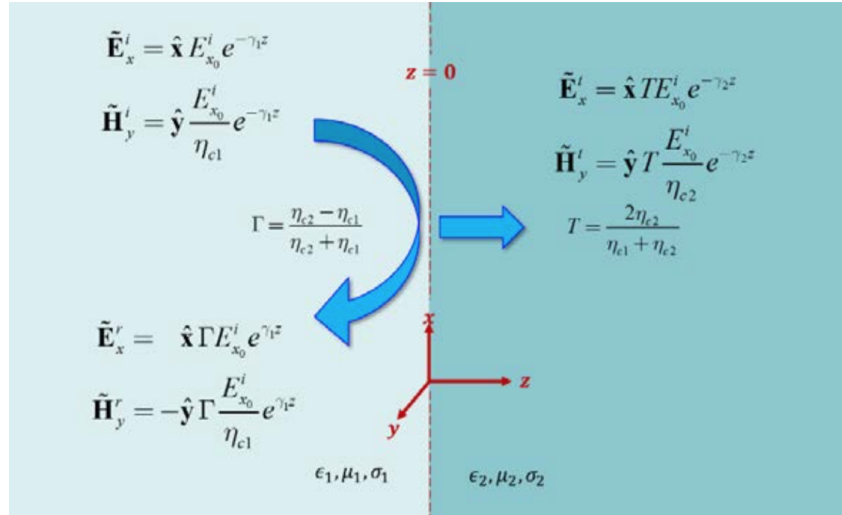
Figure 1: Reflection and transmission of a uniform plane wave at a normal material boundary

This lab uses a parallel plate wave guide filled with two different dielectrics to investigate reflection and transmission. When a uniform plane waves hits the boundary between two different dielectrics part of it is transmitted into the second medium and part of it is reflected back. The reflected wave interferes with in incident wave and creates a standing wave. This process is shown in Fig. 1.

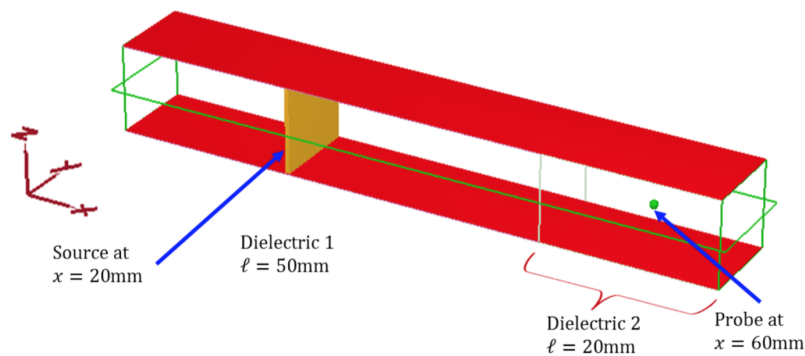
Figure 2: Parallel plate waveguide

A waveguide was constructed in MEFiSTo and filled with two dielectric media, as shown in Fig. 2.

Initially, we made both dielectrics identical and changed the right end to a perfect electrical boundary. The source generated a 10 GHz plane wave through the structure. By observing the wave envelope in the structure we were able to determine the standing wave amplitudes, E_{max} and E_{min} , and positions of l_{max} and l_{min} . The type of right boundary (absorbing, electric, magnetic) was changed, as well as the dielectric properties ϵ_r and σ . See Section 4 for the effect of these variations of the wave patterns.

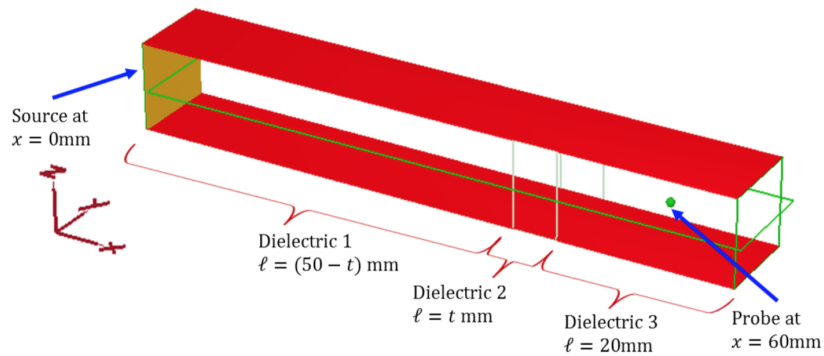
Figure 3: Waveguide with three dielectric regions

A third material was added to study the use of dielectrics as impedance transformers. The structure is shown in Fig. 3

By choosing the length of the second dielectric region as $\lambda_2/4$ and $\epsilon_2 = \sqrt{\epsilon_1\epsilon_3}$, we were able to create several impedance transformers by varying the length of the second medium and by using different pairs of input frequency and medium size.

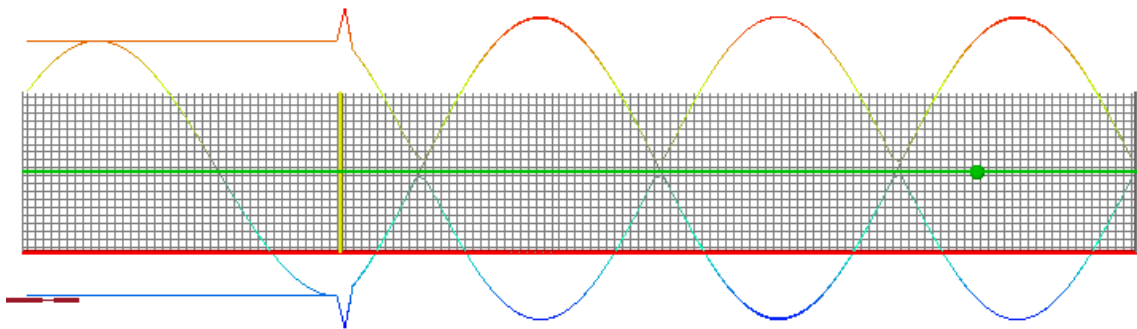
Figure 4: Standing wave pattern for waveguide with electric boundary at right end

Fig. 4 shows that the wave has an amplitude of 2 V m^{-1} . This is because the reflected wave is in phase with the source wave and constructive interference occurs.

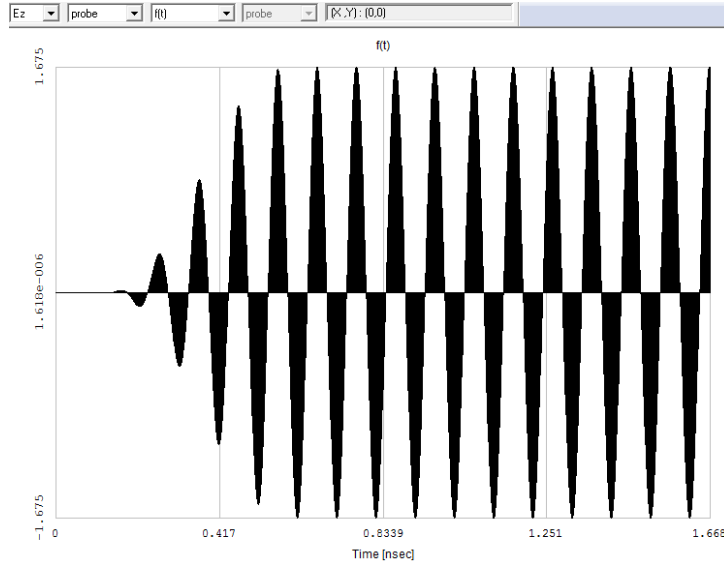
The amplitude of the standing wave is 1.675 V m^{-1} because the probe is not located at a standing wave antinode: odd integer multiples of l_{max} .

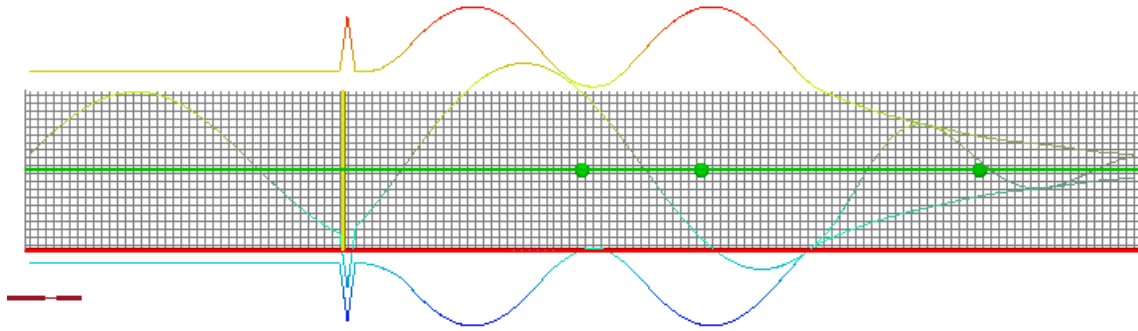
Figure 5: $\epsilon_{r2} = 4$, $\sigma_2 = 1 \text{ S m}^{-1}$, absorbing right boundary

A standing wave envelope is produced between the source and dielectric boundary. As the wave enters the second medium it is attenuated.

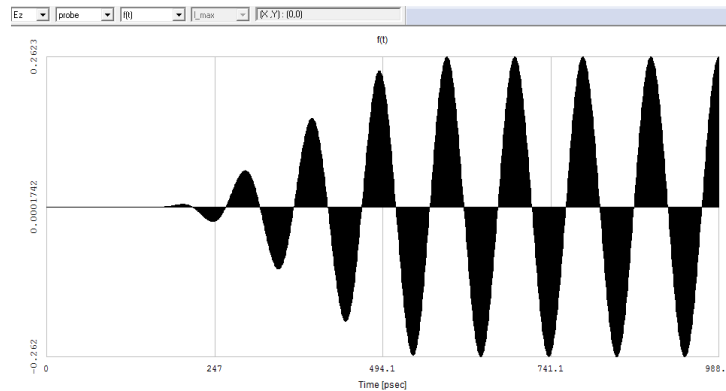
The amplitude is 0.263 V m^{-1} . As noted in 2b, the source is not placed at an antinode. Also, the wave attenuates as it enters the second medium because $\sigma_2 \neq 0$.

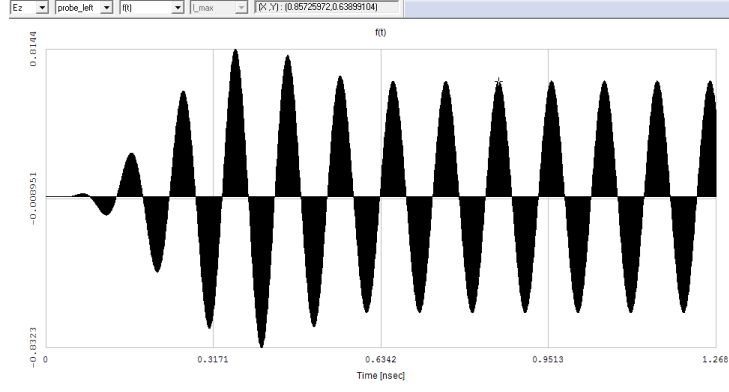
Task 5d What are: $E_{max}, E_{min}, I_{max}, I_{min}, |\Gamma|, \phi_\Gamma$? What are possible sources of error between the simulation and expected values?

Again, error comes from approximating c_0 .

Parameter	Expected	Actual
E_{max}	1.33 V m^{-1}	1.365 V m^{-1}
E_{min}	0.67 V m^{-1}	0.685 V m^{-1}
l_{max}	42.5 mm	$> 42.5 \text{ mm}$
l_{min}	50 mm	$> 50 \text{ mm}$
$ \Gamma $	$\frac{1}{7}$	$\frac{1}{7}$
ϕ_{Γ}	0 rad	0 rad

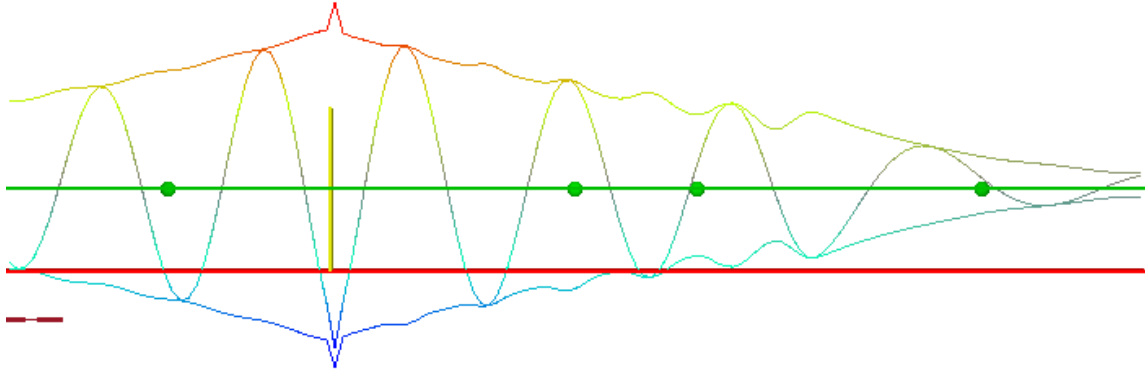
Figure 6: $\epsilon_{r1} = 9$, $\sigma_1 = 0.5 \text{ S m}^{-1}$, $\epsilon_{r2} = 4$, $\sigma_2 = 1 \text{ S m}^{-1}$

The wave attenuates in the first dielectric because $\sigma_1 \neq 0$.

Task 6c What is the amplitude of the wave to the left of the source region? Is it 2 V m^{-1} ? Why? The amplitude is 0.7345 V m^{-1} at the location of the leftmost probe in Fig. 6. It does

not receive constructive interference from the reflection and is attenuated by the dielectric.

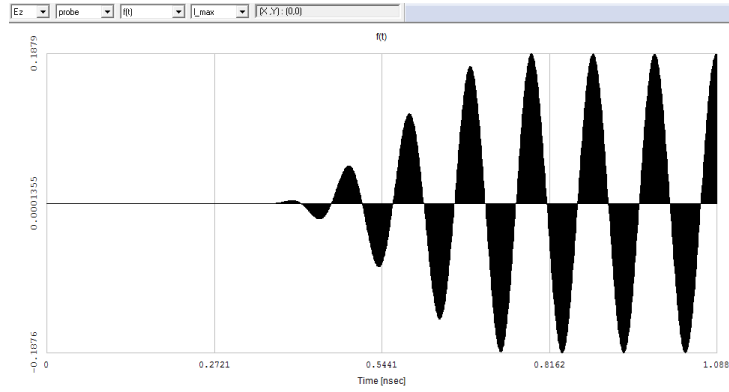
The amplitude is 0.1879 V m^{-1} . It is smaller than in 5b because the wave attenuated in the first medium.
