Where is the Ordinary High Water Mark of a River?

The Ordinary High Water Mark in the Chagrin River Watershed

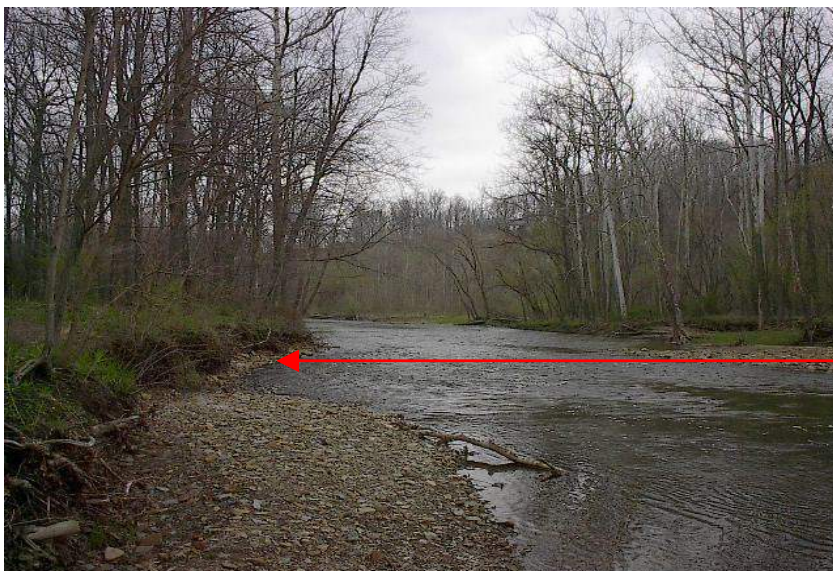
Figure 1: South Chagrin Reservation, Village of Bentleyville

The ordinary high water mark on this section of the Chagrin River is clear at the point where gravel meets terrestrial grasses along the stream bank.

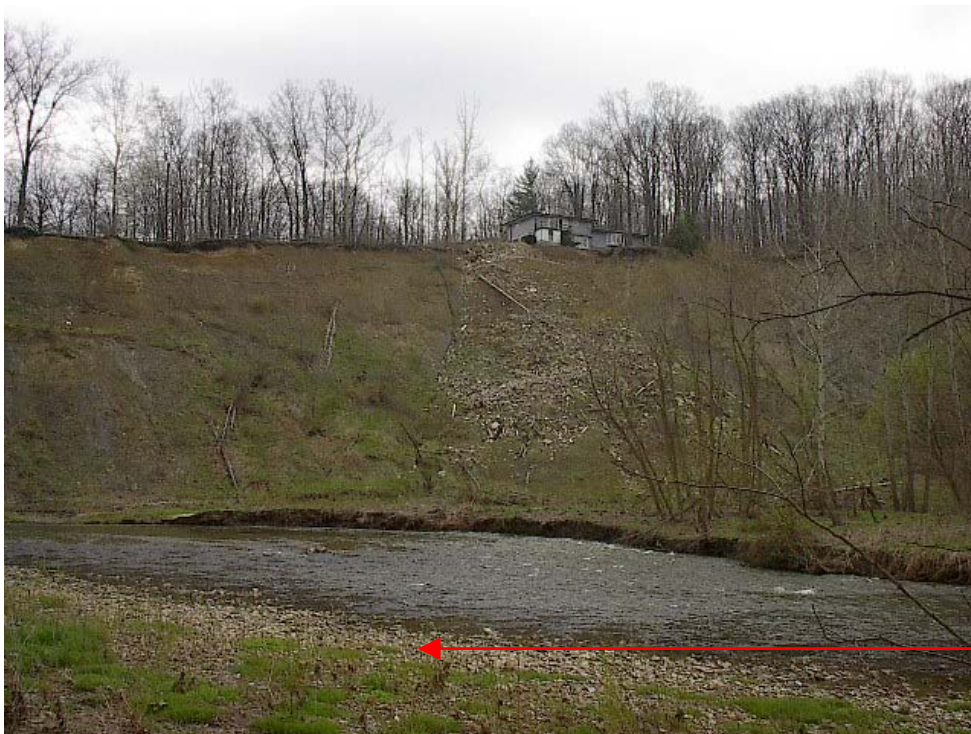
Figure 3: Village of Moreland Hills

This ordinary high water mark area highlights a transition between aquatic plants and terrestrial plants.
