RIPARIAN DEMONSTRATION/ EVALUATION PROJECT

The Importance of Large Woody Debris in Sandy River Systems

REPORT REFERENCE: WRC4

JUNE 2000

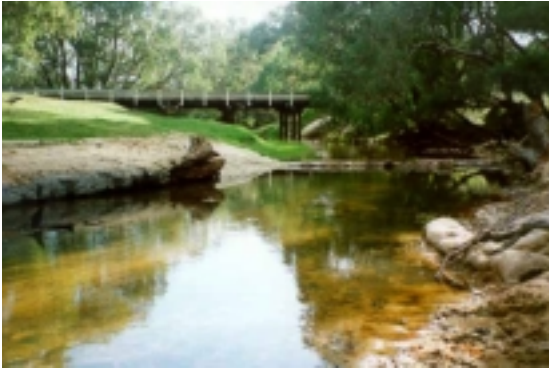
Looking downstream at Riffle A. Log toe protection was placed against the left bank and a jute log used to divert flows away from the right bank and towards the riffle. (22.5.1998)

At three locations (shown on Attachment 2 Site Plan) logs were placed perpendicular to the flow to form “riffles”. Two logs were used at each site to build a V-shaped riffle across the low flow channel (figure 1). A trench was excavated into the bed and the logs buried to half their diameter. The riffles were constructed with the root balls of the logs buried into the bank to anchor the logs and the tapered ends pointing slightly upstream. The lowest point of the riffles was at the join of the two logs in the centre of the channel. The riffles were constructed to a maximum height of about 0.3 metres to allow fish migration.

One very large trunk was placed mid-channel about 470 metres upstream of the bridge. The remainder of the logs were orientated to provide “toe protection” to support stream banks either immediately upstream or downstream of the riffles or on the outside of meander bends to direct flows away from the banks. Sections of the banks were stabilised with jute matting, which was pinned down.

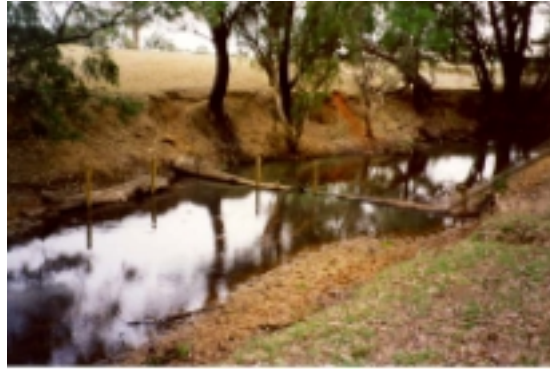
Looking downstream at Log Riffle B. (5.5.1999)

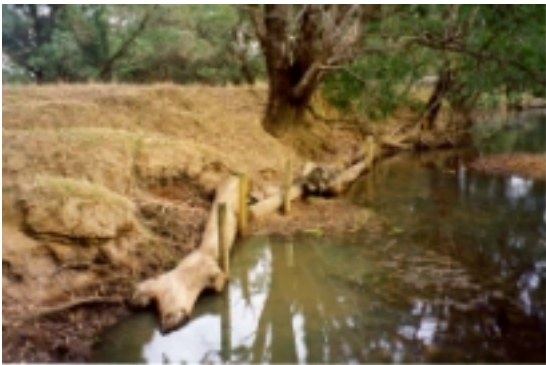
Logs pinned against left bank, looking downstream. (5.5.1999)

In February 1999, the logs which had moved were re-positioned and an additional twelve logs were placed along the reach. The logs were wired to 3.5 metre long, 100 to 150 millimetre diameter pine posts driven into the bed to secure the logs placed on the outside of bends into position. No significant movement of logs were observed during the 1999 winter, however peak flows were much lower than in 1998. Deterioration of the jute matting was mainly caused by cattle trampling.

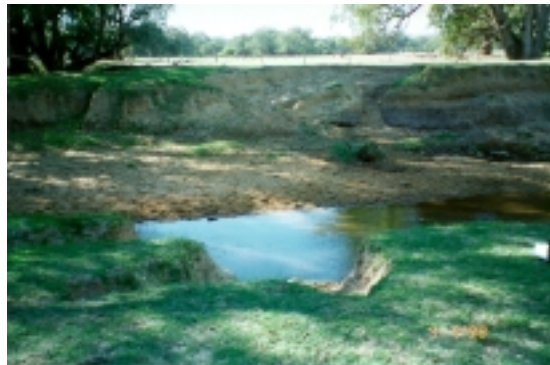
Cattle access track prior to construction of Riffle C. (4.5.1998)

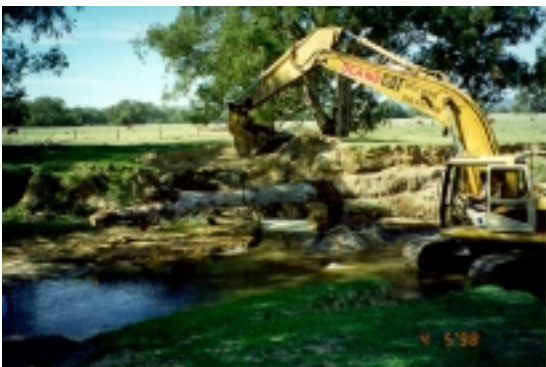
During construction of Riffle C, a trench was excavated and the butt of the logs buried into the bank. (4.5.1998)

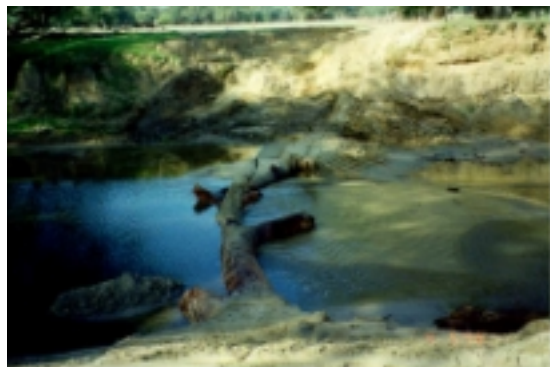
Log Riffle C. (4.5.1998)

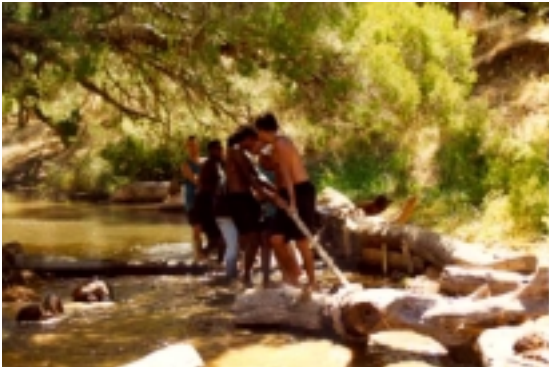
Landcare trainees installing logs. (March 1999)

In order to minimise disturbance to the riparian zone, the logs were installed manually by Landcare trainees through the Fairbridge “Ecohouse Project”. Twelve trainees manually dragged the logs into position. Thirty logs of somewhat smaller size than at Paterson Rd were installed. The logs were retained by wiring and bracing to pine posts and galvanised fencing droppers jettied or driven into the bed. Sedges and rushes were also transplanted and brushing installed to protect banks from undercutting. Some minor movement of logs occurred during the 1999 winter. The movement was due to some of the pine posts being inadequately installed by the Landcare trainees. This was easily rectified.

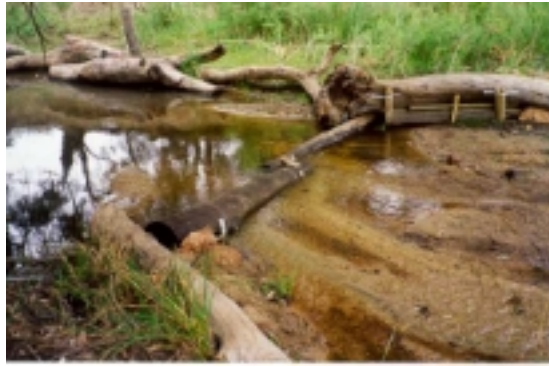
Log riffle and bank protection. (5.5.1999)

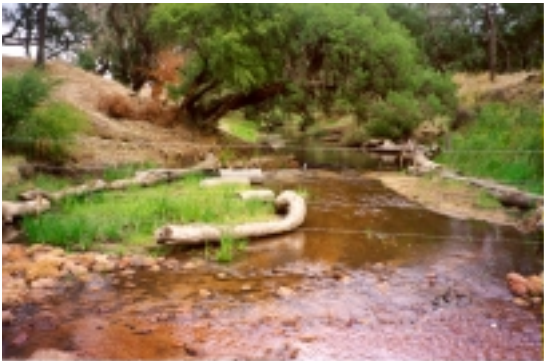
Looking downstream from cattle crossing.
(5.5.1999)

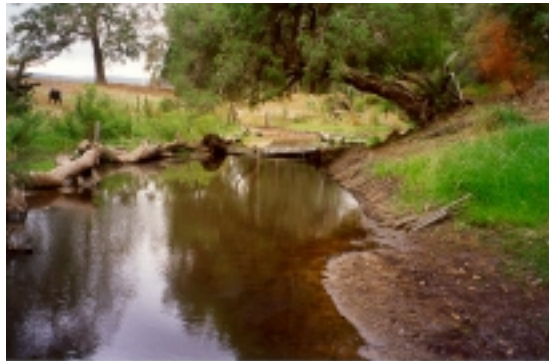
Looking upstream towards cattle crossing. Logs
and brushwood were used to protect the banks
from undercutting. (5.5.1999)
