Executive Summary

This report provides an analysis and recommendations based on the data related to the 2015 Gorkha Earthquake in Nepal. The data contained 20,000 samples collected by the Central Bureau of Statistics pertaining to the location and various attributes of structures.

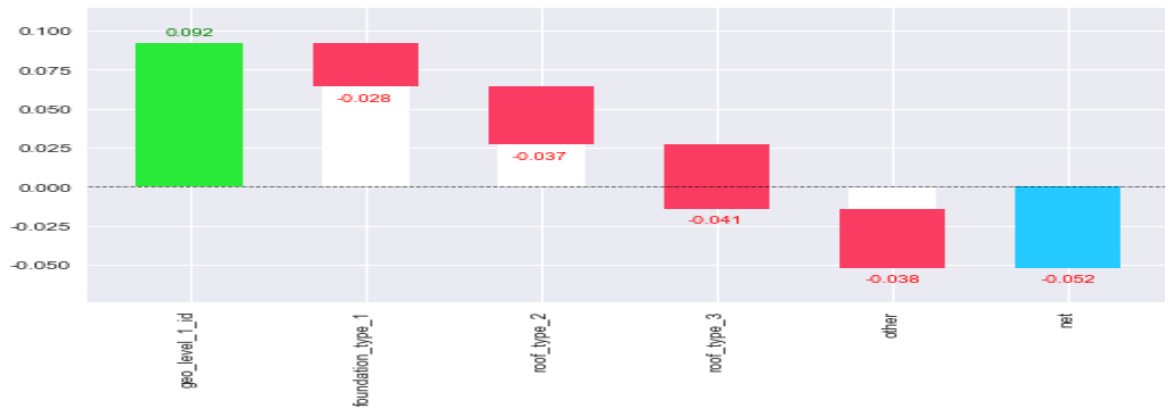
Damage Grade 2, Building 7484:

Building 7484 is interesting because it is in the geo_level_1_id of 10 which appears to be lightly hit region, yet the damage grade was 2. The primary contributing factors to its predicted damage grade of 2 are its foundation type_1 which is type 337f, it does not have roof type 2, but it does have a roof type of 3, e0e2. It also has several smaller contributions that add up to a significant increase in damage grade. A more detailed report, as shown below, reveals several features that make up the “other” category.

This report would recommend these structural issues be addressed to reduce the damage grade of 2 despite its low risk geo level. It should be considered a medium priority for triage.

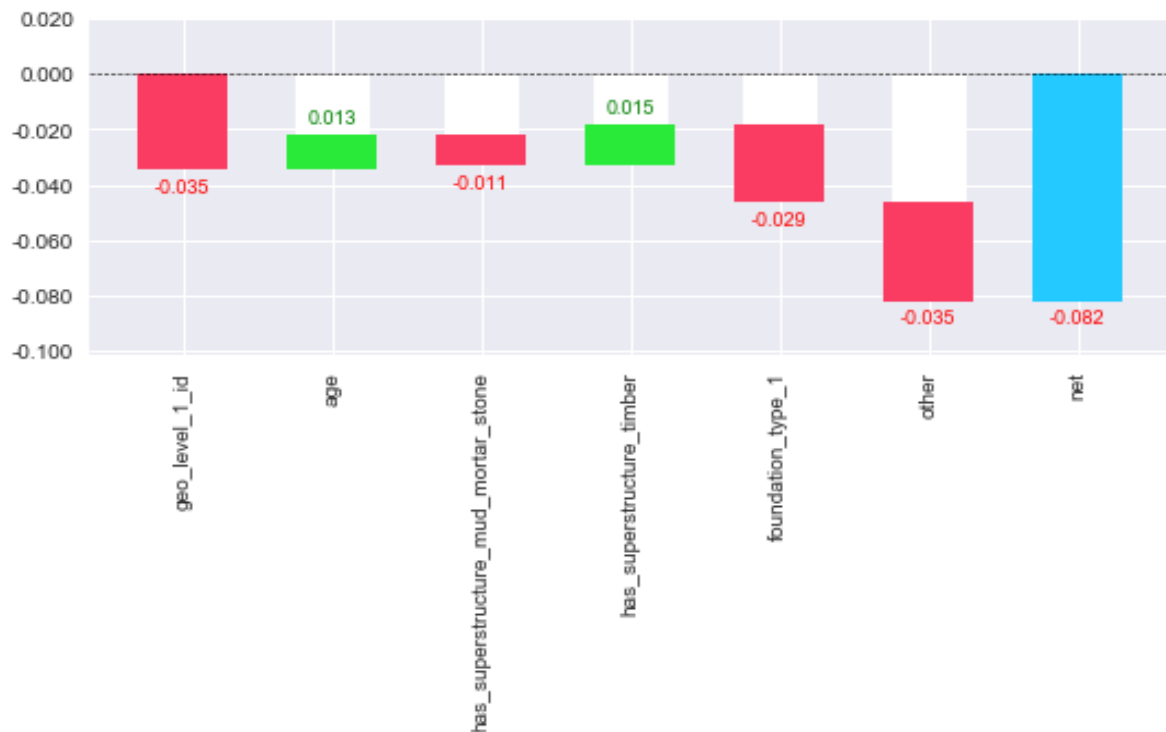
Damage Grade 3, Building 6668:

Building 6668 was a damage grade 3 building yet it had some positive features. The geo_level_1_id is 5, a very large contributor to the damage grade. The age of the building was 5, which was a plus. Contrary to building 4218 the superstructure is mud, mortar, or stone so it takes a hit, but the fact that the superstructure also contain timber negates this feature. Again, we have foundation type 1(337f) which greatly contributes to this buildings damage grade and a primary reason for the damage grade of building 7484 despite its advantageous geographic region.

This report would recommend a closer look at all buildings in this geo level of 5 and all buildings with foundation type 337f should be considered at risk and a priority for triage.
