Jorde Farms HOA
Queen Creek, AZ

Report #: 47818-0
Beginning: January 1, 2024
Expires: December 31, 2024

RESERVE STUDY
"Full"

August 31, 2023

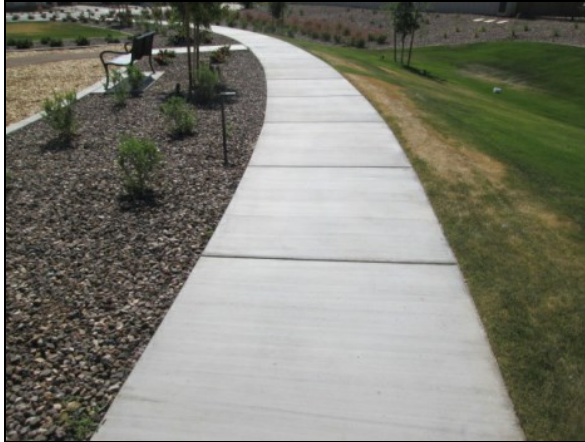
Comp #: 103 Concrete/Pavers - Repair**Quantity: Numerous Sq Ft**

Comments: There is no expectancy to completely replace the concrete or walkway pavers. This component funds an allowance for periodic repairs and partial replacements as needed.

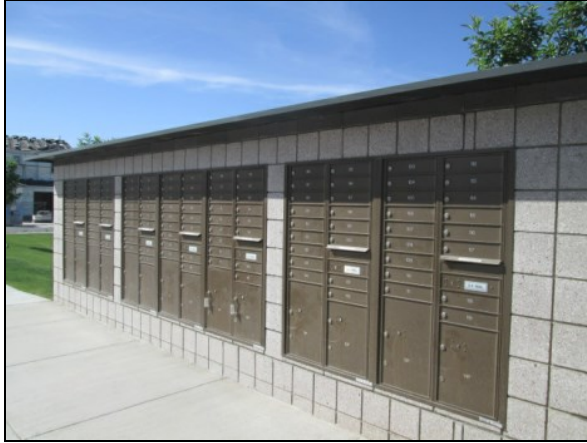
Comments: Manufactured by Florence Corporation. We located (14) 17-box clusters during our inspection in 2023. We assume another approximately (10) more clusters will be installed during 2023-2024. Model: 4C15D-17, Mfg. Date: 10/2021.

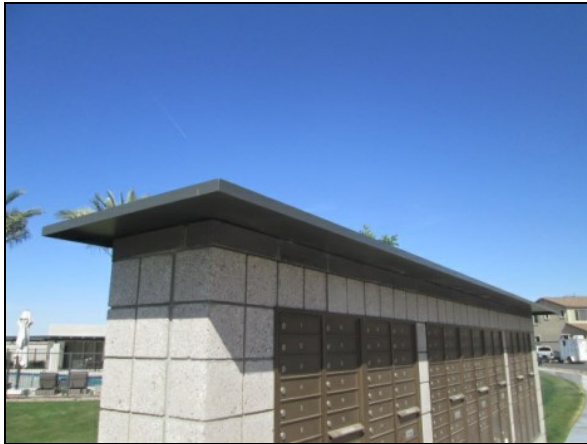
Comments: These metal roofs have a long life span anticipated under normal circumstances. It would still be prudent to plan for replacement at some point.

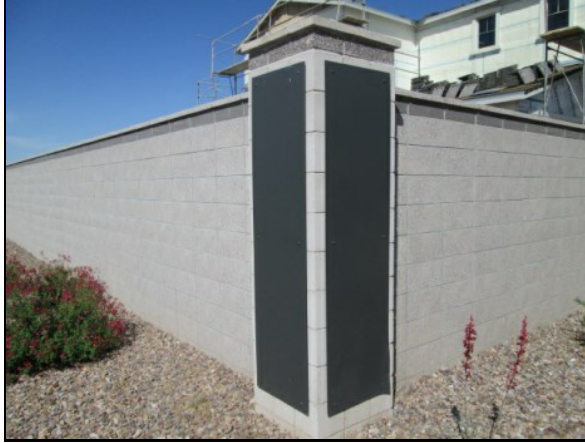
Comments: There are approximately (158) stucco wall columns and (54) columns with 2 decorative metal panels mounted to each of them. Periodic repainting should be anticipated to maintain the appearance and to keep the surfaces properly sealed.

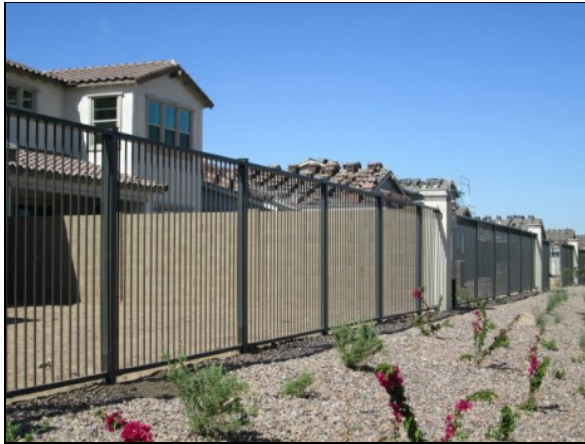
Comments: This view fence is approximately 6' tall and mounted in-ground. This component funds for complete replacement eventually.

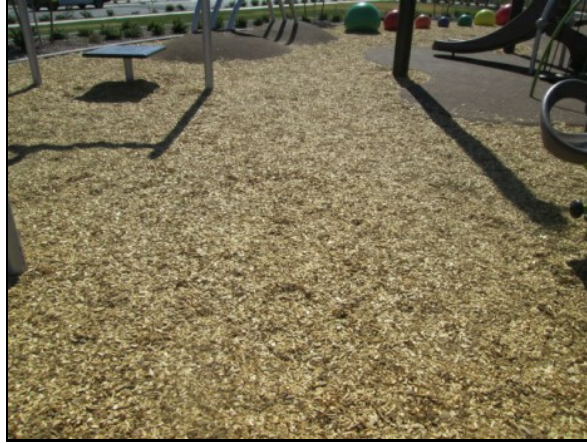
Comments: There is no expectancy to completely replace the wood mulch surface. HOA should expect to top dress/replenish it periodically to maintain proper surfacing depths.

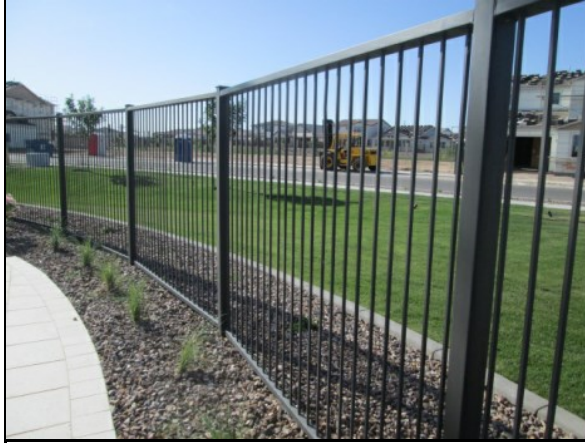
Comments: Observed to be stable and secure. This component funds for future replacement.

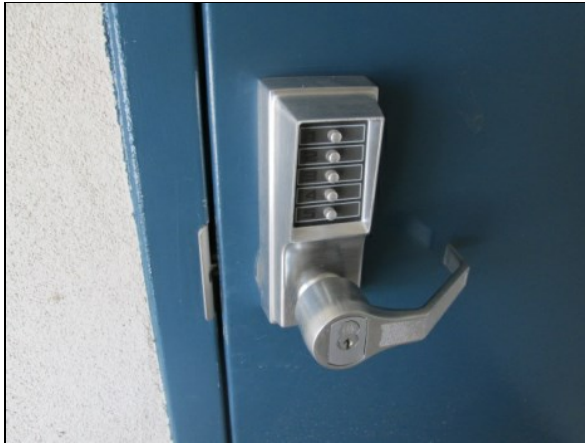
Comments: Observed to be functional and in good shape. Future replacement should be anticipated.

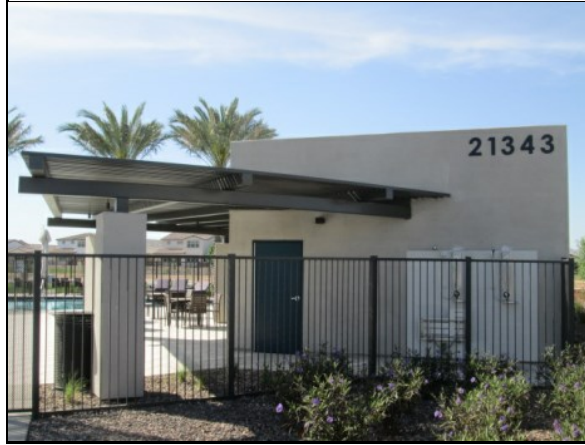
Comments: Surfaces appear uniform and in good shape. Repaint periodically to maintain the appearance and to keep the surfaces properly sealed.

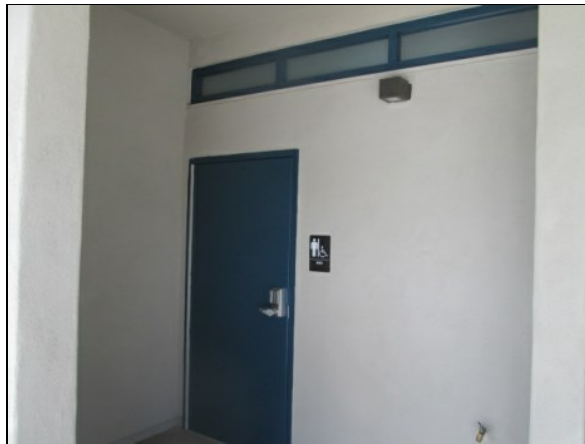
Comments: Long life expectancy anticipated under normal circumstances. It would still be prudent to plan for replacement at some point.
