Wardak Watershed and Irrigation Survey Project

Day Mirdad District Report

March 2011

CERP Project Number 20100204152503

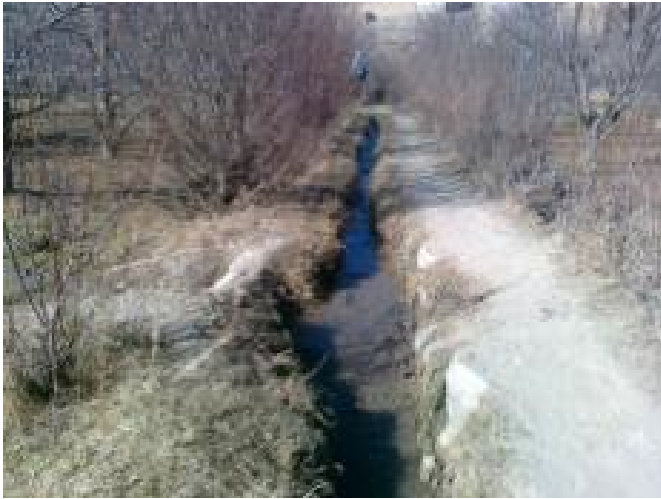
1. The Village Canal

There is one village canal. The water is potable and the flow is moderate irrigating 6,000 jeribs of land and 390 families benefit from this canal. The canal is shared by 3 villages and its source is the Jilga River. The canal has leaks and has blockages. It is damaged and is full of mud and stone (see pictures 1, 3 and 4). There is one check dam which is 2m deep and 25 m wide. They use this check dam for irrigation only. It was built about 50 years ago and it has visible cracks and damage and leaks. It is full of mud and stone and needs cleaning and repairs and concreting (see picture 2).

Various interventions were requested by the village elders. In terms of water and irrigation needs, they suggested repairs to the canal and check dam and its channels damaged by flooding. These are a priority. The need for work on the canal and the check dam was confirmed by the survey team. The potential for improving ground-water replenishment was not noted by the survey, but looking at the photographs there is obviously potential for better rangeland and catchment management and some reforestation.

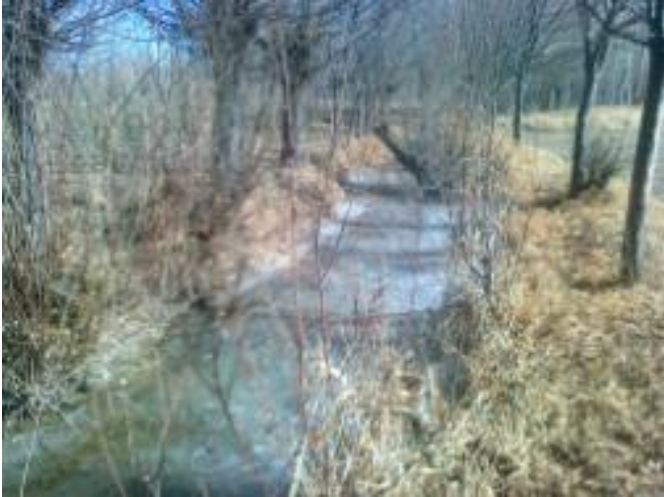
1. The village Canal

The water comes from a canal and a spring. The canal is called Jawe Lala Canal and its source is the Jilga River. The total length of the canal is 1,000m and 2 villages share it. 100 families benefit from this canal and 700 jeribs of land is irrigated from it. It leaks and has blockages and some damage. There are some trees and grass growing along the canal. The irrigation system is furrow and flood. The spring also needs some attention.

All the village elders interviewed recommended the cleaning, repair and concreting of the canal and spring and the concreting of the spring's reservoir. This will have positive effect on water.

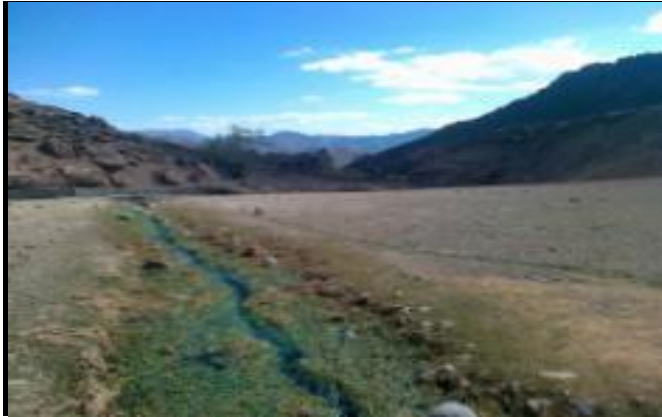
1. Wech Karez canal

According to the villagers, the irrigation system is in a very bad state due to recent floods and the past drought and the two Karezes are damaged. The survey team thought that hard work was needed. Water is mainly by Karez, but a properly constructed reservoir and channel from the karez to the field would have a positive effect on irrigation for the village. General improvements to the Karezes systems were requested to clear blockages and prevent leaks. There are several inconsistencies in the data collected for the Karezes and it is suggested that the team return to check their readings.

The elders mentioned that the two karezes need cleaning and that the water channel leaks. It is damaged every year by floods. Concreting could solve this problem. They were concerned about a flood protection wall for the Karezes and building a reservoir for each Karez.

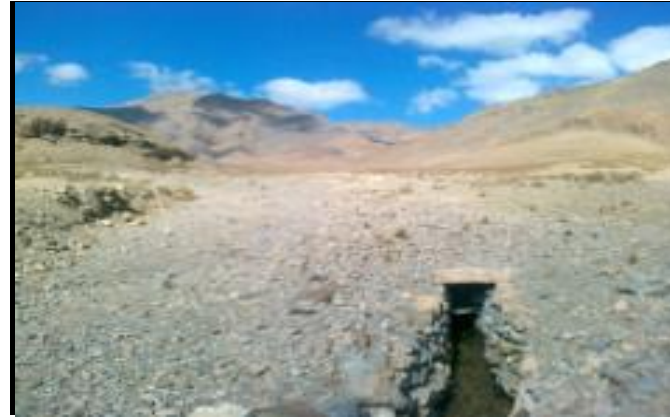
2. Ster Karez canal

Name: Village Item	Type	GPS (Of Exit) N E Altitude (M)	Description	Condition & Repairs Needed	Cost Estimate USD	Cost Per Beneficiary USD	Cost Per Jeribs Irrigated USD
			The water is potable.				
Tara	Ster Karez	N 34.27600 E 68.39968 Alt:2715 m	<p>The karez supplies 180 households and irrigates 450 jeribs of land</p> <p>The soil type is gravel and soil erosion is moderate.</p> <p>There are some grasses and forestry trees around this karez and its canal.</p> <p>The water is Potable.</p>	<p>The karez is full of mud and stone and has blockages and damaged sections. Its canal also has leaks and blockages.</p> <p>The karez needs cleaning and its shafts need re-digging. It needs other repairs to damaged sections and also the cleaning and repairing of its canal.</p>	18,000	100/families	40
Rashid	Rashid Spring	N 34.23012 E 68.4228 Alt:2374 m	<p>The spring supplies 90 households and irrigates 150 jeribs of land.</p> <p>There are some grasses around the spring.</p> <p>The water is potable.</p>	<p>The spring is full of mud and stone and its canal leaks and has blockages and visible cracks.</p> <p>It requires cleaning and concreting of the damage and leaking sections .</p>	250,000	2777/families	1666

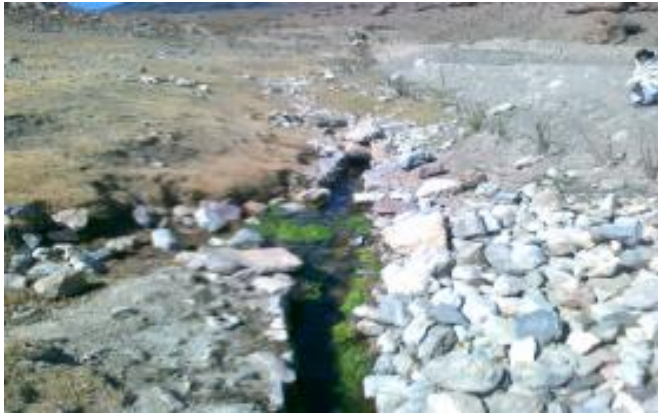
1. Toiaka Village Karez

Water is sourced from karez and canal which are in poor condition with leaks, blockages and damage. Both canal and karez require cleaning and repair and perhaps concreting in some areas.

The village elders from Toiaka say that they need karez, canal and reservoir cleaning and repair. They would also like village improvements including a health clinic, greenhouses and one cold store.

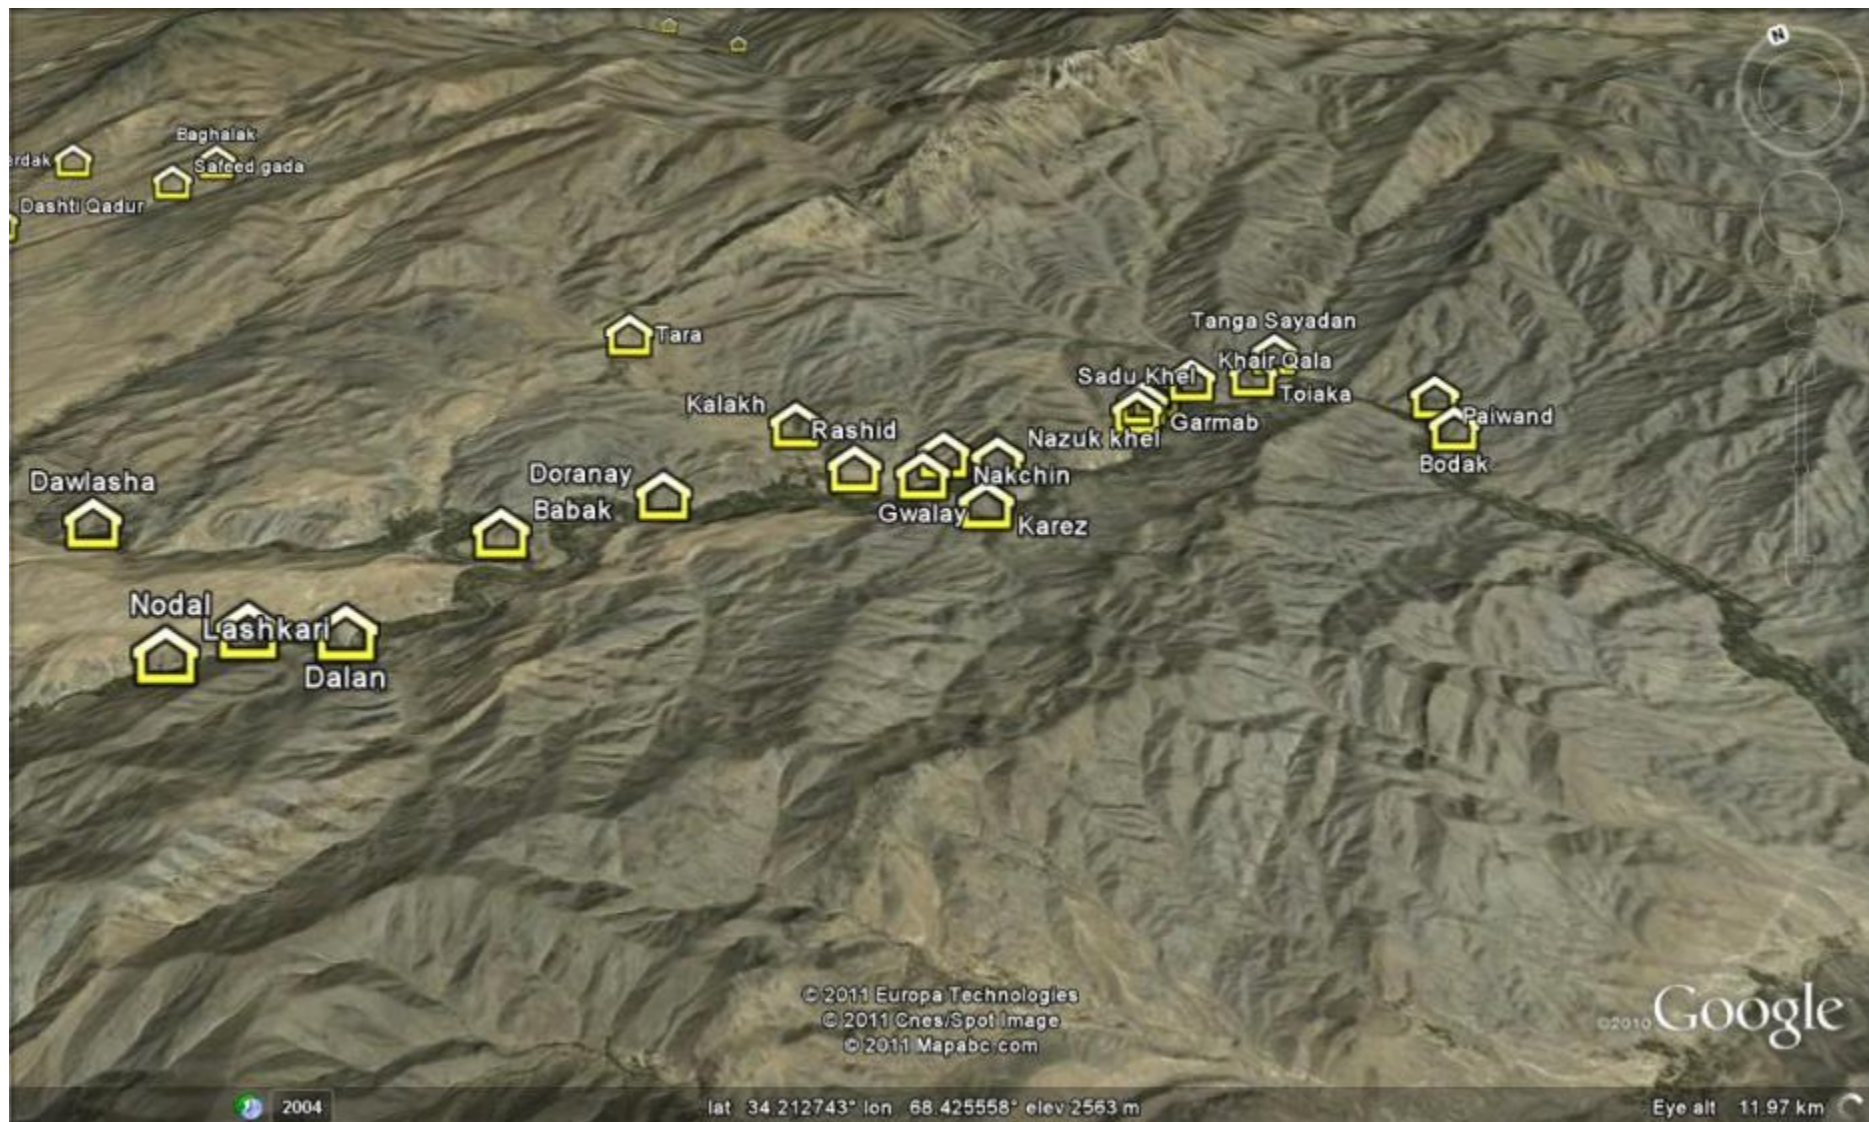
Photograph: Villages located on both sides of the Koza Jilga River

Name: Village	Population Jeribs	GPS N E Altitude (M)	Village Description	Water Supply	Cost Estimate USD	Cost Per Beneficiary USD	Cost Per Jeribs Irrigated USD
			There are 95 cows, 60 sheep and goats and 15 donkeys.	cleaning, concreting and repair of damage and leaks. The reservoir is 90 years and irrigates 1,500 jeribs of land. It supplies 600 people. It leaks and has cracks sections and wastes much water. Its canal also has leak and blockages.
