Example Report

Company	Thermal Specialists of Conway LLC 3180 Cresthaven Conway AR	Tester: Thomas Epperson Phone: 501-733-7390 E-Mail: thomas.epperson@gmail.com
----------------	--	--

Customer	Jim Doyle 1305 Grape Jelly Ave Chair, NM	Measuring Site: 1305 Grape Jelly Ave Char, NM
-----------------	--	---

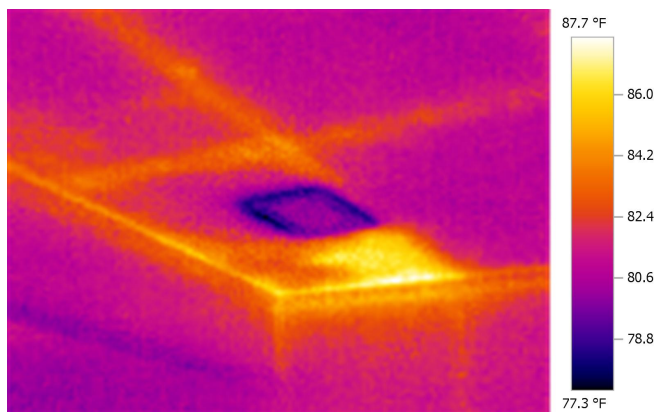
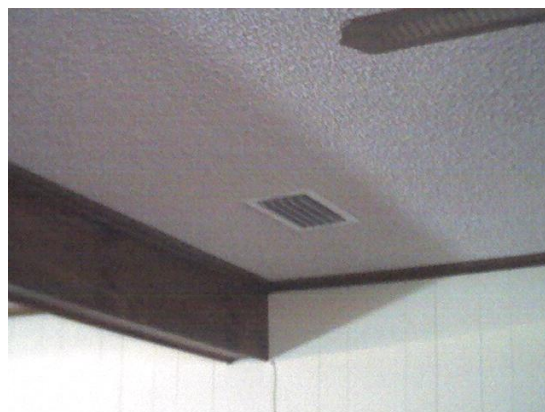
File:
DUCTCEILING.BMT

Insulation missing in ceiling near new duct-work. The duct-work in question is located in the living room. Insulation should be placed in this area to reduce energy losses.

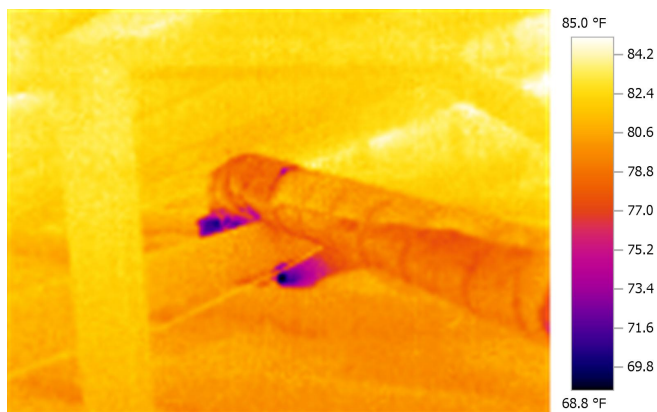
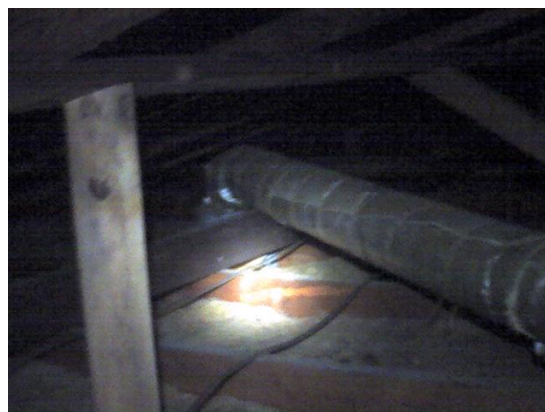
File:
DUCTATTIC.BMT

Insulation missing around air ducts allowing cold air to flow into the hot attic.

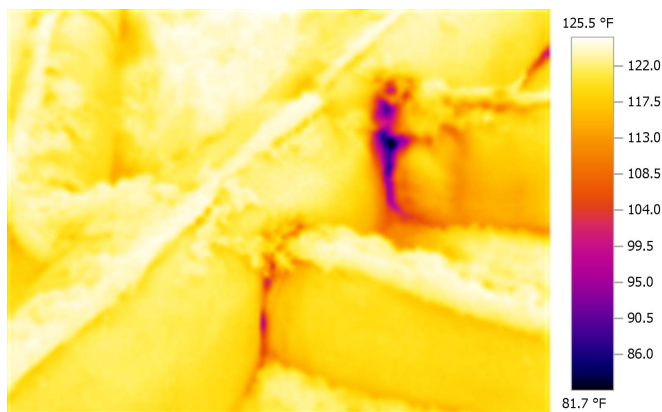
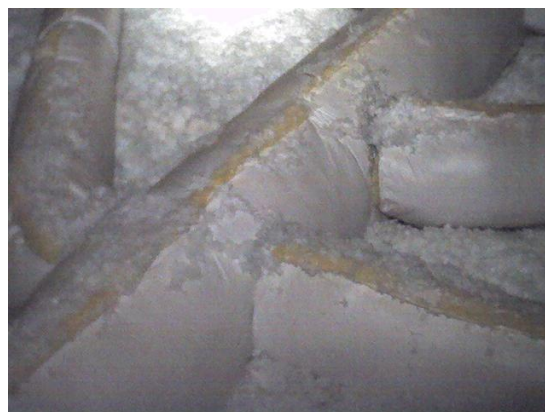
File:
DUCTJOINT.BMT

This particular branch of the duct work is missing insulation at the joint. The metal duct is visible at the joint instead of being covered with insulation.

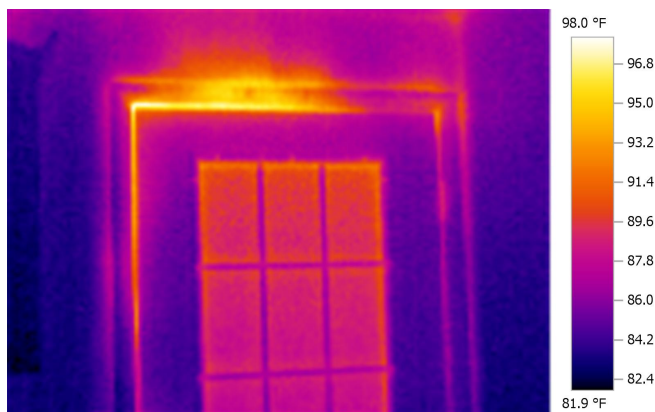
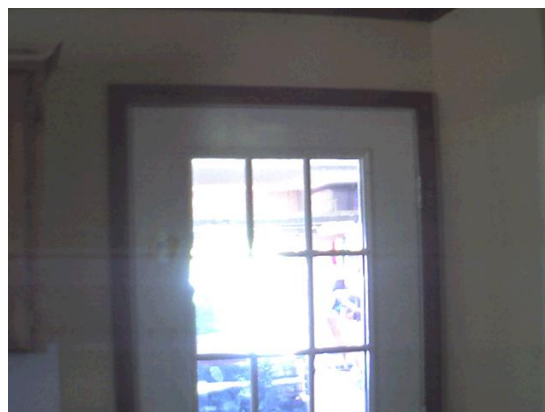
File:
DOORJAMB.BMT

This energy leak is caused by a worn door jamb seal.

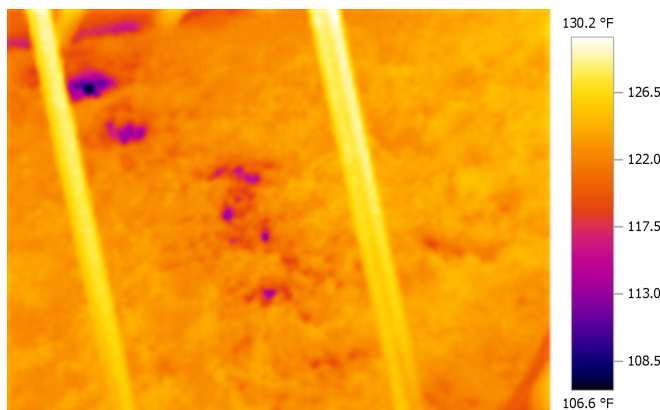
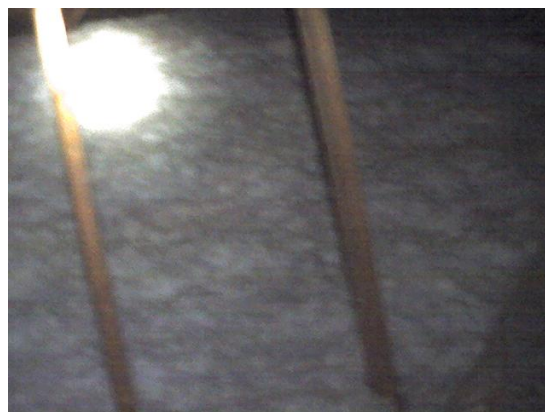
File:
CABLEATTIC.BMT

Thin spots in the insulation where a cable had been run across the attic floor and the insulation had been disturbed.
