Asbestos Management Plan 2013

Church Street Corporate Centre

410 - 422 Church Street

Inspection Details	
Date of inspection:	11 July 2013
Inspector name:	Robert Stevens

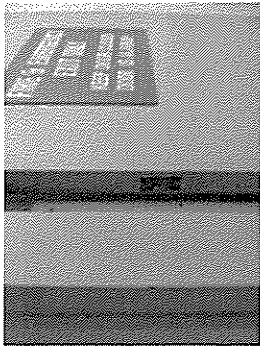
Photo	Location	Asbestos Item and Description	Condition	Work in adjacent areas	Current Controls	Risk Level	Control Measure	Sample No
Photo 8: Level 1 fire stairs fire door

Common Property	The fire rated door at fire stairs on level 1 is presumed to contain asbestos, although it is not possible to test the encapsulated material to determine its composition without removing and breaking the door frame.	GOOD - No sign of damage or deterioration due to weather, non-friable	General repairs and maintenance	None	P3	Administrative, control or remove access	
Photo 9: Level 2 fire stairs fire door

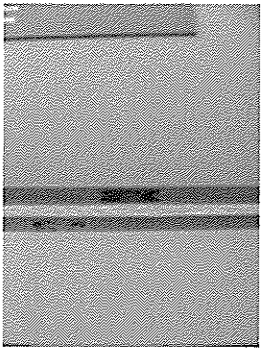
Common Property	The fire rated door at fire stairs on level 3 is presumed to contain asbestos, although it is not possible to test the encapsulated material to determine its composition without removing and breaking the door frame.	GOOD - No sign of damage or deterioration due to weather, non-friable	General repairs and maintenance	None	P3	Administrative, control or remove access

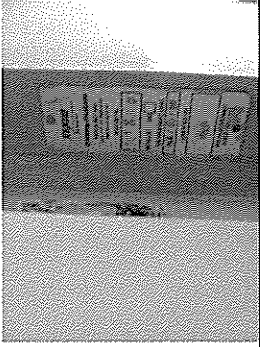
Common Property	No asbestos containing materials (ACM) identified.						
Photo 13: Level 6 fire stairs fire door

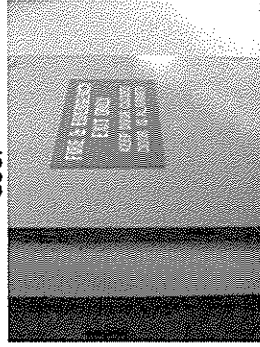
Common Property	The fire rated door at fire stairs on level 6 is presumed to contain asbestos, although it is not possible to test the encapsulated material to determine its composition without removing and breaking the door frame.	GOOD - No sign of damage or deterioration due to weather, non-friable	General repairs and maintenance	None	P3	Administrative control or remove access

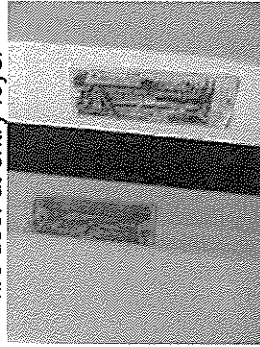
Common Property	No asbestos containing materials (ACM) identified.						
Photo 16: Ross Street fire stairs fire door at entry foyer

Common Property	No asbestos containing materials (ACM) identified.

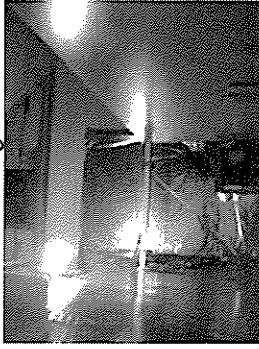
Photo	Location	Asbestos Item and Description	Condition	Work in adjacent areas	Current Controls	Risk Level	Control Measure	Sample No
Photo 20: Level 5 Air conditioning room

Common Property	No asbestos containing materials (ACM) identified.						
Photo 21: Ground floor electrical back board panel

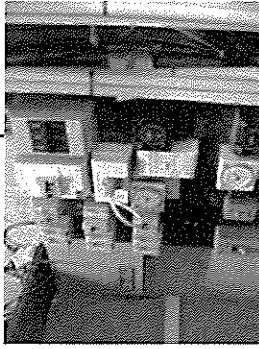
Common Property	The electrical meter backing panel on ground floor is presumed to contain asbestos.	GOOD - No sign of damage or deterioration due to weather, non-friable	Electrical	None	P4	Administrative, control access	
Photo 22: Main switch room electrical back board panel

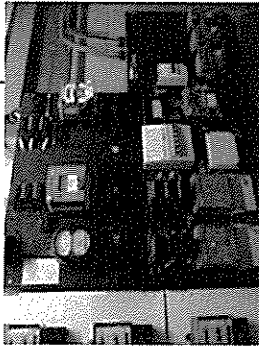
Common Property	The electrical meter backing panel in the main electrical back board panel is presumed to contain asbestos.	GOOD - No sign of damage or deterioration due to weather, non-friable	Electrical	None	P4	Administrative, control access

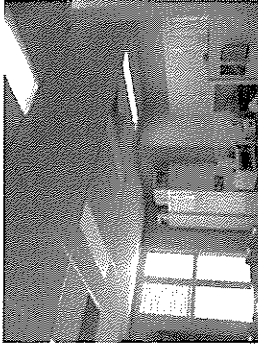
Photo	Location	Asbestos Item and Description	Condition	Work in adjacent areas	Current Controls	Risk Level	Control Measure	Sample No
Photo 26: Suite 52 training and kitchen area

Internal Inspection	No asbestos containing materials (ACM) identified.						
Photo 27: Suite 41 suspended ceiling infill panels

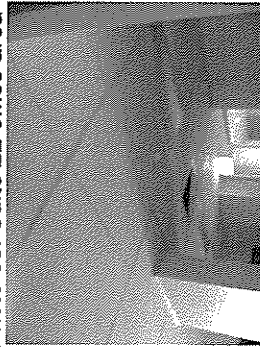
Internal Inspection	No asbestos containing materials (ACM) identified.						
Photo 33: Suite 22 office area

Internal Inspection	No asbestos containing materials (ACM) identified.						
Photo 34: Suite 14 office area

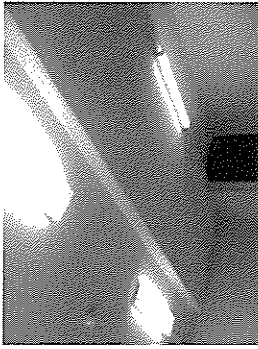
Photo	Location	Asbestos Item and Description	Condition	Work in adjacent areas	Current Controls	Risk Level	Control Measure	Sample No
Photo 44: Suites 2, 3, & 4 upper office areas

Internal Inspection	No asbestos containing materials (ACM) identified.						
Photo 45: Suites 2, 3, & 4 general office areas

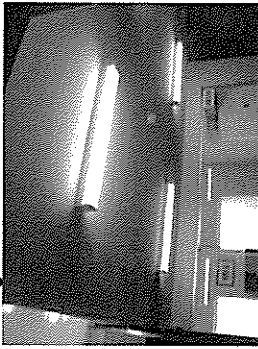
Internal Inspection	No asbestos containing materials (ACM) identified.						
Photo 46: Suite 34 general office area

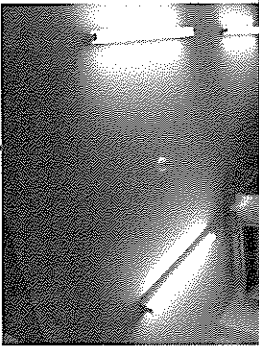
Photo	Location	Asbestos Item and Description	Condition	Work in adjacent areas	Current Controls	Risk Level	Control Measure	Sample No
Photo 47: Suite 34 storeroom ceiling

Internal Inspection	No asbestos containing materials (ACM) identified.						
Photo 48: Toilet ceilings common to all levels

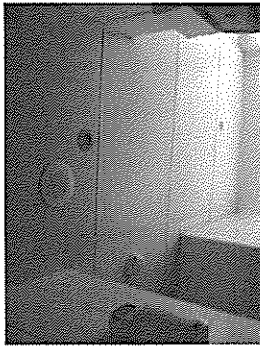
Common Property	No asbestos containing materials (ACM) identified.						
Photo 49: Toilet ceilings common to all levels
