HAZARDOUS MATERIALS ASSESSMENT REPORT

Job details: Owner: Mr. A. & Mrs. K. Foley.
Location: 16 Kaneruka Place, Baulkham Hills.

Date of assessment: 20th January 2017

Our reference: HM05520117

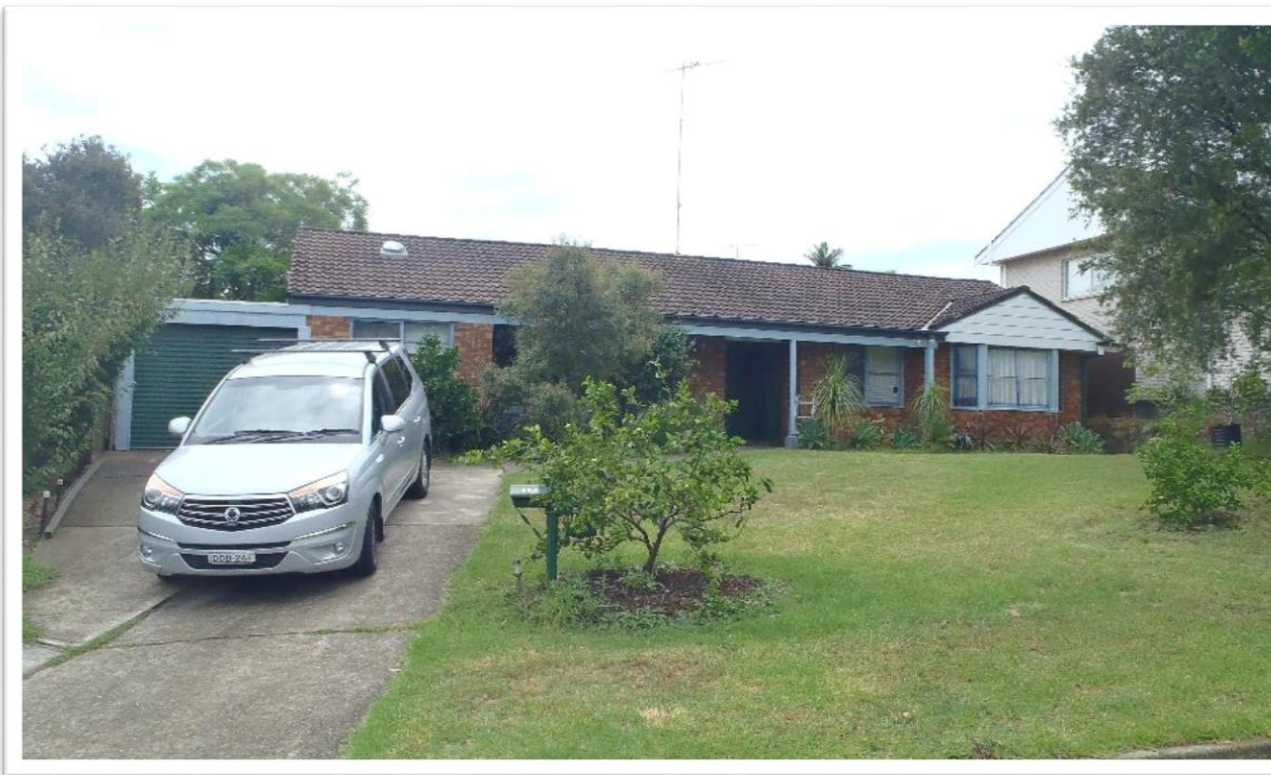
Front south eastern elevation of the residence

Estimated age:	Circa 1960 - 1970
Type of construction:	Freestanding single storey brick veneer residence with a concrete slab on ground floor system
External cladding:	Clay masonry brickwork
Roof:	Traditional cut and pitched, gable ended, hip and valley structure with concrete roofing tiles.
