Asbestos Inspection and Condition Report (Sampling)

Inspection Date: Mon., 13 Feb. 2017

Property Address: 16 Kaneruka Pl, Baulkham Hills NSW 2153, Australia

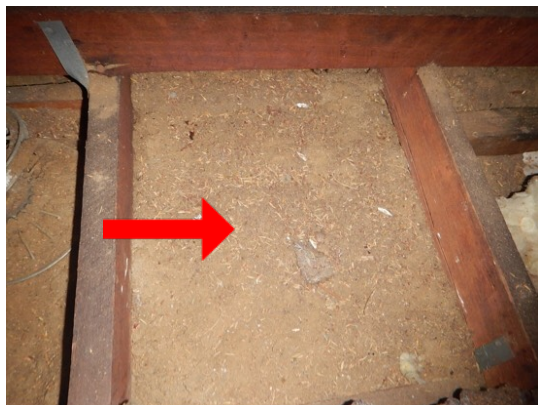
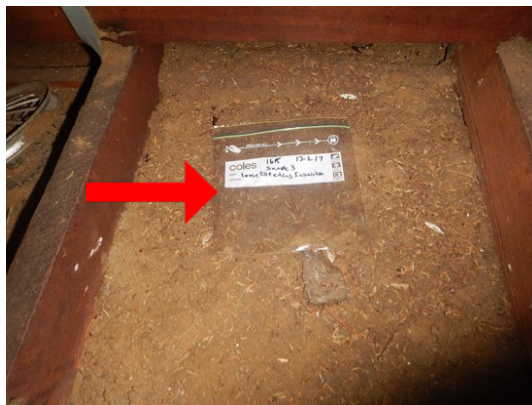
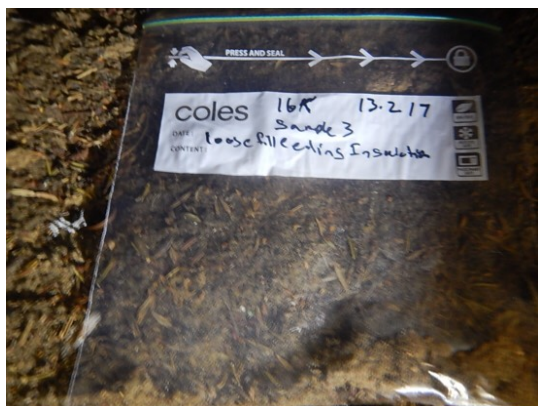
Building: Main Building
Location: Roof Void
Finding: Loose Fill Insulation - Sample 1
Information: At the time of the inspection, it was observed that the loose filled insulation in the roof space was suspected of being made up from Asbestos Containing Material.

A sample for lab analysis to confirm the presence of asbestos was taken from this location. The client is advised to assume that the affected area and construction material contains Asbestos until the lab analysis results are available. The area should be avoided and no works should be undertaken on the area until lab analysis results are available.

Where the client elects to retain the ACM, the client should regularly monitor the condition of the loose filled insulation material to identify any further damage or deterioration. Such monitoring should be conducted at least annually, but more frequently should damage or deterioration occur.

No works should be carried out to the ACM or associated building elements without further specialist advice.

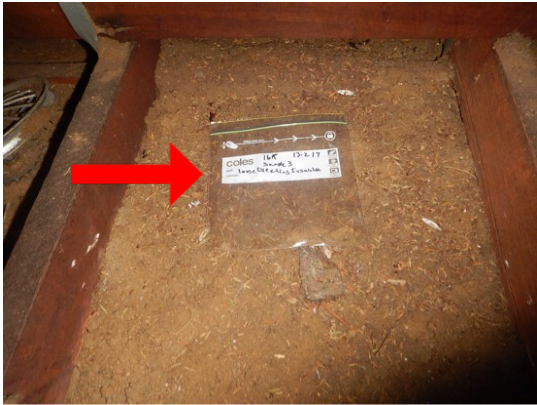
Finding: Asbestos - Negative lab result. Sample 3

Information: A sample of suspected Asbestos Containing Material (ACM) was removed from the ceiling insulation for analysis by a NATA accredited laboratory.

The sample analysed was free of Asbestos fibres.

Test Report No: R13256
Client Ref: 16K
Sampling Procedures: Samples taken by client; analysed as received

Analytical method: Polarised light microscopy including dispersion staining to AS 4964
Sample Preparation: Safe Environments in-house SOP - Asbestos Identification
Approved Identifier: Dorothy Simmonds

Sample Number	Sample Description	Weight (g)	Analysis Result
1	Loose fill ceiling insulation; sample containing insulation material (homogenous) consisting of organic fibres.	< 1	No Asbestos Detected
2	Loose fill ceiling insulation; sample containing insulation material (homogenous) consisting of organic fibres.	< 1	No Asbestos Detected
3	Loose fill ceiling insulation; sample containing insulation material (homogenous) consisting of organic fibres.	< 1	No Asbestos Detected
