Type 26 Register Update No. 5

The time has come for a progress update on the restoration of units 88, 186 and 4585, together with a summary of some of the issues that have arisen along the way.

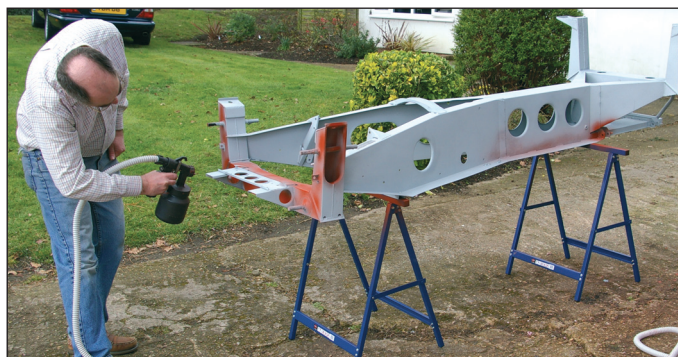
PAINTING ZINC SPRAYED CHASSIS IN RED OXIDE

After mixed success using powder coating in the past (where cracking leads to water ingress by capillary action under the coating, causing rust, flaking and difficulty with subsequent rectification), a hot zinc thermal spray finish was used, followed by spray painting with red oxide to replicate the original factory finish colour of Type 26 chassis. This method has the advantage of comparable corrosion protection to that of hot dip galvanizing, but without the associated risks of heat distortion, surface contamination and unsightly run marks.

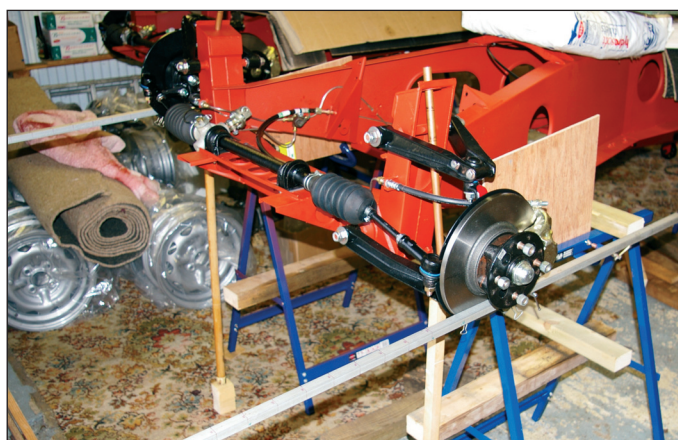
ADJUSTMENT OF BUMP-STEER

No rack height shim information was supplied for the non-galvanized chassis. This necessitated the rather time consuming but enjoyable task of adjustment of the steering rack height to avoid bump-steer. The process involves setting up two parallel alignment datums either side of the chassis, and with the spring damper assemblies removed, measuring the variance of toe-in/ toe-out relative to these datums at full droop, normal ride height and full bump. By a process of trial and error, the steering rack height can be adjusted so any variation of toe-in over the range of full bump to full droop is eliminated completely. Interestingly, after completing this process on four chassis, shimming of up to 5mm/ 0.2" was required. A full illustrated article on this process will be published in the near future.

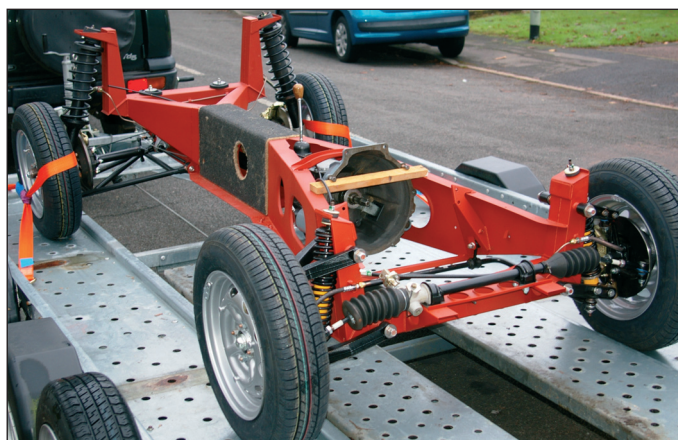
COMPLETED ROLLING CHASSIS

All three rolling chassis have now been assembled. The refurbished bodies from Option1 are now correctly located and fastened upon them.

It was decided to use new, original spec non-galvanized chassis. Amongst some of the issues which had to be considered when building them up were the type of surface finish to use, setting rack height correctly to avoid bump-steer and the fit of the existing body to chassis to ensure it is centralised correctly.

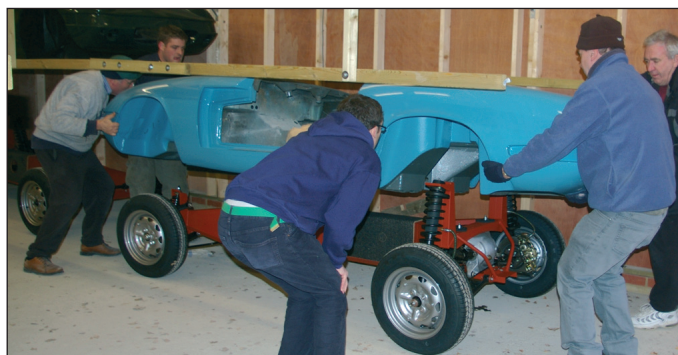
UNIT 88 BODY IN MEDICI BLUE BEING LOWERED TO CHASSIS

Problems arose when offering the original bodysells to the assembled rolling chassis for the first time. In every case (there were four chassis, including a galvanised one for Charles' Sprint 5) the bodies would foul the chassis on the gussets at the front turrets. In order for the body to sit correctly on the chassis – and for it to be centralized properly – these gussets had to be carefully fettled in order to create sufficient clearance. Additionally, Bourne bodies do not have a clearance hole drilled for the top threaded part of the right-hand front shock absorber, which could result in the body not seating on the chassis properly and thus it was necessary to drill such a clearance hole.
