## **Panzer III in Romanian Service: T-3 Tank**

### **Brief Historical Context**

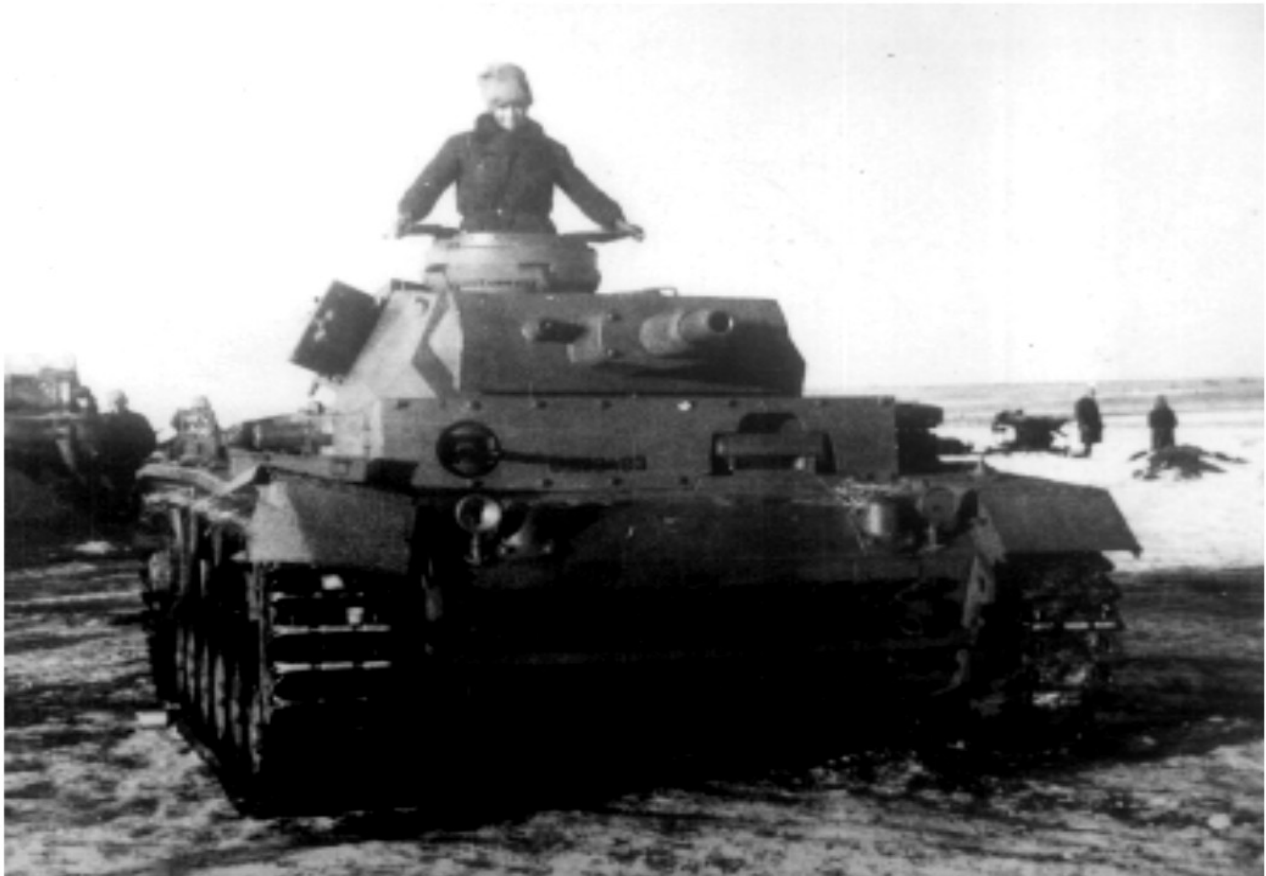
A Romanian Panzer III (T-3) on the Eastern Front during the winter of 1942-1943: the German Balkenkreuz is clearly visible on the side together with a black silhouette-only Michael's Cross on the front of the side armour plate; military registration number in black on the front glacis, with no white plate painted behind it, reading U-039483; spare track links only on the lower front armour plate; note that the vehicle does not wear a whitewash and the overall colour appears to be too dark to be Field Grey (Feldgrau), suggesting either a darker shade of grey or olive/khaki green; note the tank commander's fur hat - "cusma" (kushma) - a traditional Romanian hat made of sheepskin, very warm and soft and worn in cold winter weather.

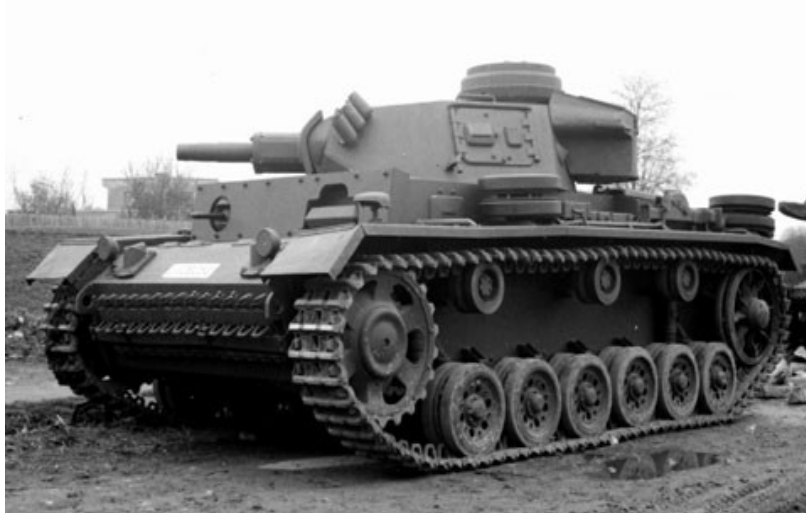
A Romanian Panzer III (T-3): this vehicle has military registration plates and no other national or divisional markings or emblems; it appears that the gun recoil sleeve is removed.

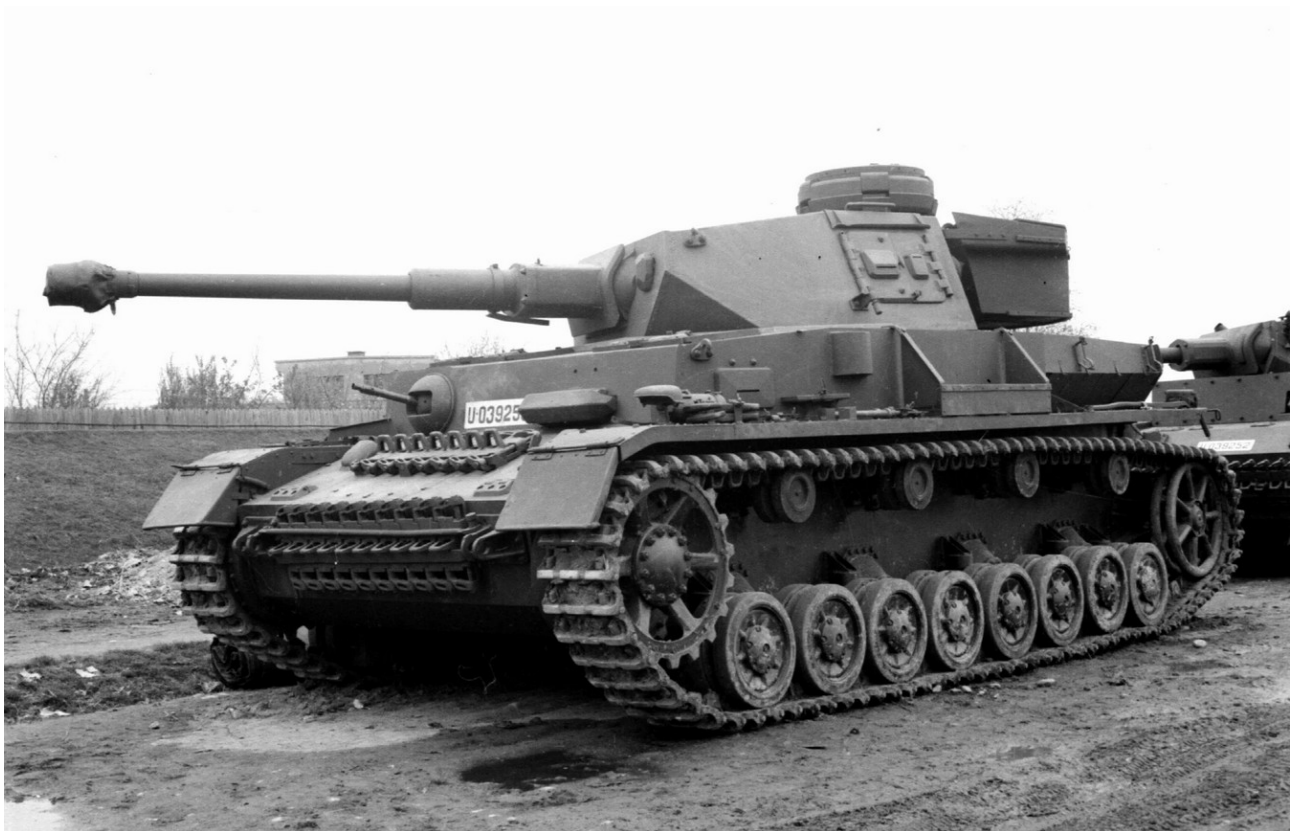
A Romanian Panzer IV Ausf. G (T-4) and a T-3 in the background, behind the T-4 – we can clearly see military number plates on both tanks, on the sloped front armour on the T-3 and on the front glacis on the T-4. The T-4's registration number is U-039253 and the T-3's number is U-039252; it seems that the T-3 recoil sleeve was removed. The tanks belong to the same unit, most probably the 1<sup>st</sup> Regiment of the 1<sup>st</sup> Armoured Division. Given the surrounding settings and T-3's missing gun sleeve, it is almost certain that this tank is the same as the one in the photo above. It is believed that these tanks were survivors of the Battle of Stalingrad (the last of each type that survived the onslaught), and are pictured here after the battle.

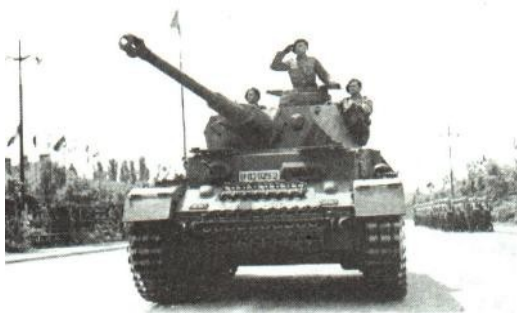
(left) Same T-4 with registration U-039253 at King's Day Parade on May 10, 1943, in Bucharest, Romania; multiple sources mention this machine as the last surviving Romanian Panzer IV Ausf. G (T-4) from the Eastern Front in 1942-1943, before a new batch of Panzer IV's were delivered by the Germans, later in 1943 (Ausf. H and J).
