## **Panzer III in Romanian Service: T-3 Tank**

## **Panzer 38(t) in Romanian Service: T-38 Tank**

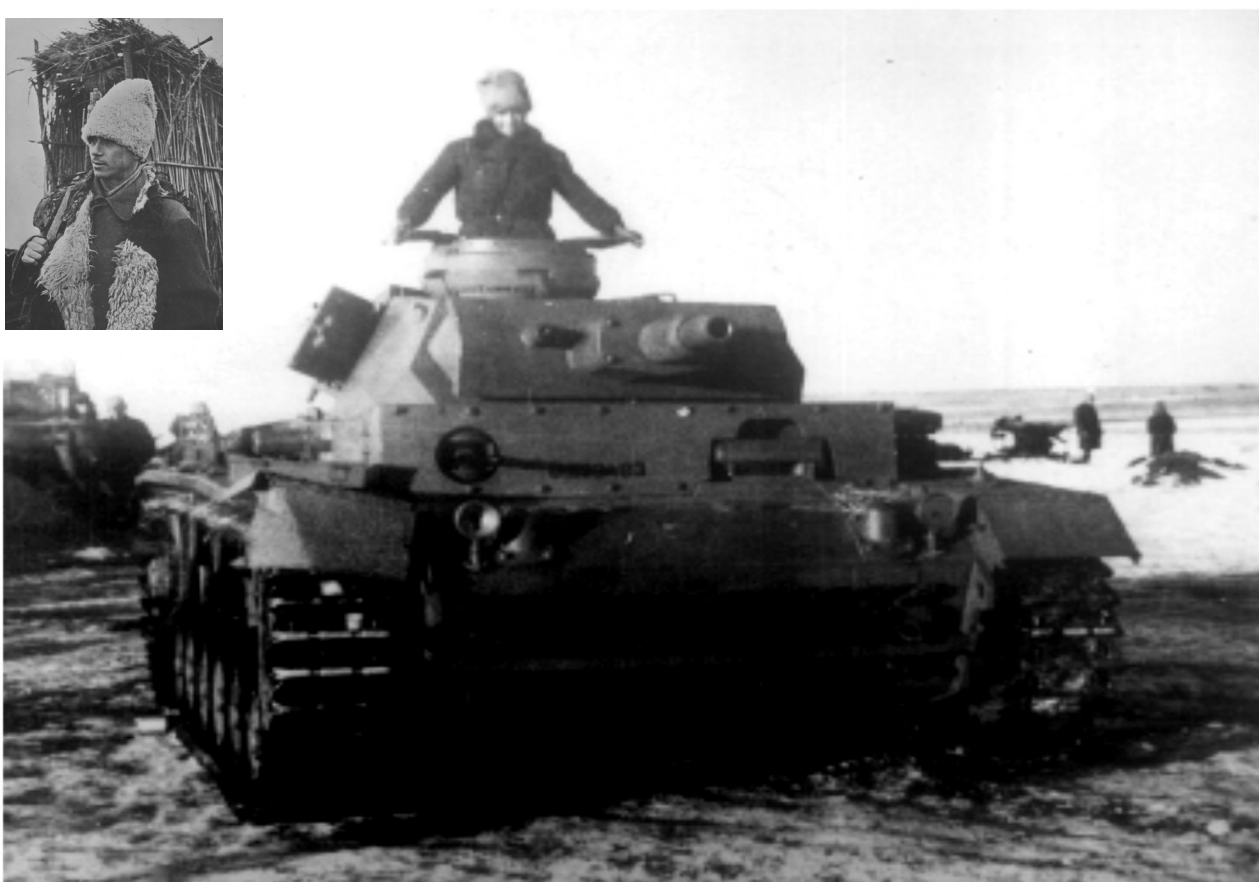
A Romanian Panzer III (T-3) on the Eastern Front during the winter of 1942-1943: the German Balkenkreuz is clearly visible on the side together with a black silhouette-only Michael's Cross on the front of the side armour plate; military registration number in black on the front glacis, with no white plate painted behind it, reading U-039483; spare track links only on the lower front armour plate; note that the vehicle does not wear a whitewash and the overall colour appears to be too dark to be Field Grey (Feldgrau), suggesting either a darker shade of grey or olive/khaki green; note the tank commander's fur hat - "cusma" (kushma) - a traditional Romanian hat made of sheepskin, very warm and soft and worn in cold winter weather (corner: Romanian infantryman at Stalingrad, wearing the same type of hat).

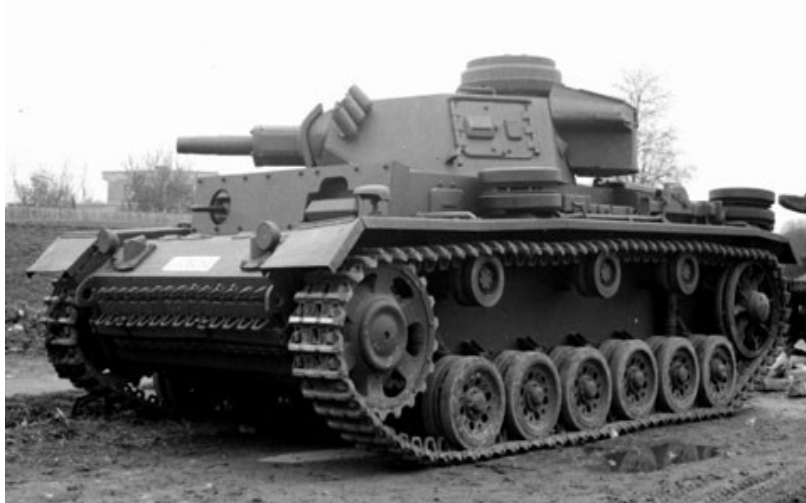
A Romanian Panzer III (T-3): this vehicle has military registration plates and no other national or divisional markings or emblems; it appears that the gun recoil sleeve is removed.

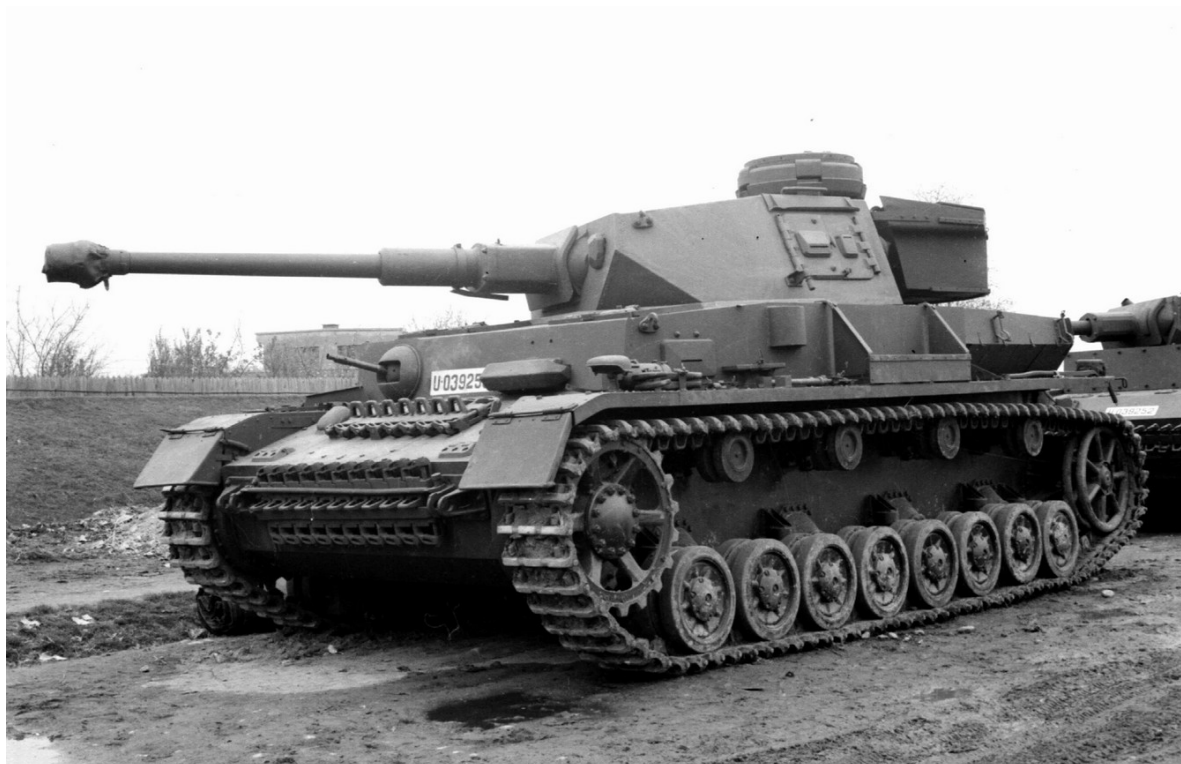
A Romanian Panzer IV Ausf. G (T-4) and a T-3 in the background, behind the T-4 – we can clearly see military number plates on both tanks, on the sloped front armour on the T-3 and on the front glacis on the T-4. The T-4's registration number is U-039253 and the T-3's number is U-039252; it seems that the T-3 recoil sleeve was removed. The tanks belong to the same unit, most probably the 1<sup>st</sup> Regiment of the 1<sup>st</sup> Armoured Division. Given the surrounding settings and T-3's missing gun sleeve, it is almost certain that this tank is the same as the one in the photo above. It is believed that these tanks were survivors of the Battle of Stalingrad (the last of each type that survived the onslaught), and are pictured here after the battle.

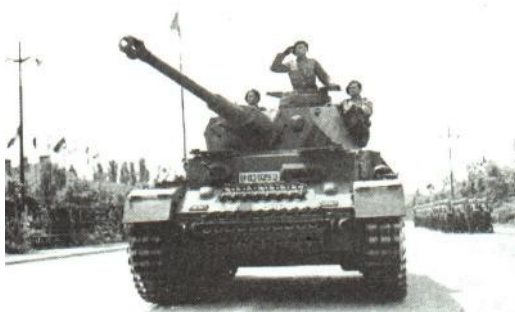
(left) Same T-4 with registration U-039253 at King's Day Parade on May 10, 1943, in Bucharest, Romania; multiple sources mention this machine as the last surviving Romanian Panzer IV Ausf. G (T-4) from the Eastern Front in 1942-1943, before a new batch of Panzer IV's were delivered by the Germans, later in 1943 (Ausf. H and J).

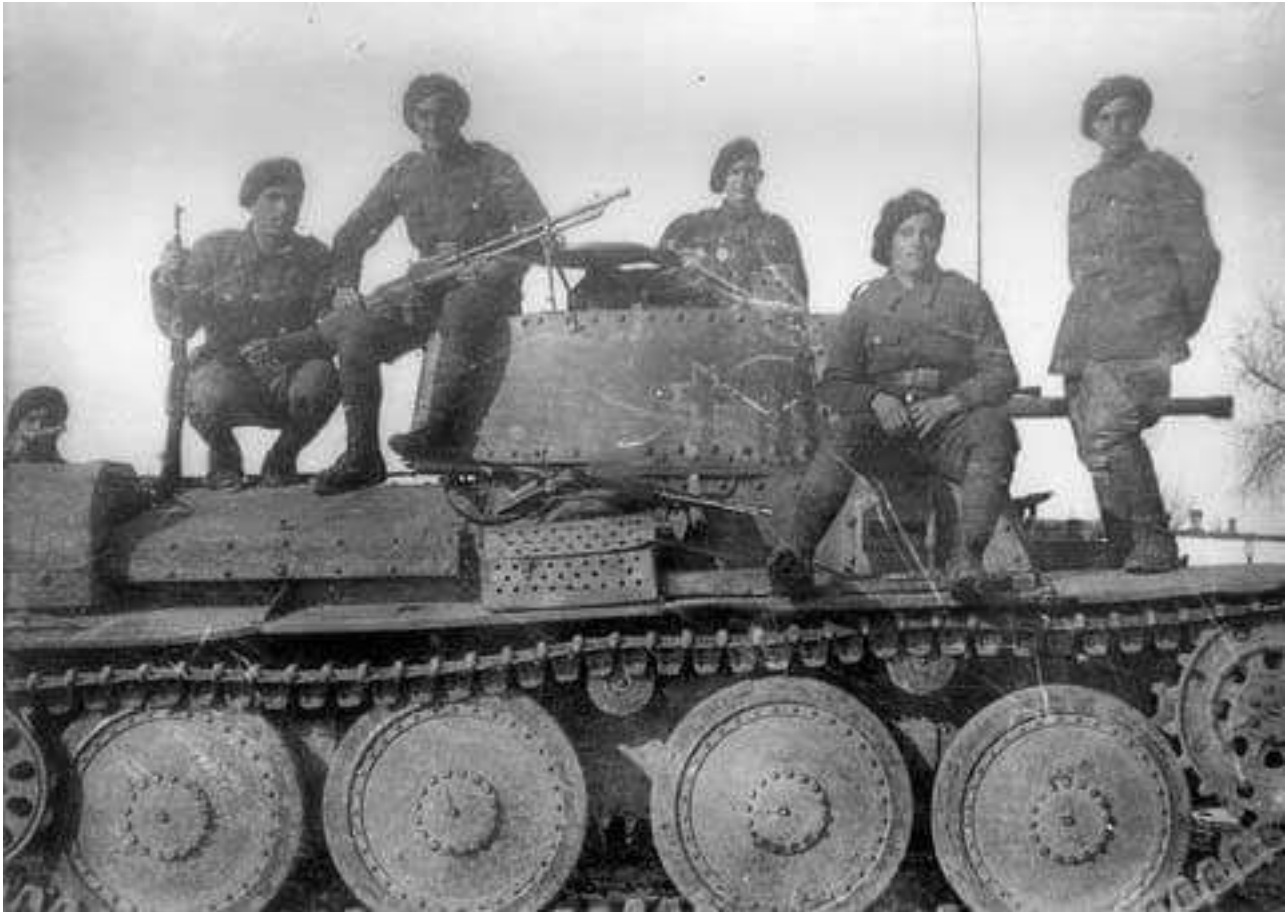
A Romanian Panzer 38(t) Ausf. E/F (T-38 in Romanian documents) and soldiers of the 1<sup>st</sup> Mountain Rifles Division ("Vanatori de Munte") on the Eastern Front, during the battles in Kuban/Kerch Peninsula. Note the Romanian Michael's Cross in white contour only on the turret, with no other unit markings. Also to note the heavy wear on the tank's turret around the bolts. The light machine-gun is the licence-built Czechoslovak ZB vz 30 7.92mm (licence-produced in Britain as the Bren gun), fitted with a bipod and missing the magazine case. To note the (khaki) Chasseur Alpin-style plain berets of the Mountain Rifles. It appears that the soldier sat on the tank hull (second from right) is a junior officer since he's the only one to wear the oval pine cluster on his beret (regular soldiers and NCO's were wearing plain berets).

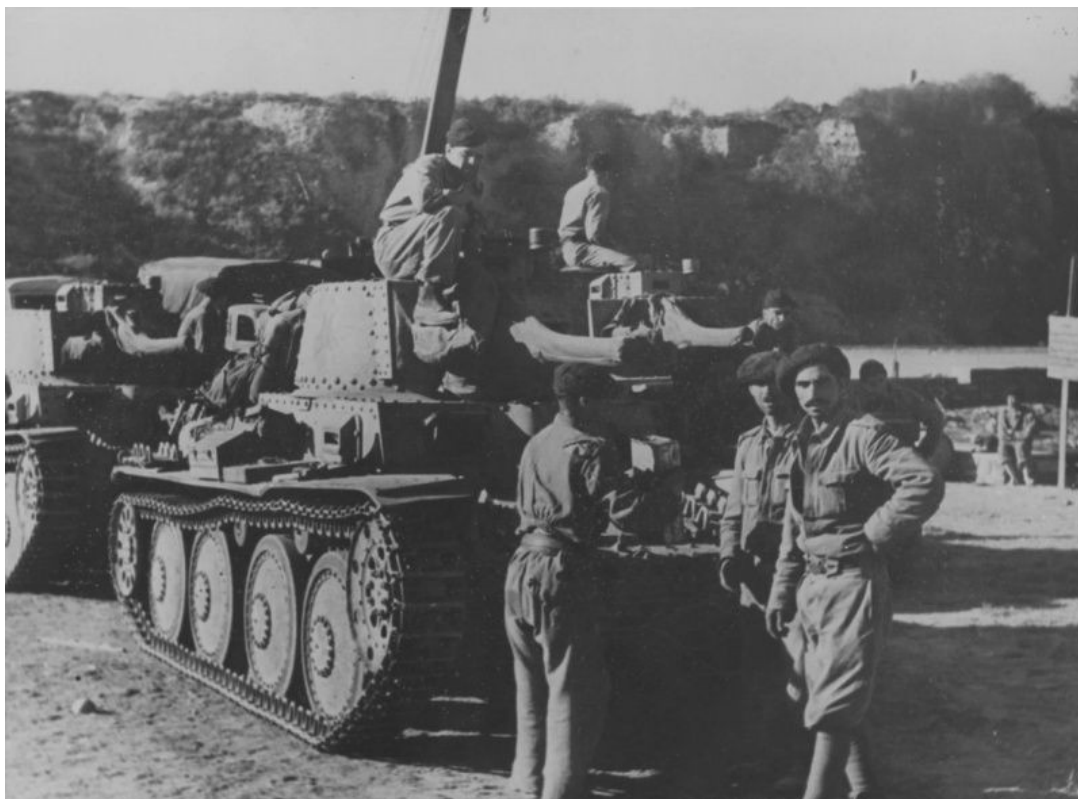
Romanian T-38's on the Eastern Front, summer 1943. To note the Romanian tanker's uniform: black beret, the same pattern as the Mountain Rifle Division (only black, with no insignia) and regular khakis, M1941 pattern. Also to note the canvas cover over the gun and spare track links (probably ad-hoc up-armour) on the driver's side of the hull and at the rear; the grouser box is located towards the middle of the right side.

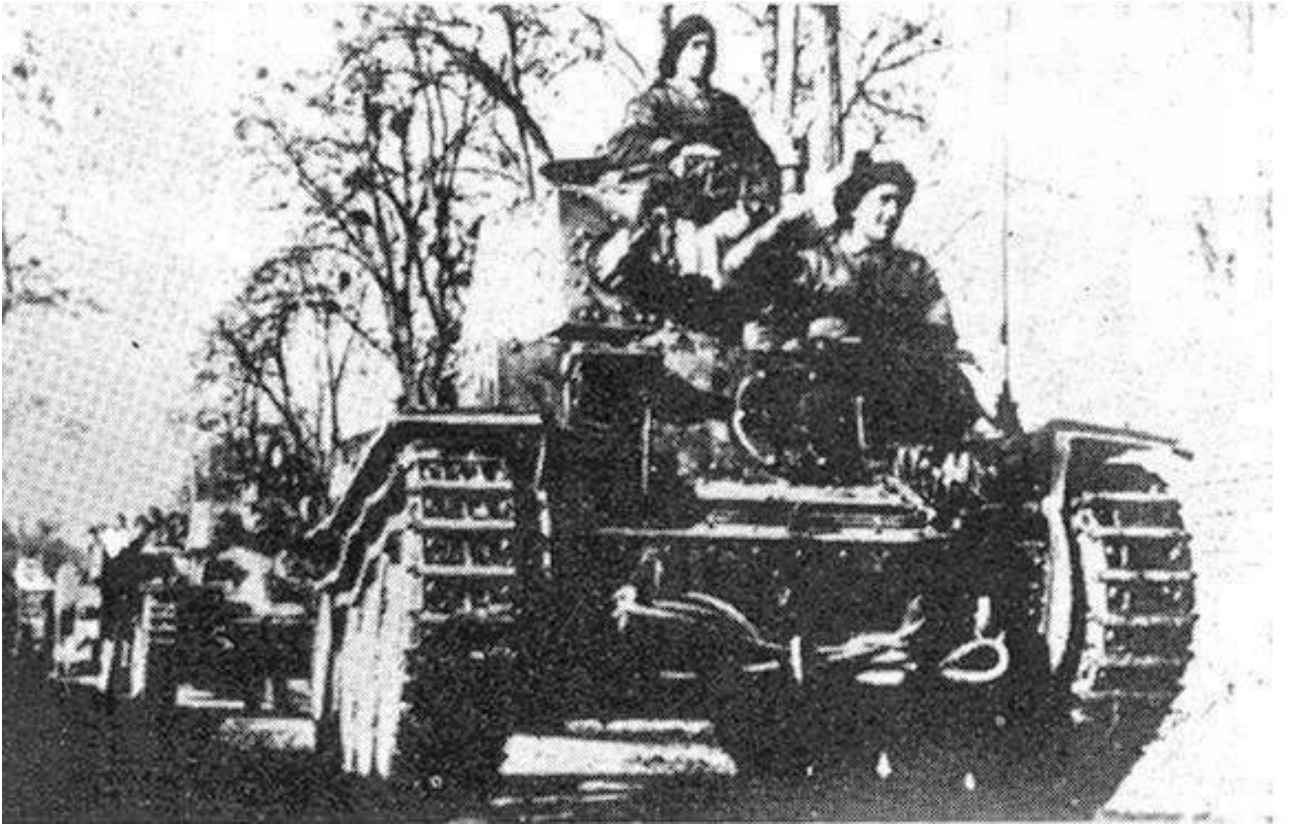
Romanian T-38 tank and its crew in the Kuban, on the way to the front, spring-summer 1943. The tow cable is stowed on the front armour plate, with spare track links on both sides of the front.

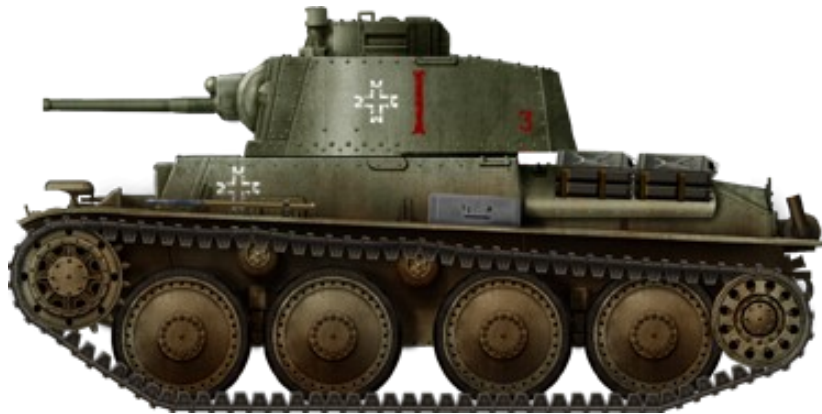
Colour profile of a T-38, in overall olive/khaki green, belonging to the 51<sup>st</sup> company (3<sup>rd</sup> tank).

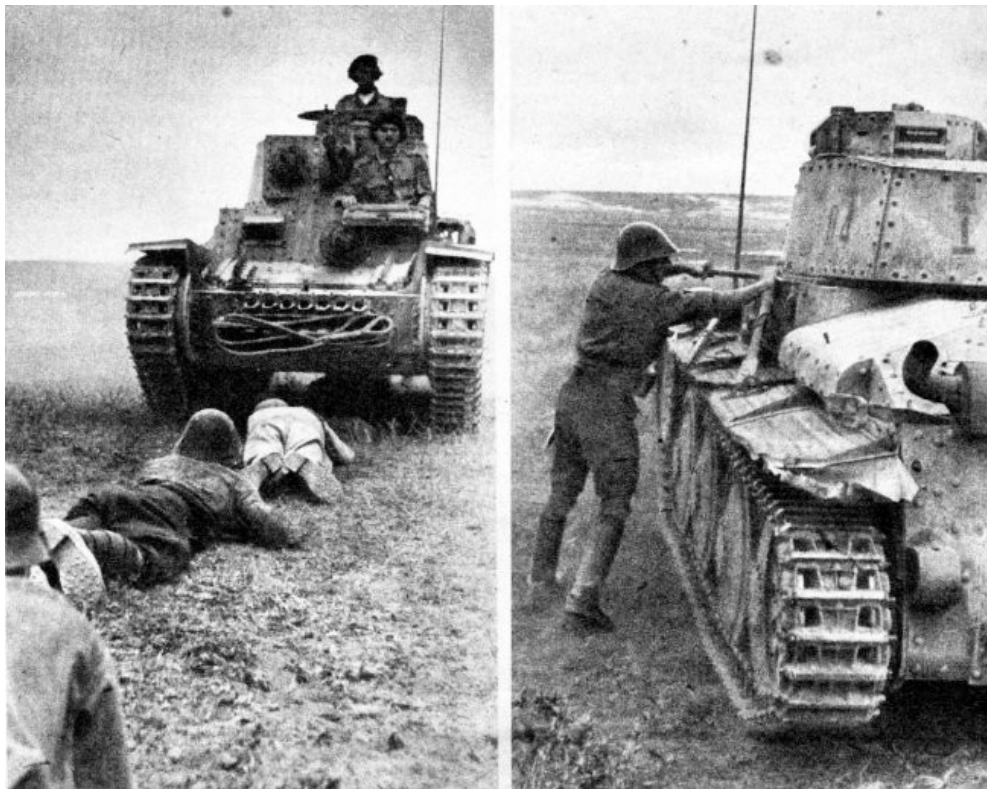
Romanian T-38 tanks in training. (left) to note the towing cable stowed on top of spare track links on the front hull; (right) to note the markings of the 4<sup>th</sup> tank of the 51<sup>st</sup> Company, T-38 Tank Batallion. Training was very limited for the Romanian crews since the Germans delivered the 50 Panzer 38(t) tanks straight to the frontline batallion and a large proportion of these tanks was necessitated lengthy repairs.
