Panzer III in Romanian Service: T-3 Tank

Panzer 38(t) in Romanian Service: T-38 Tank

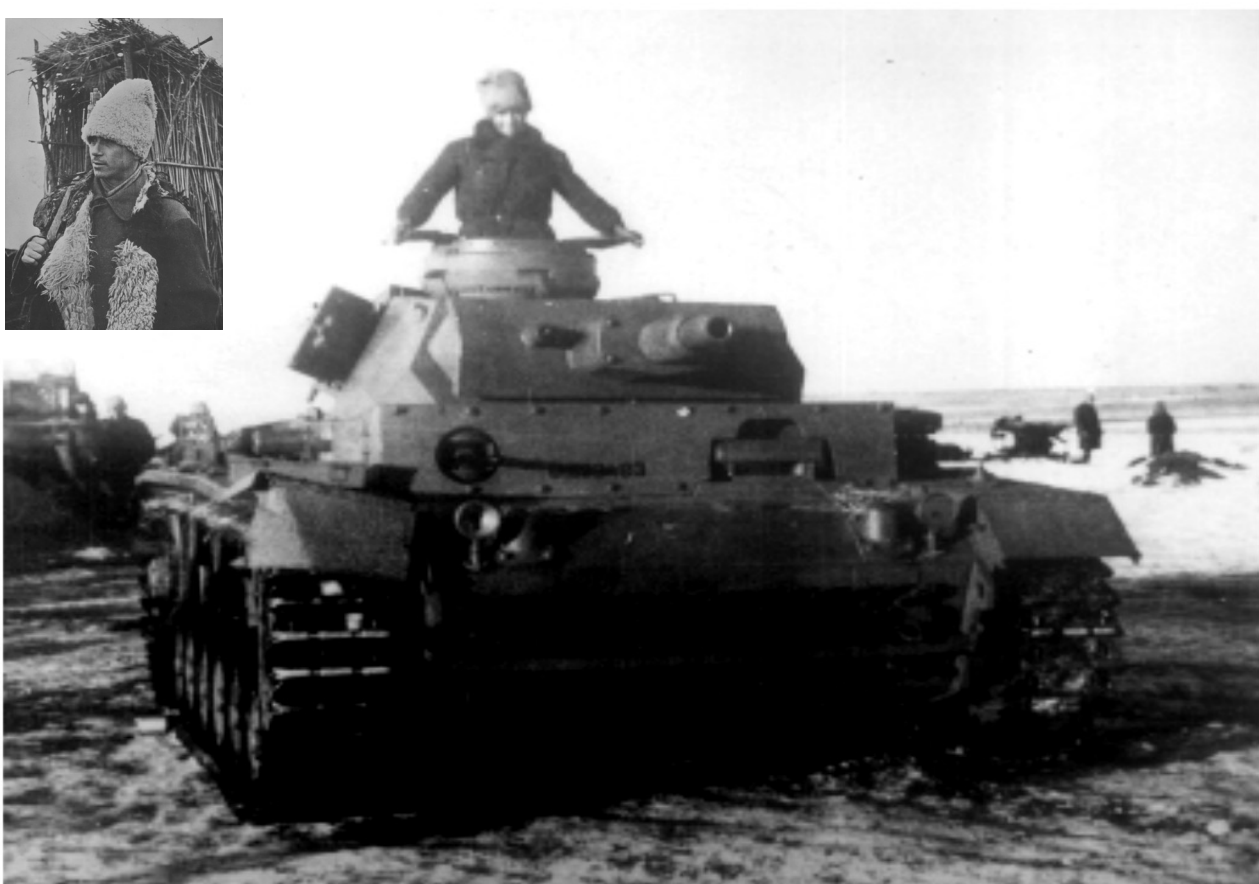
A Romanian Panzer III (T-3) on the Eastern Front during the winter of 1942-1943: the German Balkenkreuz is clearly visible on the side together with a black silhouette-only Michael's Cross on the front of the side armour plate; military registration number in black on the front glacis, with no white plate painted behind it, reading U-039483; spare track links only on the lower front armour plate; note that the vehicle does not wear a whitewash and the overall colour appears to be too dark to be Field Grey (Feldgrau), suggesting either a darker shade of grey or olive/khaki green; note the tank commander's fur hat - "cusma" (kushma) - a traditional Romanian hat made of sheepskin, very warm and soft and worn in cold winter weather (corner: Romanian infantryman at Stalingrad, wearing the same type of hat).

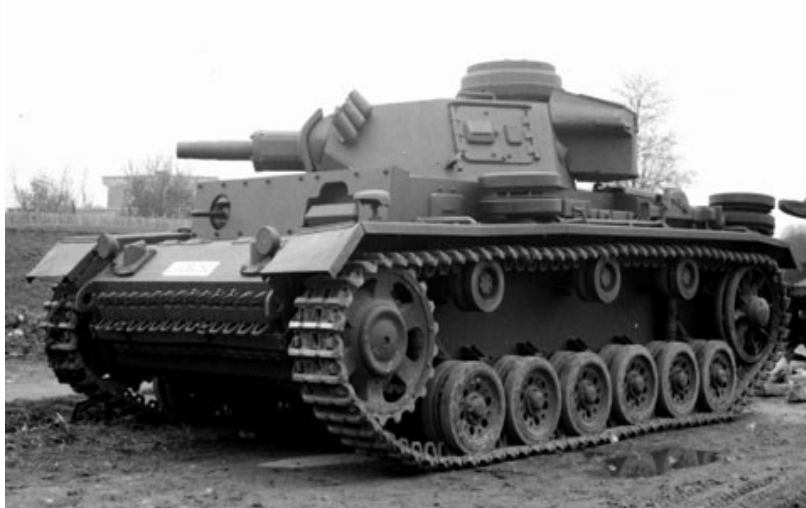
A Romanian Panzer III (T-3): this vehicle has military registration plates and no other national or divisional markings or emblems; it appears that the gun recoil sleeve is removed.

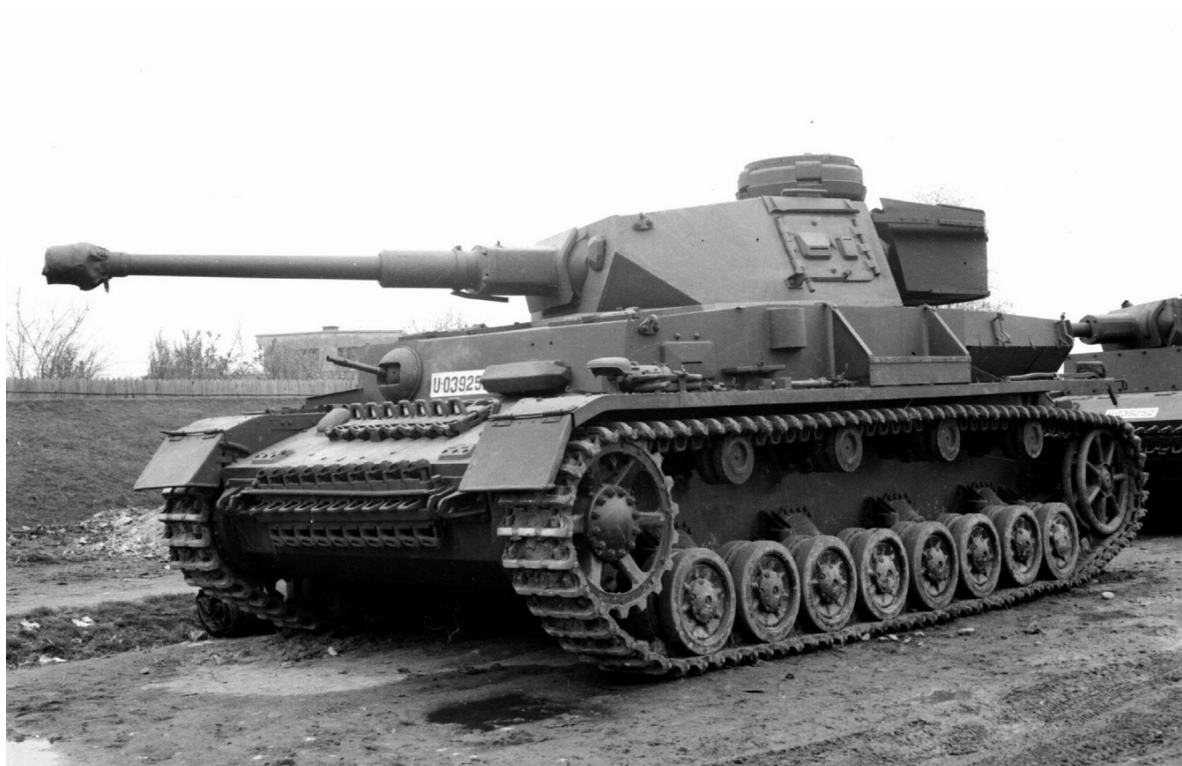
A Romanian Panzer IV Ausf. G (T-4) and a T-3 in the background, behind the T-4 – we can clearly see military number plates on both tanks, on the sloped front armour on the T-3 and on the front glacis on the T-4. The T-4's registration number is U-039253 and the T-3's number is U-039252; it seems that the T-3 recoil sleeve was removed. The tanks belong to the same unit, most probably the 1st Regiment of the 1st Armoured Division. Given the surrounding settings and T-3's missing gun sleeve, it is almost certain that this tank is the same as the one in the photo above. It is believed that these tanks were survivors of the Battle of Stalingrad (the last of each type that survived the onslaught), and are pictured here after the battle.

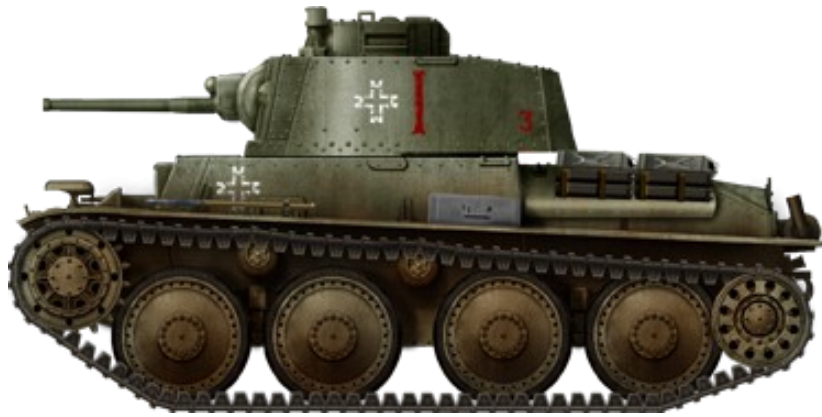
Colour profile of a T-38 belonging to the 51st company.

The Romanian T-38 tanks were painted in overall olive/khaki green, like all other Romanian vehicles of the period. Interm of national markings, they wore Michael's Cross in white contour only on the front sides of the hull, with some vehicles wearing it on the turret sides, and other vehicles wearing on both hull and turret sides. Vehicles of the 51st company wore large Roman I (or 1) numerals and smaller tank numbers in red, on the turret sides. No military registration plates or numbers are seen in any of the available photographs. We provide a set of colour profiles, courtesy of <http://www.wardrawings.be/> representing the 4th vehicle of the 51st company of the T-38 Tank Battalion (Batalionul Cărelor de Luptă T-38), from summer 1943. Full colour Michael Cross could still be on the engine deck, provided that its main reason was air recognition, and in 1943 Axis air superiority was still more or less in place on the southern Eastern Front.
