**SITE VERIFICATION REPORT FOR THE PROPOSED EXPANSION OF A DIESEL  
STORAGE & DISTRIBUTION DEPOT, WESGRAAN KLIPHEUWEL SILO,  
PORTION 17 OF THE FARM VRYHEID NO. 55, KLIPHEUWEL.**

**Date: 16<sup>th</sup> September 2020**

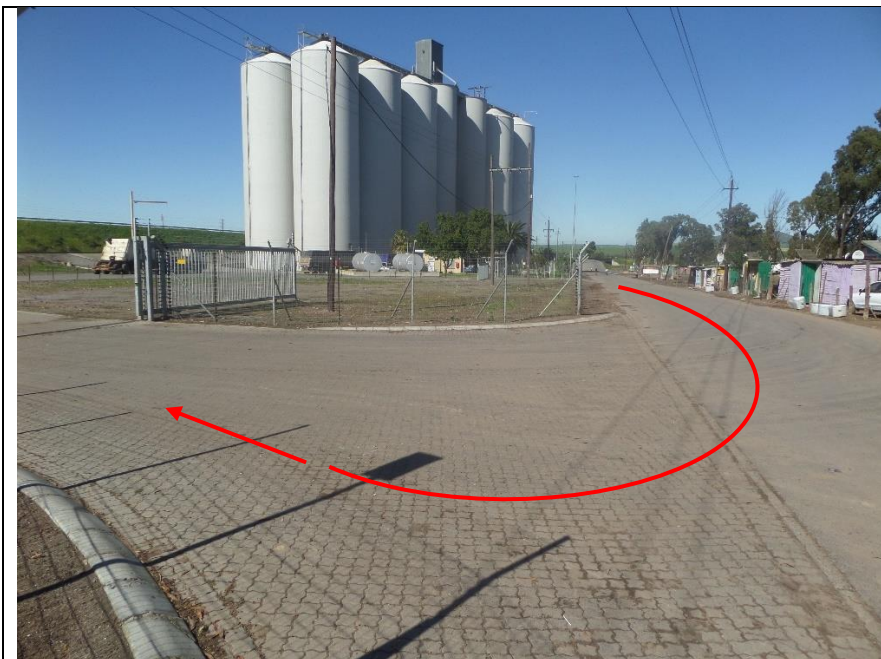
**Figure 1:** Existing grain trucks enter the existing Wesgraan-Klipheuwel Silo grain storage facility from Klipheuwel Road and the enter the site at entrance No 3 shown in the figure above.

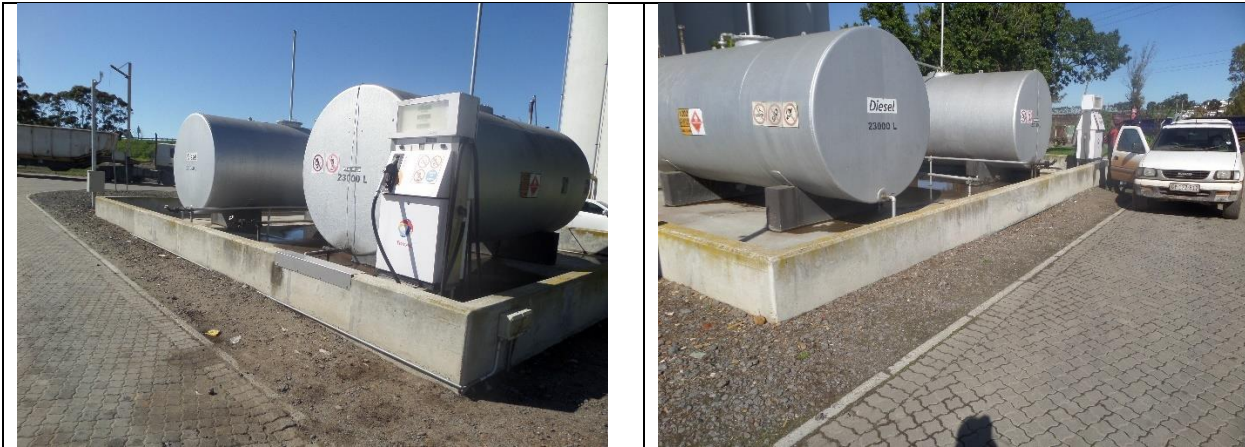
**Figure 2 & 3:** The existing 2 X 23m<sup>3</sup> diesel storage & distribution facility on site.

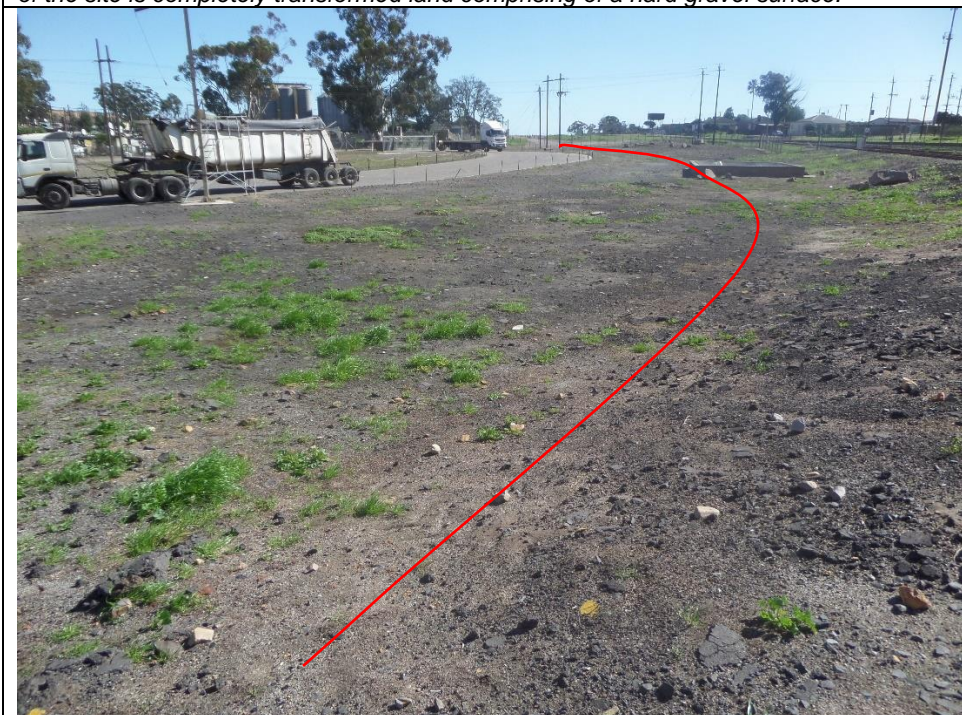
**Figure 5:** The proposed location for the new entrance road for the grain carrier trucks. The existing road currently used by the grain carrier trucks (as per this image) will be used by the trucks dispatching and refuelling.

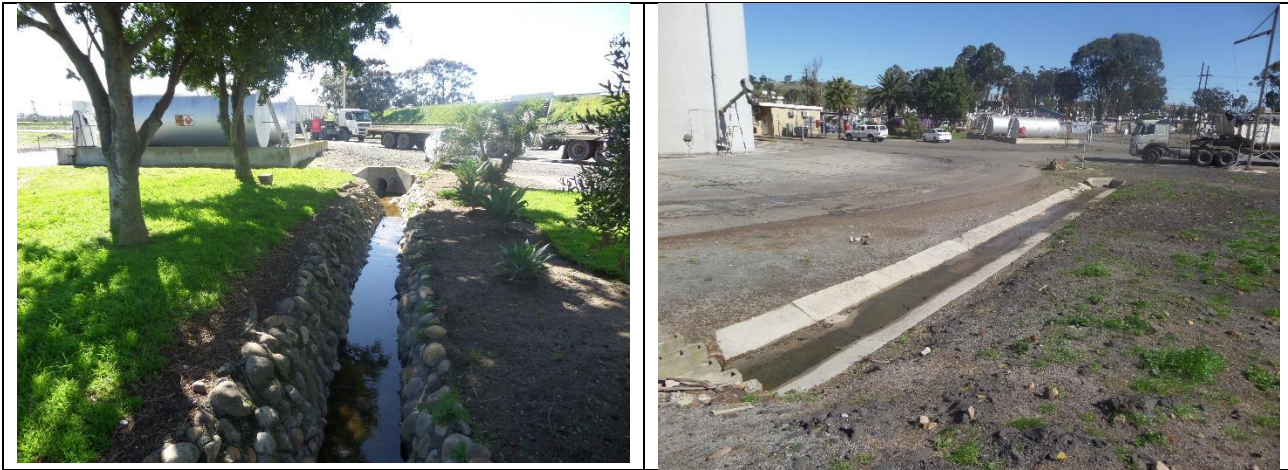
**Figure 6 & 7:** Storm water management infrastructure on site directing clean stormwater through the site underneath the existing prick paved road. A concrete canal (figure 7) and stone pitched canal (figure 6).

As is evident from Figure 6 & 7 above clean stormwater is channelled through the site with existing stormwater infrastructure. Concrete slabs will be constructed where trucks will park for loading and offloading purposes (spill containment slabs). A storm water management plan for the management of clean stormwater and dirty stormwater (from the spill containment slabs) will be designed and included as an Annexure to the Operational Phase Environmental Management Plan. This is a detailed design requirement that will be undertaken post Environmental Authorisation before the facility is built.

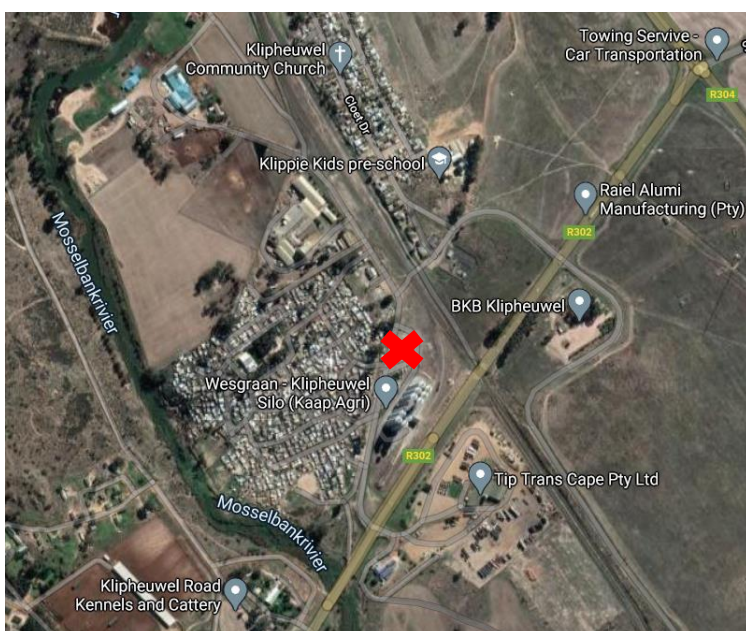
**Figure 8:** The closest watercourse to the site (red cross in image above) is the Mosselbank Rivier located 365m away from the site proposed for diesel storage. The river will not be at any risk because a bund wall will be built around the storage tanks in case of any leaks or tank failure. The tanks are proposed above ground.
