**ENVIRONMENTAL AUTHORISATION AUDIT REPORT  
AFROX / GASFIT (PTY) LTD, WORCESTER**

**July 2021**

**DEA&DP Reference Number: 16/3/3/1/B2/32/1020/20**

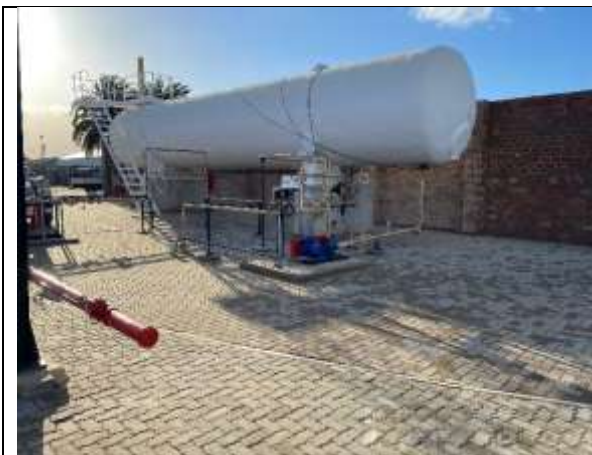
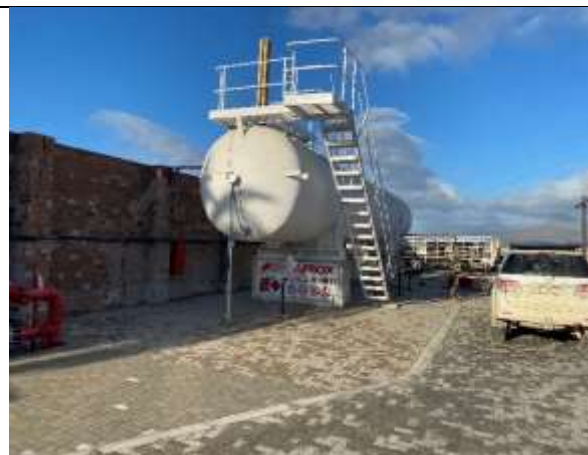
**Photo 1 & 2:** 70m<sup>3</sup> LPG bulk storage tank installed at the Facility.

19.	<p>The LPG storage tank must be installed according to the following South African National Standards (“SANS”):</p> <ul style="list-style-type: none"> <li>• All relevant electrical works must be compliant with SANS 10108.</li> <li>• All LPG storage and filling installations must comply with SANS 10087-7.</li> <li>• All relevant building works must comply with SANS 10400.</li> <li>• SANS 10087-3 (2008) (English): The handling, storage, distribution and maintenance of liquefied petroleum gas in domestic, commercial, and industrial installations Part 3: Liquefied petroleum gas installations involving storage vessels of individual water capacity exceeding 500 L.</li> </ul>	Compliant	<p>An IB Steel Engineering Pressure Vessel Inspection Report (Report No: REP- GR25877) dated 13 March 2021 and a Certificate of Conformity for Gas Installation: Occupational Health &amp; Safety Act, 1993 (Certificate No: 715427) dated 19 April 2021 were reviewed during the audit.</p> <p>These reports confirmed that the installation of the LPG storage tank was according to the required listed South African National Standards (“SANS”).</p>

21.	<p>The installation of the Aboveground Storage Tank and associated pipework must comply with the National Building Regulations and Standards Act No. 103 of 1977.</p>	Compliant	<p>An IB Steel Engineering Pressure Vessel Inspection Report (Report No: REP- GR25877) dated 13 March 2021 and a Certificate of Conformity for Gas Installation: Occupational Health &amp; Safety Act, 1993 (Certificate No: 715427) dated 19 April 2021 were reviewed during the audit.</p> <p>These reports confirmed that the installation of the LPG storage tank comply with the National Building Regulations and Standards Act No. 103 of 1977.</p>

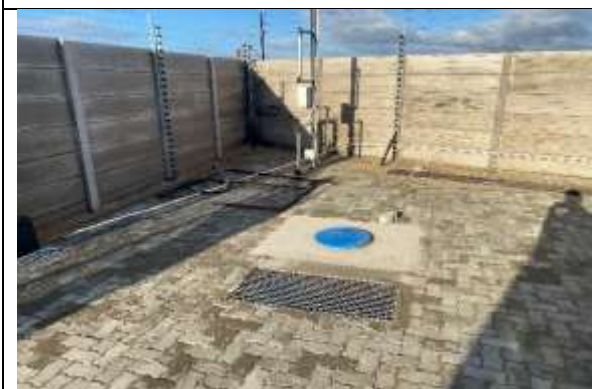
**Photo 3:** Oil separator system installed at the southern corner of the Facility.

17.	An oil separator system must be installed in the southern corner of the site prior to construction taking place to separate hazardous liquids from the stormwater prior to discharging onto the adjacent land.	Compliant	During the site audit it was noted that an oil separator system was installed at the southern corner of the Facility.  A Boland Bouers Oil Separator letter dated 6 January 2021, ECO Reports 1 – 5, dated February 2021 – April 2021, ECO Closure Report dated 16 April 2021 and a DEA&DP Proof of Compliance with the Condition of the EA letter, dated 9 June 2021 also confirmed this condition was complied with.

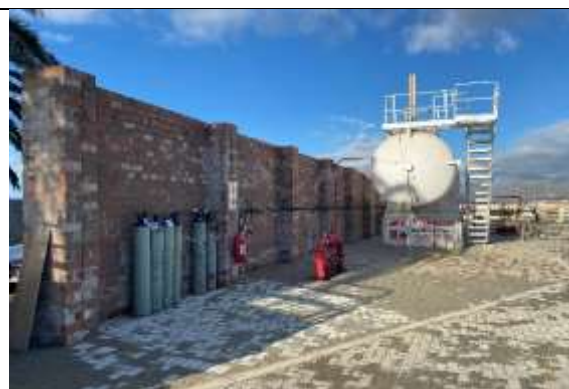
**Photo 4:** Fire wall constructed along the eastern boundary of the Facility.

18.	A 3,6 m high fire wall must be constructed along the eastern boundary of the site, adjacent to the LPG storage tank. The wall must be constructed during the construction phase prior to the installation of the tank.	Compliant	During the site audit it was noted that a 3,6 m high fire wall was constructed along the eastern boundary of the Facility.  ECO Reports 1 – 5, dated February 2021 – April 2021 and ECO Closure Report dated 16 April 2021 as well as a DEA&DP Proof of Compliance with the Condition of the EA letter, dated 9 June 2021 also confirmed this condition was complied with.
