Case Study: Rotor Bar Fault in AC Induction

Summary

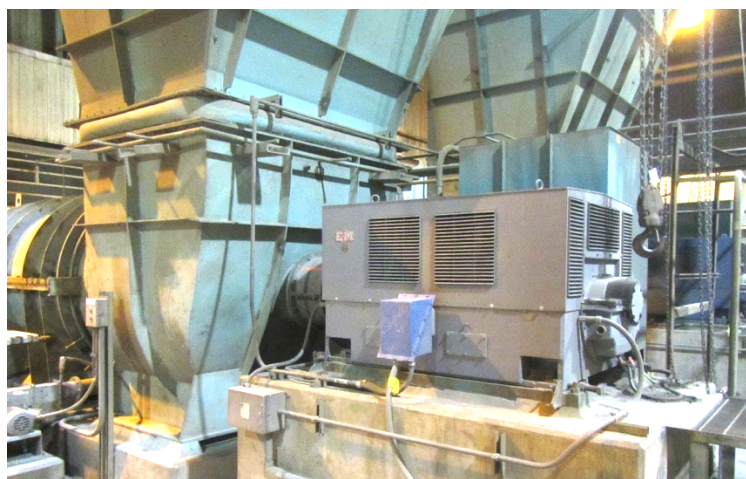
Figure 1 - Primary Air Fan

A 1500 HP AC induction motor is the driver for a Primary Air Fan at a coal-fired power plant. The motor rotor is supported with two journal bearings. The fan, shown in Figure 1, is critical to operations and is scheduled to run continuously.

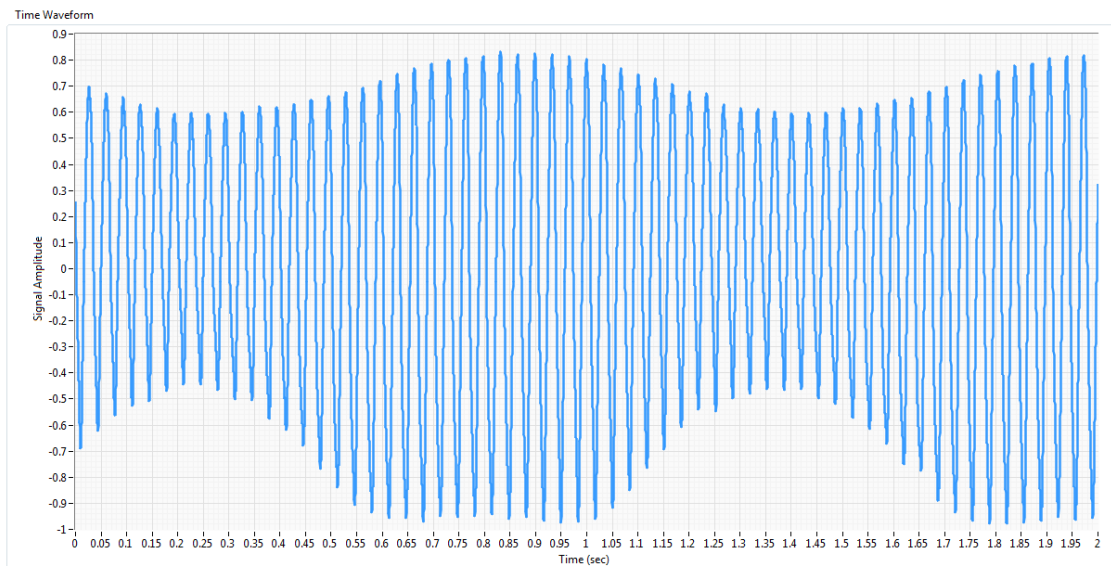
Figure 2 - Proximity Probe Time Domain Data

Figure 2 gives the time domain data collected using the proximity probe. The proximity probe clearly shows the indicative pole frequency amplitude modulation but is missing the running speed frequency harmonic. This could be a function of not removing the slow roll compensation vector and leaving the running speed peak extremely dominant.

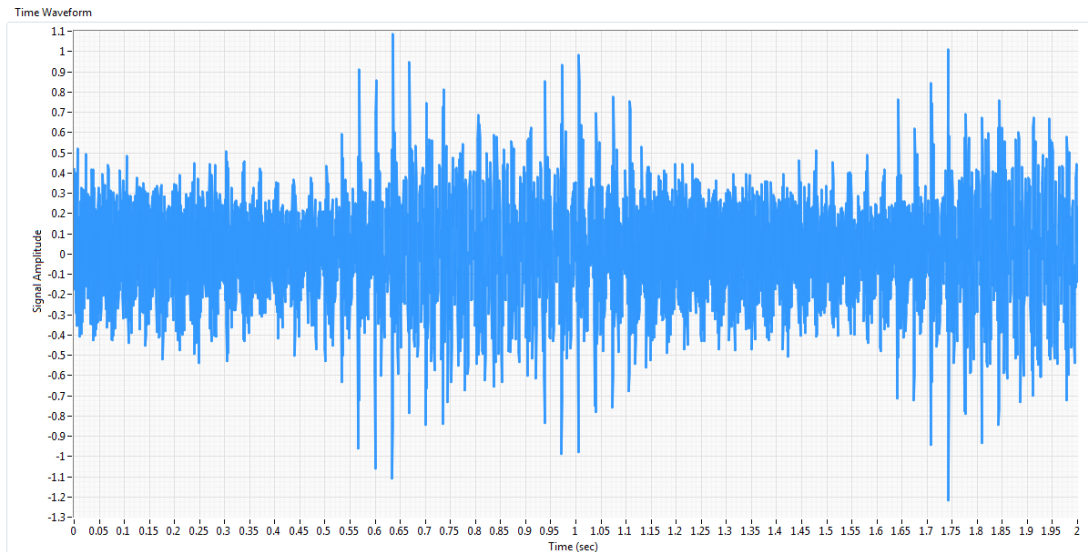
Figure 3 - Accelerometer Time Domain Data

Figure 3 is time domain data collected from the same location at the same settings but using a case mounted accelerometer. Reviewing this data set would not give the impression of a rotor fault, but rather some kind of impact event happening. Clearly, in this case, the accelerometer is not effective at measuring the malfunction. This is because the relatively small inertia of the motor rotor does not transmit well enough through the low stiffness and highly damped journal bearings.

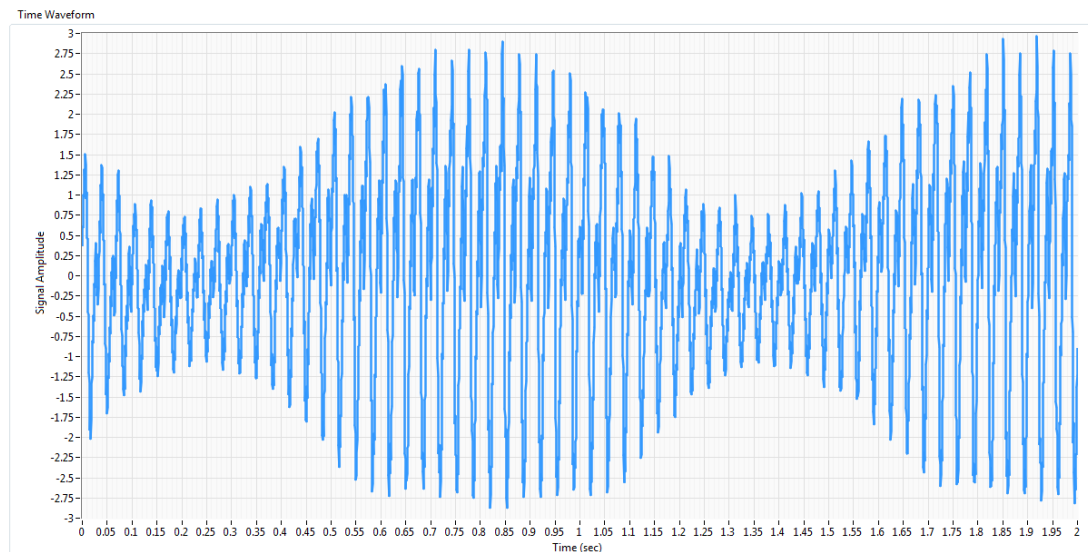
Figure 4 - Insight FDS Time Domain Data

Figure 4 depicts the time domain collected with the FDS sensor. Two distinct patterns exist, the pole frequency amplitude modulation associated with a rotor fault, and a strong running speed harmonic. Since the FDS measures microstrain on the bearing, this means the bearing is loaded at both the running speed frequency and its harmonic. This is a textbook example of a rotor bar fault and would not have required outside analysis to diagnose the malfunction.

As a result, the customer replaced the motor at the next shutdown. Additionally, they placed an order for 40 Insight FDS to be installed in the plant on ID fans, FD fans, PA fans and Boiler Feed Pump motors.

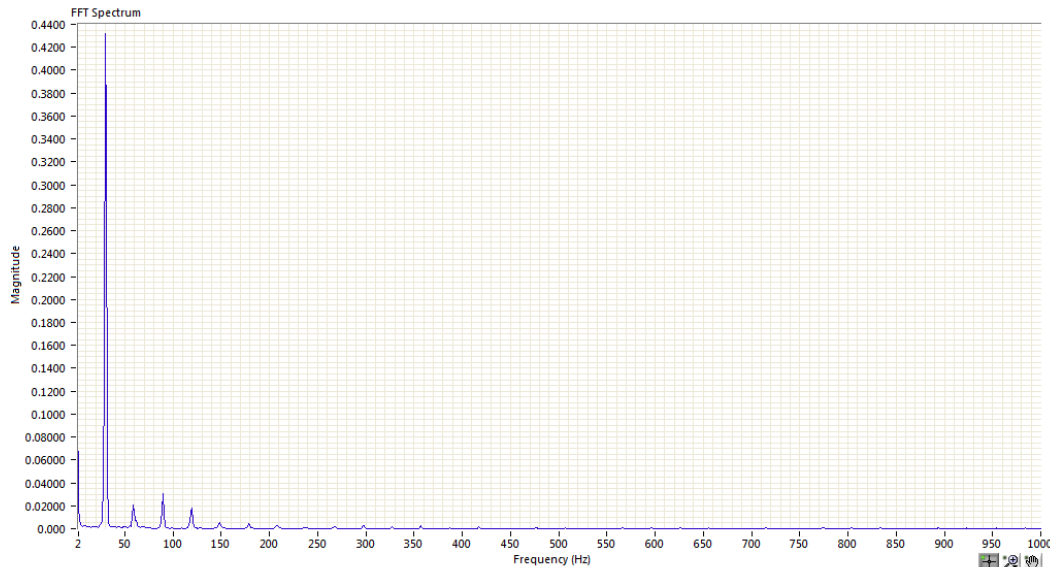
Figure 5 - Prox Probe Spectrum, 1000 Hz Fmax, 1 Hz RES, 4 Avg, Hanning

Figure 5 shows an FFT spectrum collected from the proximity probes. The resolution is fairly coarse and the frequency range is moderate. It shows the dominant running speed frequency peak but is missing the harmonic.

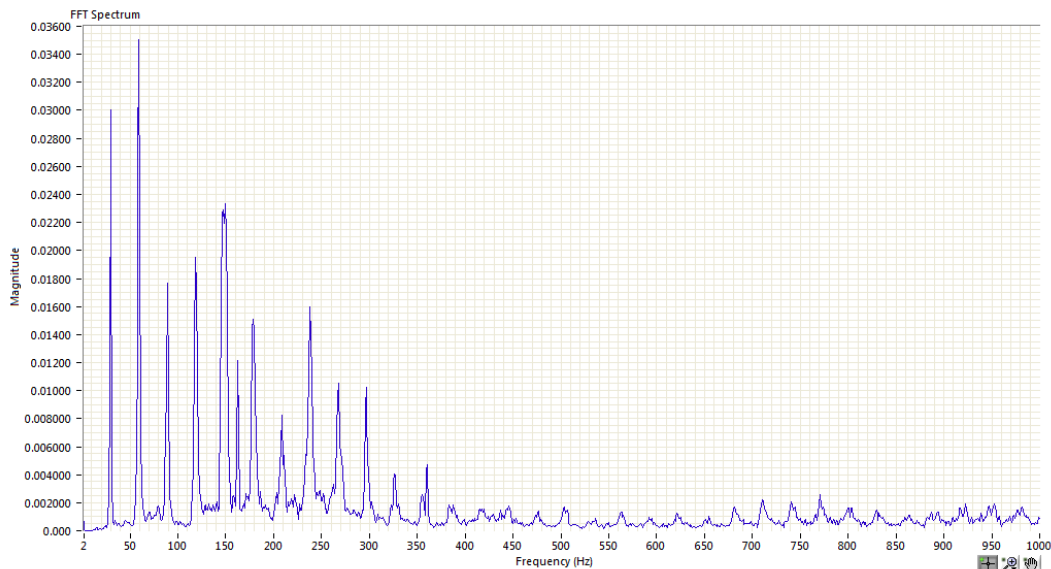
Figure 6 - Accelerometer Spectrum, 1000 Hz Fmax, 1 Hz RES, 4 Avg, Hanning

Figure 6 is an FFT spectrum collected with the accelerometer. The raised noise floor and lack of dominant frequencies is indicative again of poor performance for detecting this rotor fault through the journal bearing.

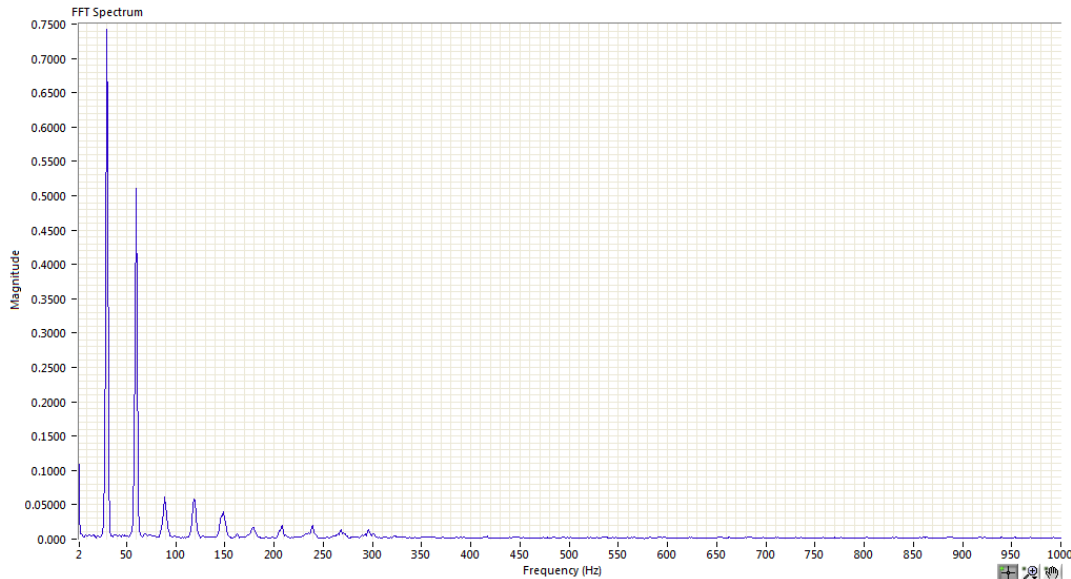
Figure 7 - Insight FDS Spectrum, 1000 Hz Fmax, 1 Hz RES, 4 Avg, Hanning

Figure 7 shows an FFT spectrum collected from the Insight FDS. It depicts the dominant frequencies, running speed and its 1st harmonic.

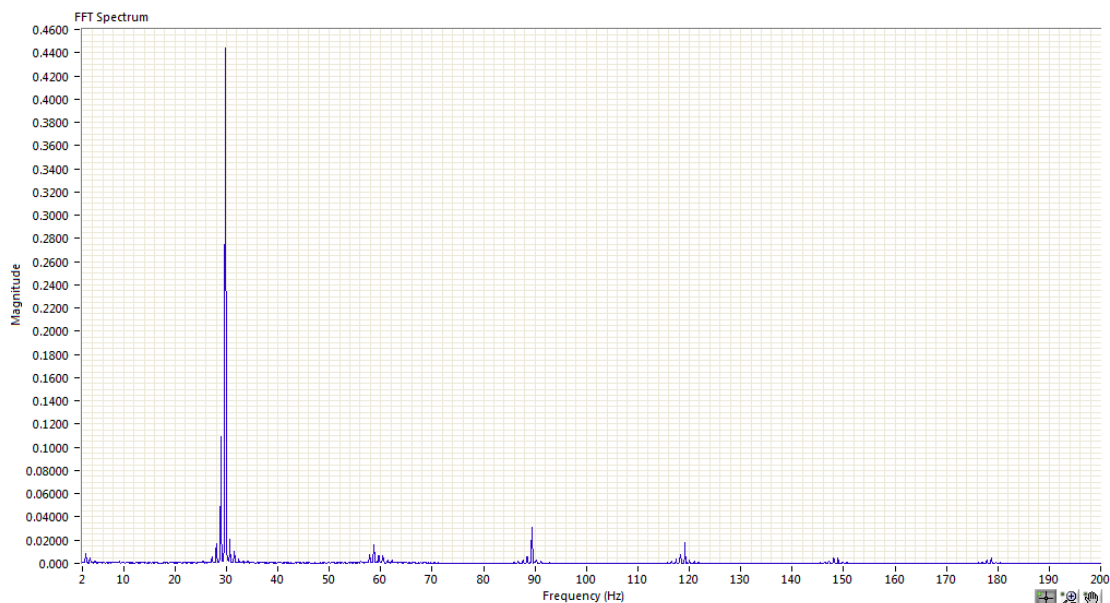
Figure 8 - Proximity Probe Spectrum, 200 Hz Fmax, 0.1 Hz RES, 4 Avg, Hanning

Figure 8 shows the high resolution FFT spectrum using the proximity probes. There are pole frequency sidebands, but less families than present with the FDS, and the 1st harmonic is still weak.

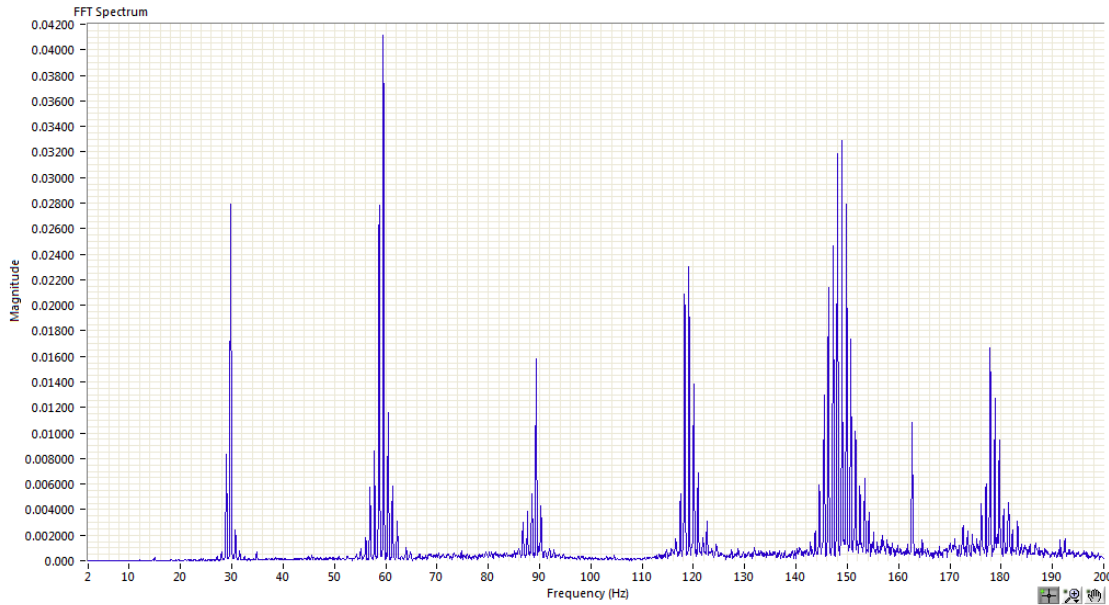
Figure 9 - Accelerometer Spectrum, 200 Hz Fmaz, 0.1 Hz RES, 4 Avg, Hanning

The high resolution FFT spectrum from the accelerometer shown in Figure 9 is dominated by the higher order harmonics making the analysis of the rotor fault confusing.

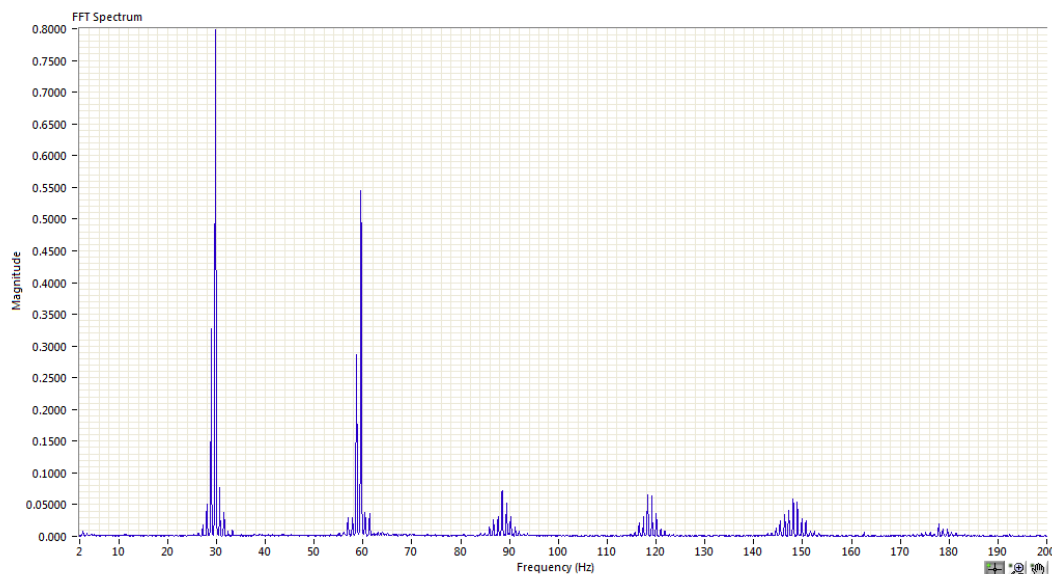
Figure 10 - Insight FDS Spectrum, 200 Hz Fmaz, 0.1 Hz RES, 4 Avg, Hanning

Figure 10 is a high resolution FFT spectrum using the FDS. The classic pole frequency sidebands as well as the descending harmonics are nearly a textbook case of an AC Induction Motor Rotor Fault.
