In a power system, insulator plays an important role to isolate among live parts and between live part and ground and as mechanical protector. The insulators are widely used at substations, transmission as well as distribution networks. Due to some superior properties such as lightweight, good water repellence and resistance to pollution, recently, polymeric insulating materials are introduced to substitute conventionally used insulators like porcelains and glasses. The level of insulation safety provided by an insulator depends on the amount of leakage current flowing on its surface. Actually increased leakage current causes a part of high voltage to appear at dead end of insulator. This voltage may sometimes be of order of 1000 to 5000 Volts depending upon weather conditions. Such a level of leakage current causes hazards to public safety as well as losses. So to monitor and keep the leakage current low is an important parameter to be considered by designers and electric supply companies. During service, several severe conditions such as high humidity, coastal and industrial pollutions as well as biological contaminations may be exposed to the outdoor insulators. Additionally the

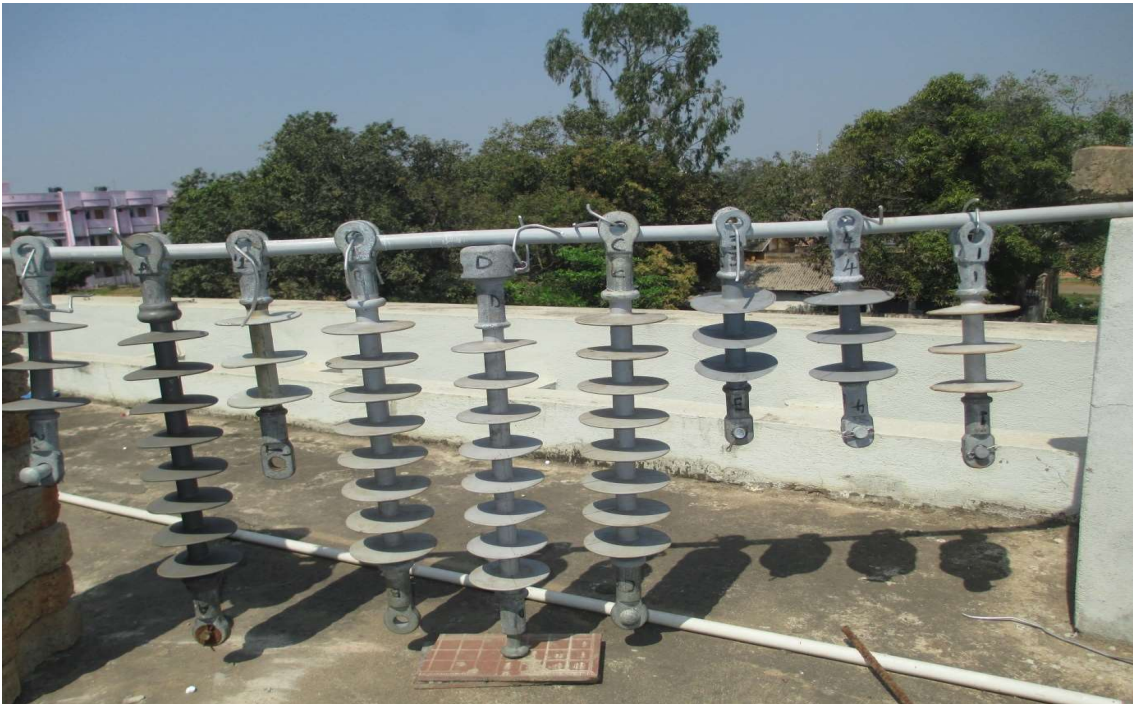
**Fig. 5.1 Setup of Polymeric Insulator samples at test site under natural atmospheric pollution**
