1.1 PROPERTY ADDRESS - INSPECTION CONDITION:

4319 Dixie Canyon Ave, Unit 2, Sherman Oaks, CA 91423.

DWELLING TYPE: Condominium. **NUMBER OF LEVELS:** 1.

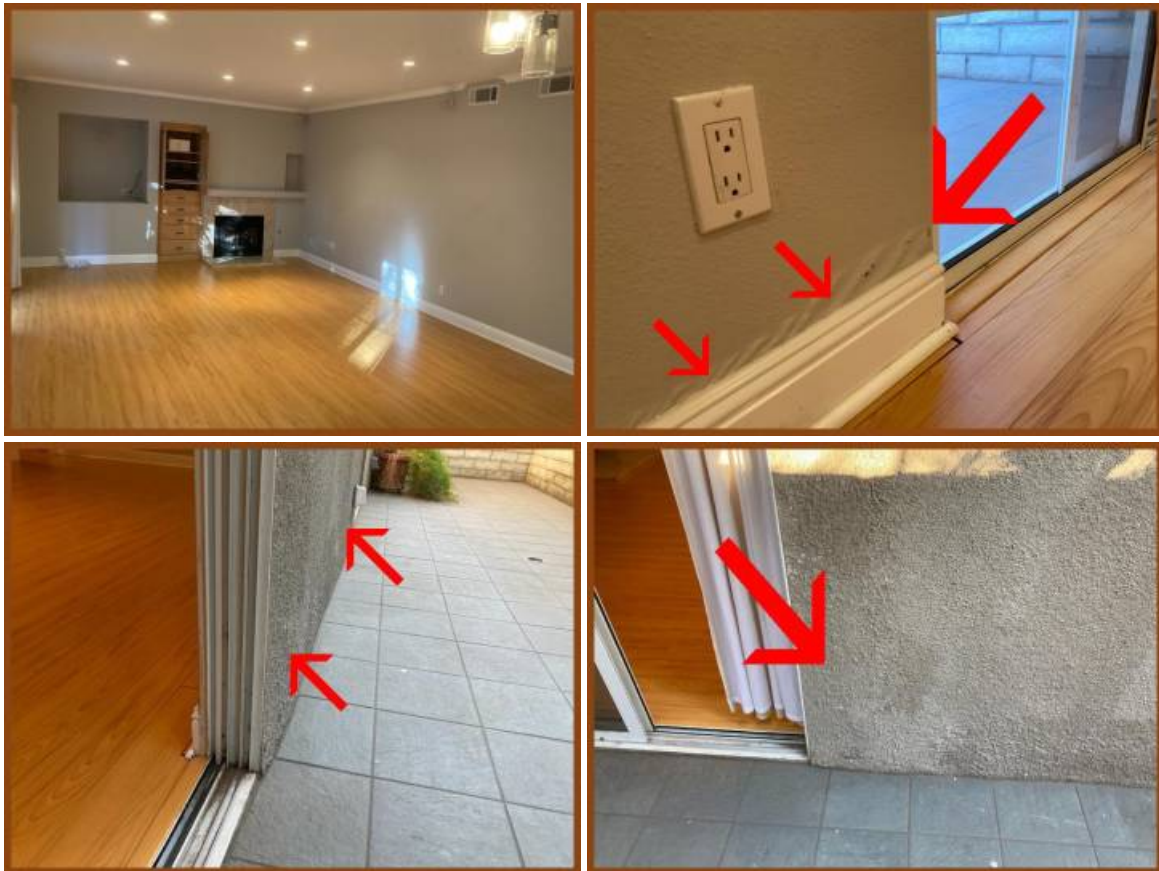
Needs Attention, parts of the living room's wall is damaged, deteriorated and may have been exposed to moisture, as noted near the base molding's area, whereas the structure's exteriors, opposite of the living room's interior walls, appears to have been subject to prior repair / modification, however, it is outside the scope of this inspection to diagnose the repairs / modifications' proficiency - Hidden damage may exist.

- Consult with a qualified and competent specialists, including an environmental / mold's specialist, prior to the expiration of the contingency period and prior to close of escrow, for further review / investigation of the entire area / system / structure, to determine the presence and / or absence of any condition that may be conducive to the growth of Fungi and / or related Pathogenic Organisms, that may affect the health or safety of the occupants. The specialist's review / investigation may include additional systems' items or components of the system and may recommend to repair / replace systems' items or components that may not have been visible in this "visual only" property inspection. Further, Request from the selling party to Provide full disclosure / details and HOA's documents to determine responsibilities of maintenance or repairs of said area / system.

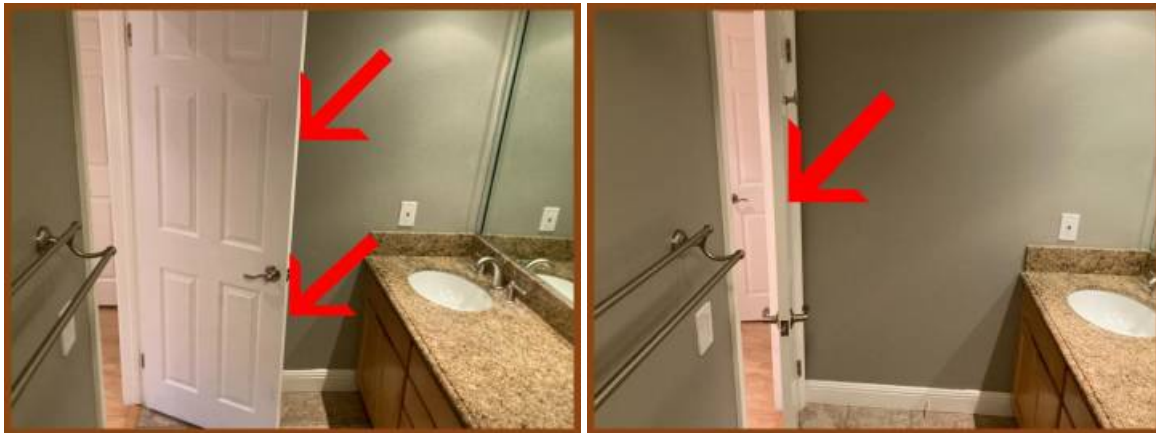
Needs Attention, Although functional, However The master bathroom door is out of adjustment and closes on its own.

- Consult with a qualified and competent specialist for further Review, Repair / Replace as needed.

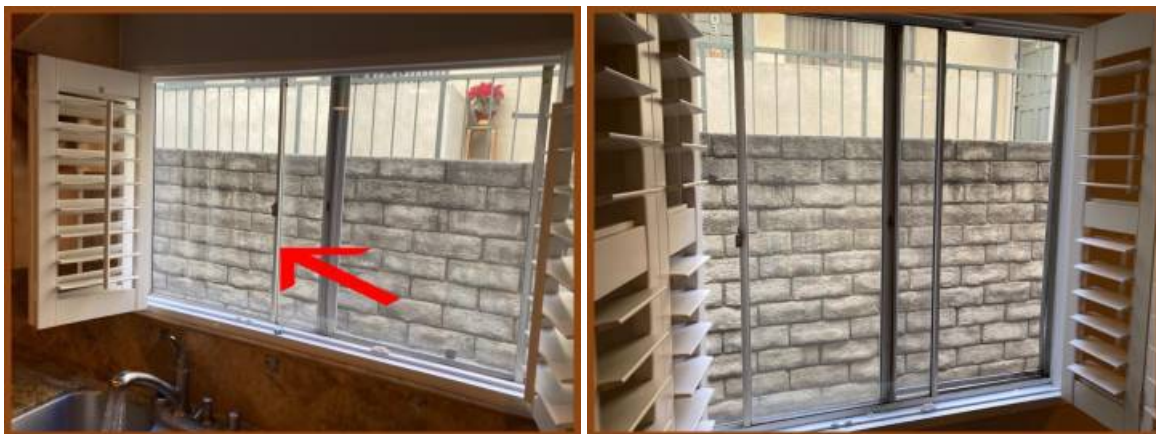
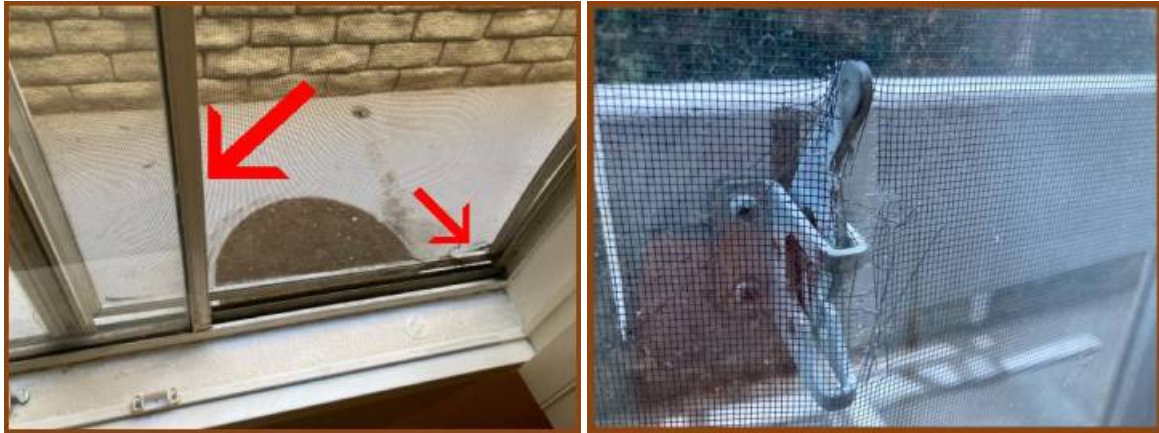
2.4 WINDOWS - GLASS:

Needs Attention, Although functional, However the windows system is older, does not slide properly near the breakfast nook, and the glass is not properly secured at the window's frame near the kitchen's sink. Further, some of the screens are damaged.

- Consult with a qualified and competent specialist for further Review, Repair / Replace as needed.

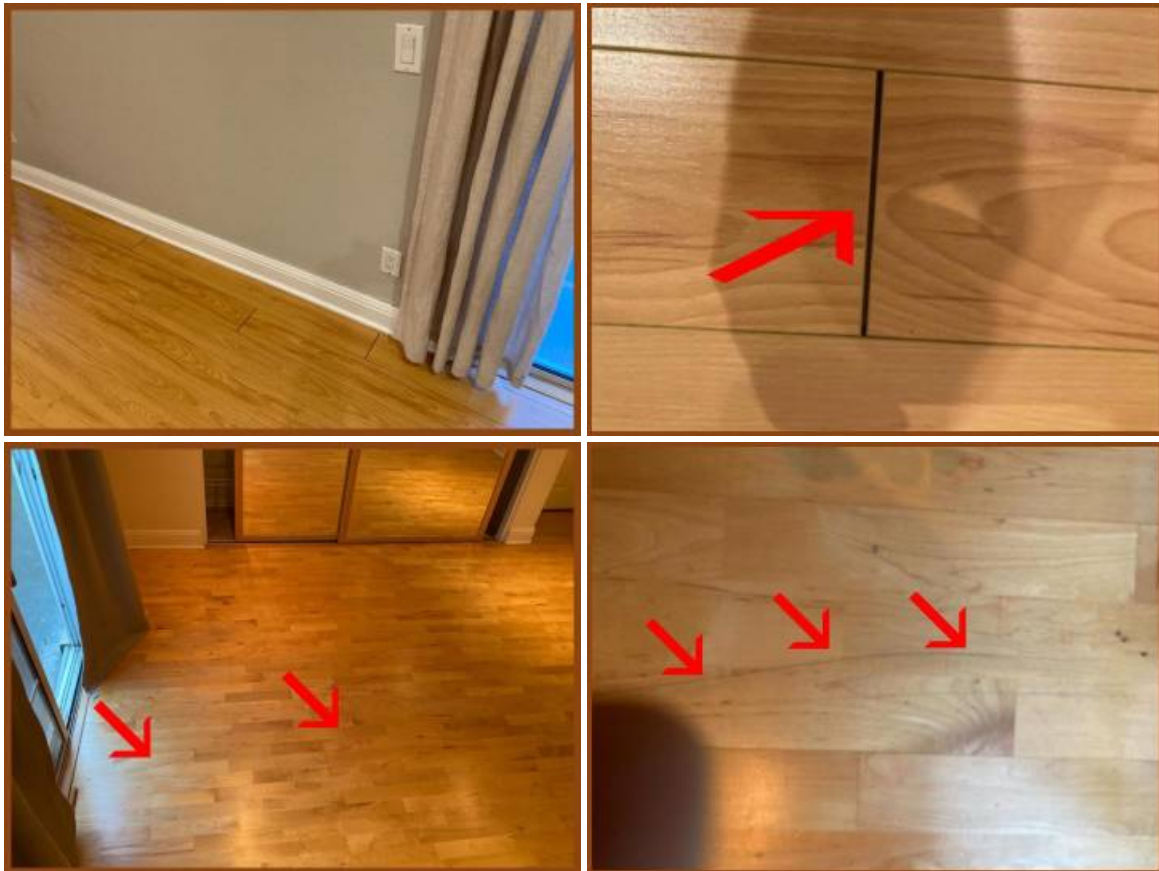
2.5 FLOOR COVERING:

Needs Attention, Although functional, However Parts of the floor covering its noted with open seams, such as at the living room, Whereas the bedroom's floor covering is cracked and discolored in area. Further, the floor is not level in some areas however cause was not determined.

- Consult with a qualified and competent specialist for further Review, Repair / Replace as needed.

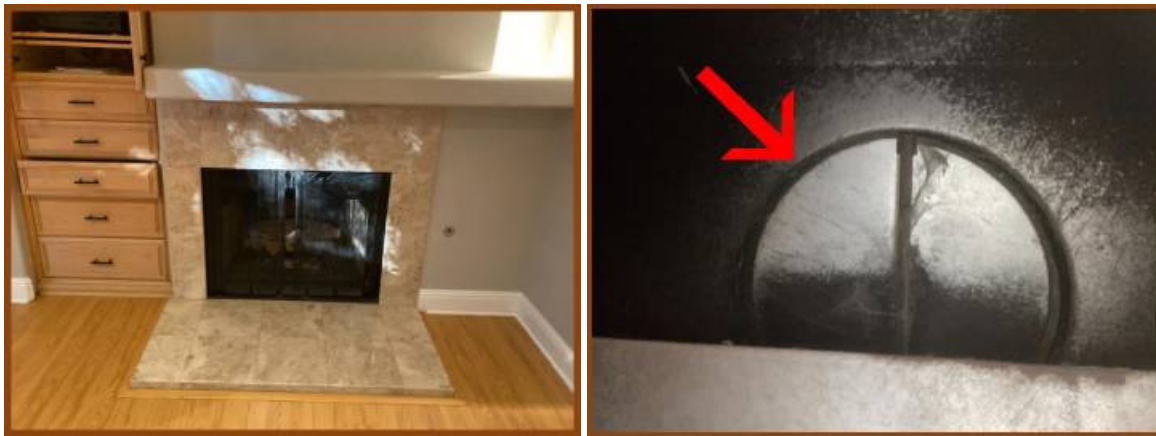
2.7 FIREBOX - GAS LOG - DAMPER:

Satisfactory / Serviceable, With typical wear, though recommend installing a gas clip on the damper, for safety.

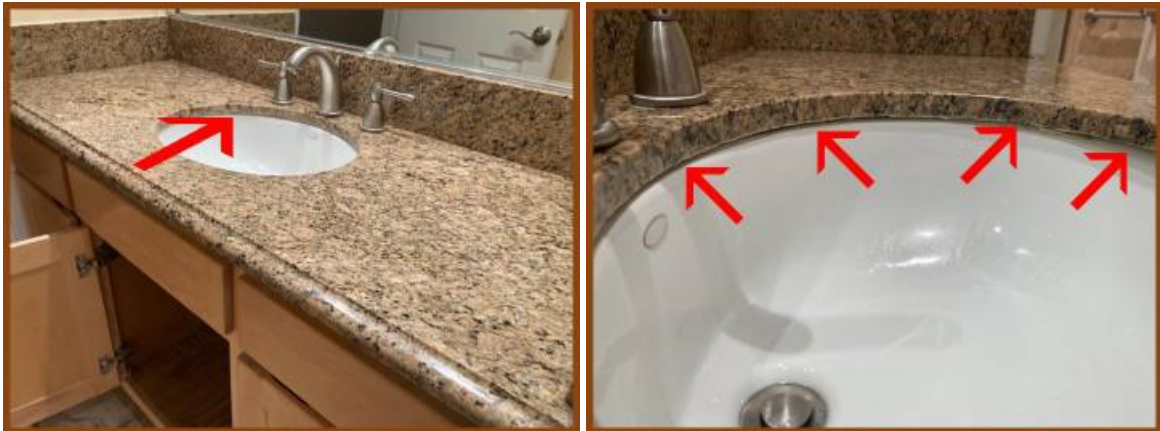
3.3 VANITY(S) - CABINET(S):

Needs Attention, The vanity' s sink sealer is deteriorated and will need proper caulking' s re-application to prevent potential water intrusion onto the cabinet' s area.

- Repair / Service or Replace as needed by a qualified and competent specialist.

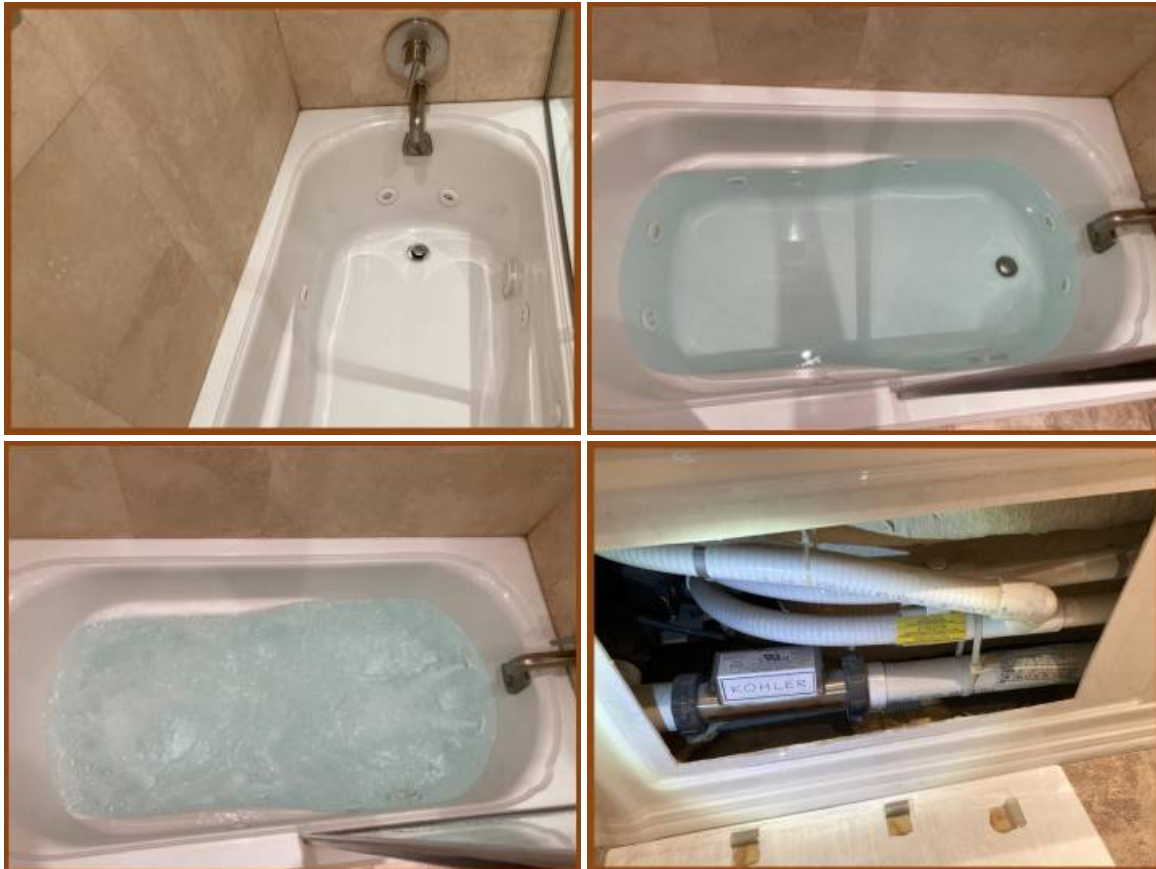
3.4 JACUZZI TUB - FIXTURE - VISIBLE PLUMBING:

Satisfactory / Serviceable, With typical wear, though the tub's drain stopper will need adjustment to operate properly.

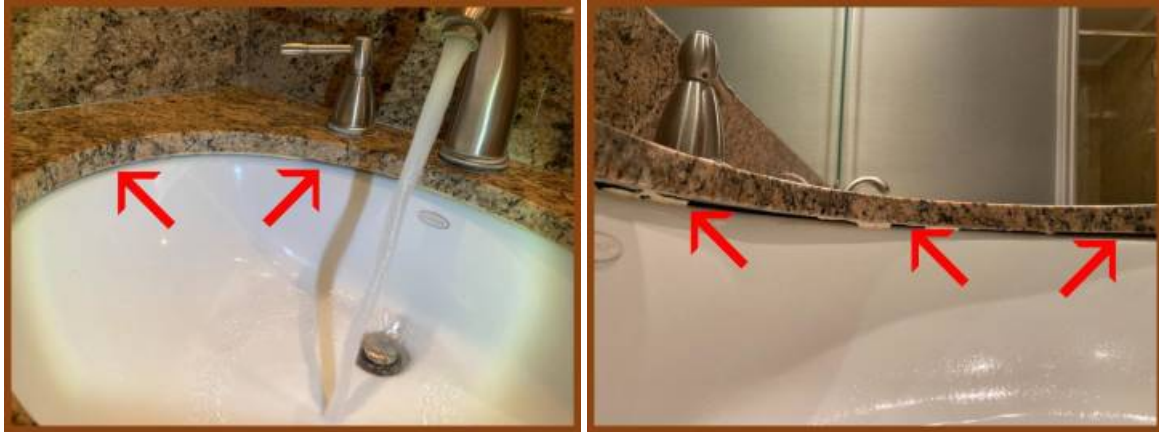
3.12 VANITY(S) - CABINET(S):

Needs Attention, The vanity's sink sealer is deteriorated and will need proper caulking's re-application to prevent potential water intrusion onto the cabinet's area.

- Repair / Service or Replace as needed by a qualified and competent specialist.

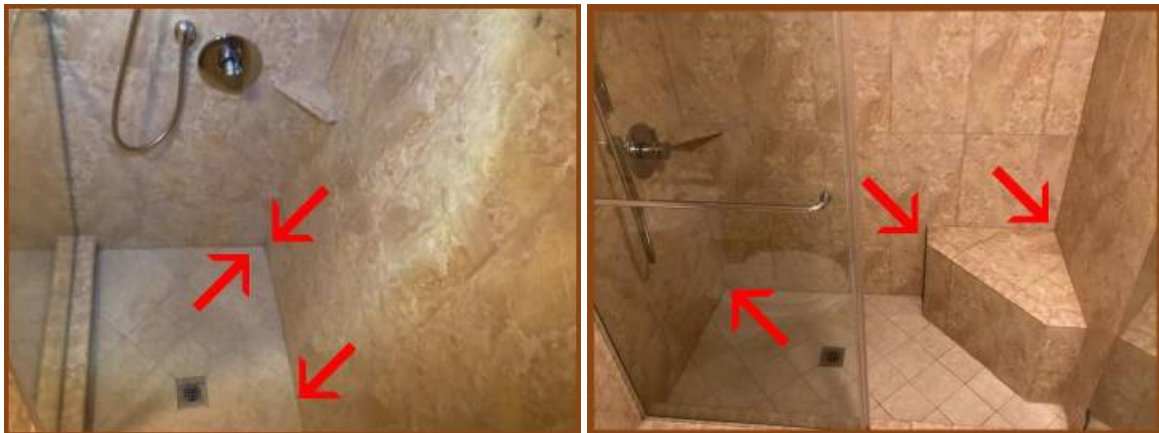
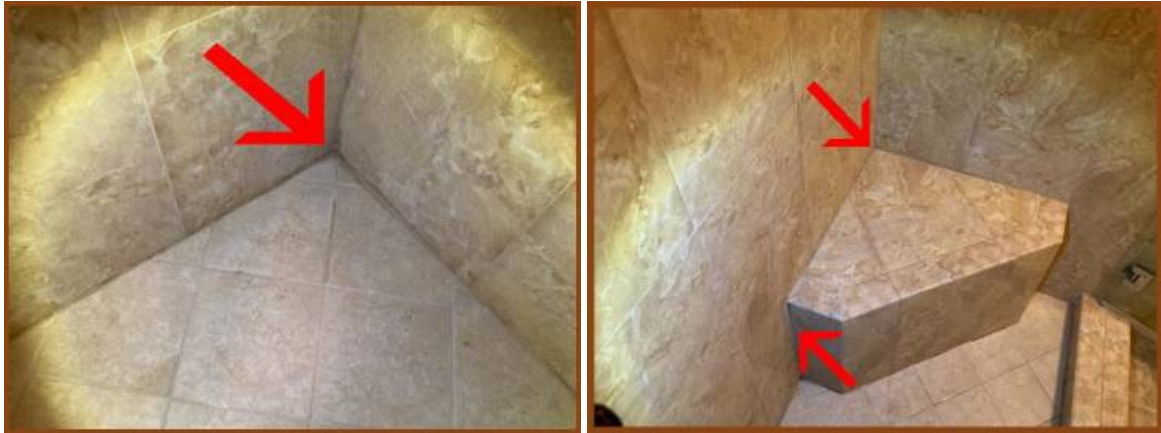
Needs Attention, the shower enclosure's grout is deteriorated on multiple locations and will need proper caulking's re-application to prevent potential water intrusion onto the interior element of the structure - Hidden damage may exist.

- Repair / Service or Replace as needed by a qualified and competent specialist.

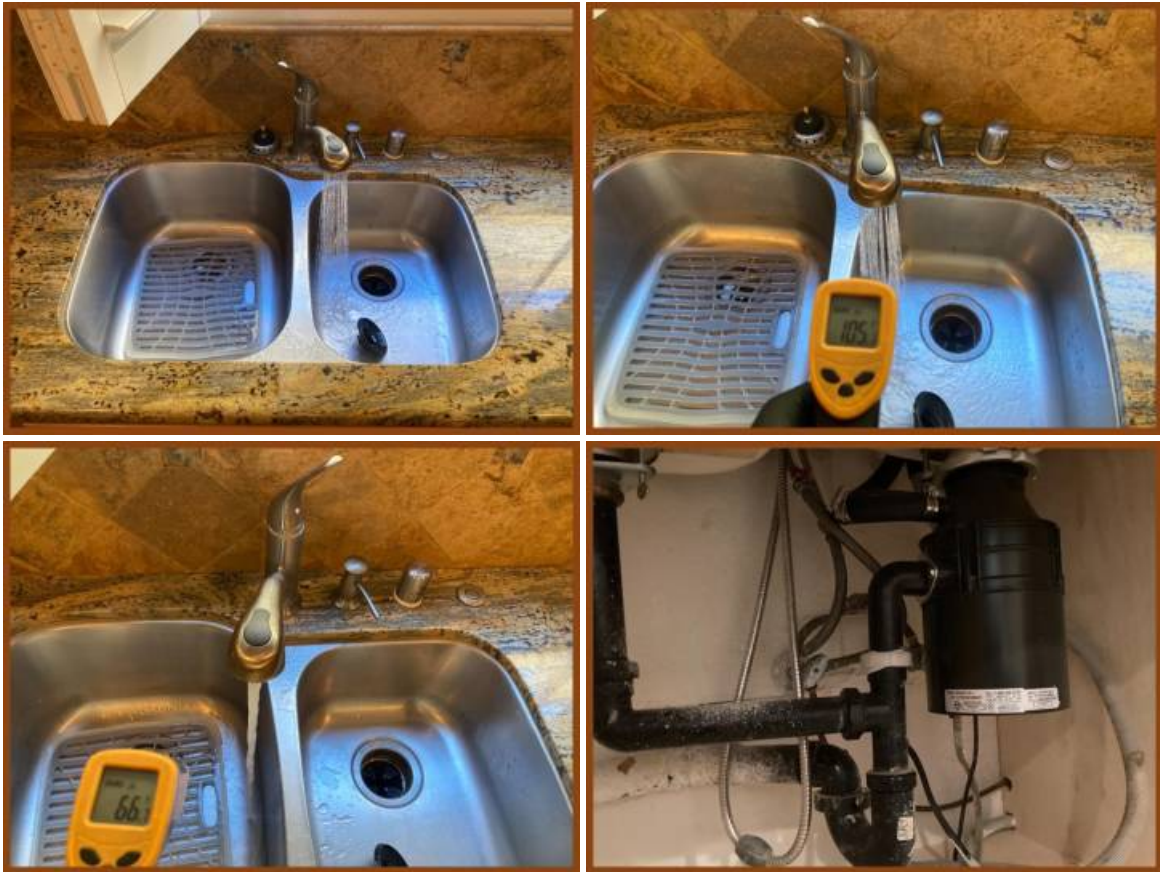
Needs Attention, Although functional, However The handle does not switch from cold to hot smoothly and may require service or adjustment.

- Monitor condition as it may require maintenance, repair / service or others as needed by a qualified and competent specialist.

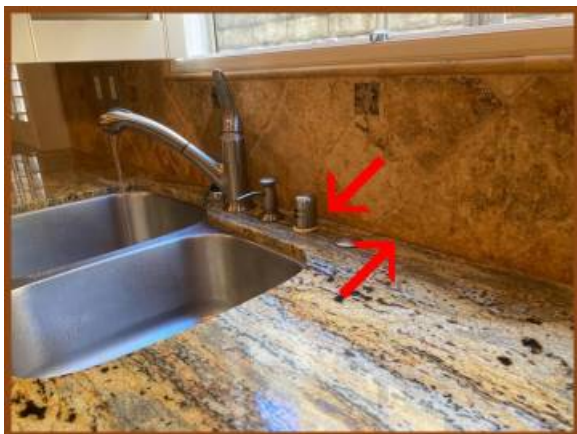
4.2 COUNTER TOP - CABINET(S):

Needs Attention, Although functional, However the counter top's grout is deteriorated, chipped or missing at the back splash, and will need proper caulking's re-application to prevent potential water intrusion onto the cabinet's area. Further, Some of the drawers did not slide smoothly and will need service or adjustment.

- Repair / Service or Replace as needed by a qualified and competent specialist.

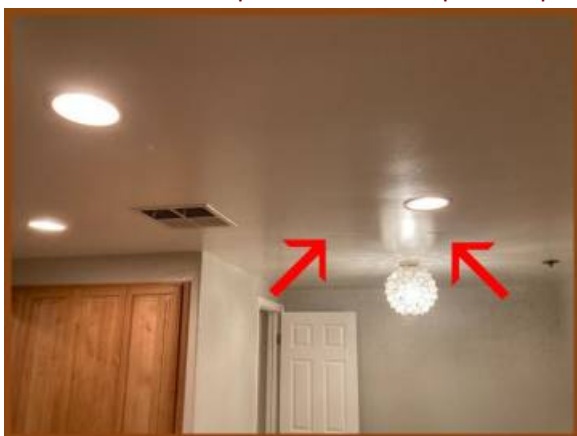
Needs Attention, The Ceiling is deteriorated in area - Cause was not deteriorated.

- Consult with a qualified and competent specialist for further Review, Repair / Replace as needed.

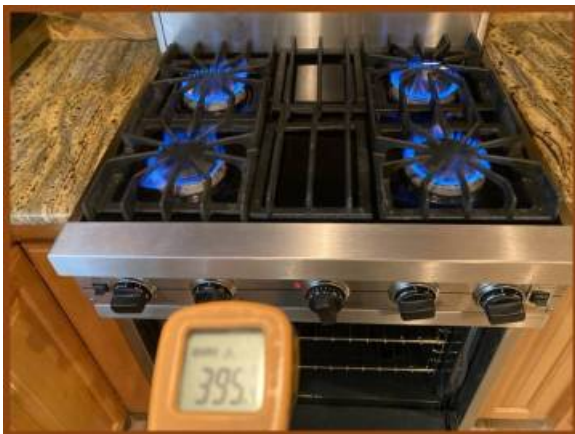
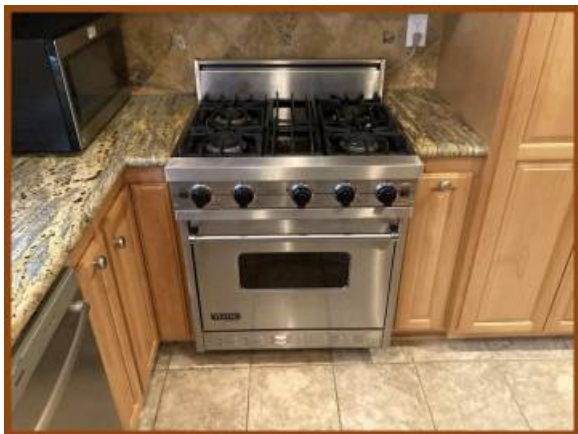
4.7 RANGE - OVEN:

Needs Attention, Although functional, However, The electronic's ignition pilot was noted clicking at times during the burners operation.

- Monitor condition as it may require maintenance, repair / service or others as needed by a qualified and competent specialist.

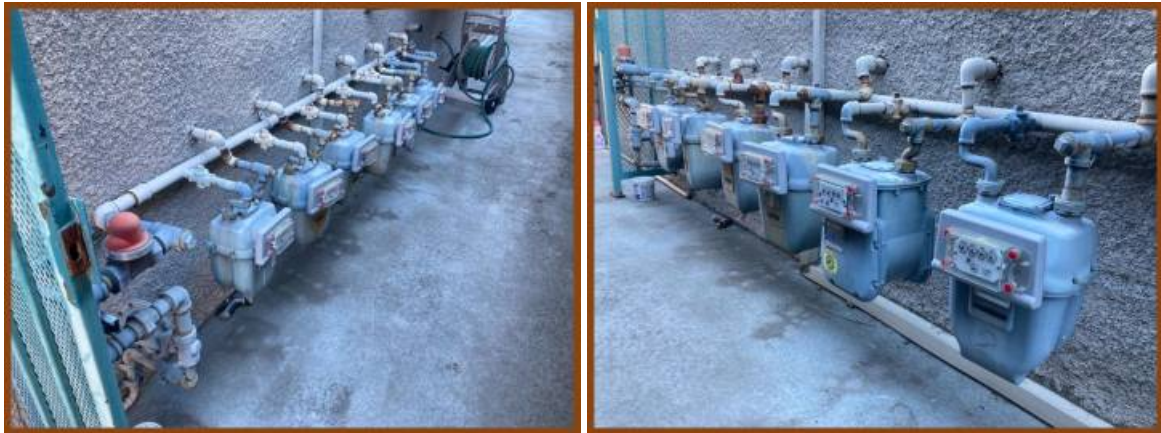
5.3 GAS SUPPLY - SHUT OFF VALVE SYSTEM:

Satisfactory / Serviceable, With typical wear - The seismic shut off valve is installed on the community's main gas line.

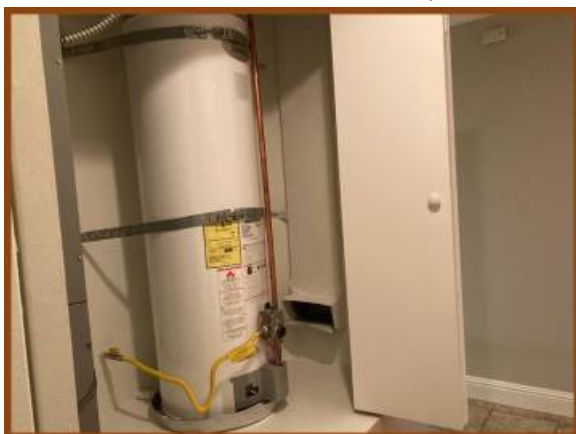
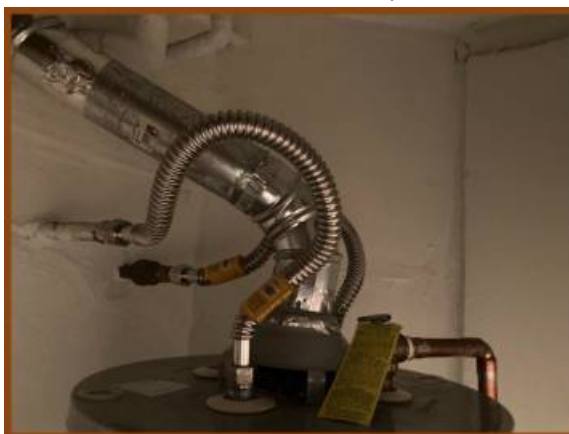
6.2 WATER HEATER SYSTEM:

Needs Attention, Although functional and appears to be newer installation, however the water heater should be equipped with Bonding cable of metallic water lines and gas line, Sediment trap on the gas line into the water heater, and a Thermal expansion tank, as done in current construction practice.

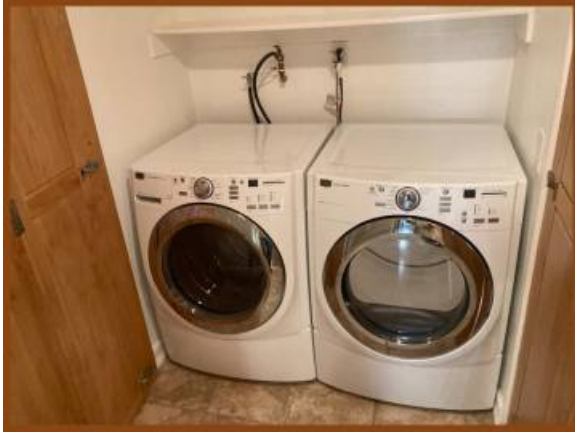
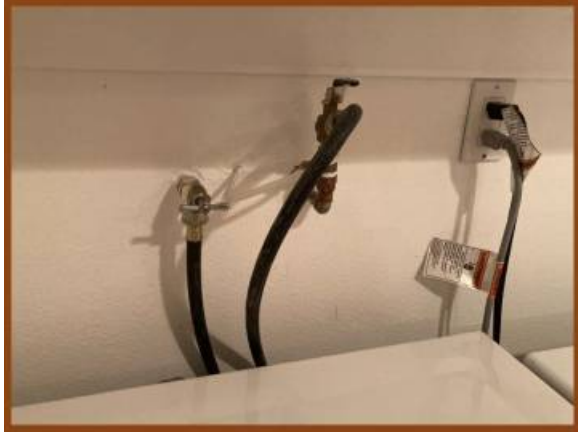
7.1 WASHER - HOOKUPS WATER-SUPPLY & DRAIN:

Satisfactory / Serviceable, With typical wear, however, Recommend installing a drip pan below the laundry appliance as a Precaution.

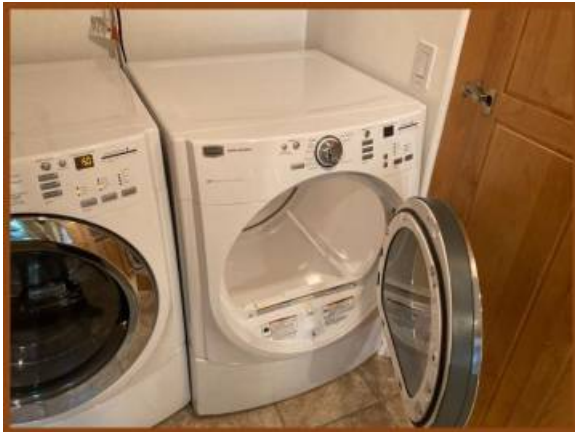
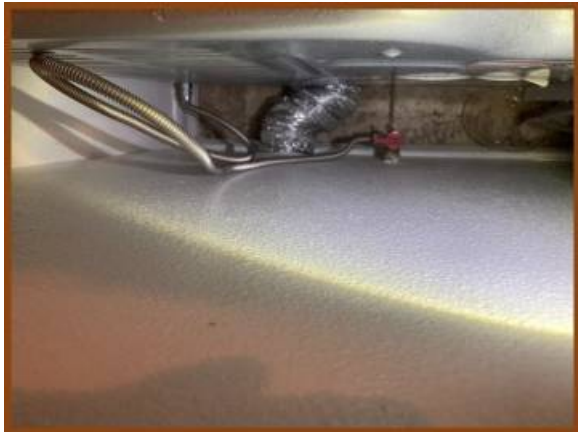
7.2 CLOTHES DRYER HOOKUPS - VENTING:

Satisfactory / Serviceable, With typical wear - Further, monitor and clean the dryer's vent line regularly to prevent lint build-up inside the vent line, as it may become a fire-hazard.

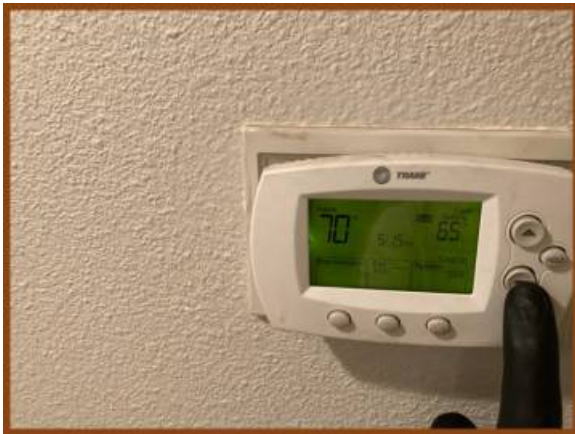
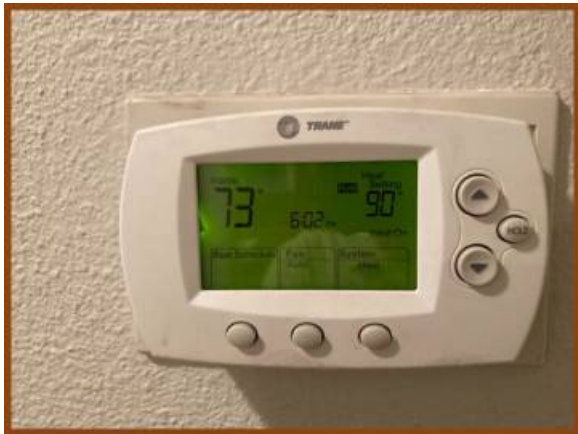
8.3 THERMOSTAT:

Satisfactory / Serviceable, With typical wear, though the thermostat does not go below 65.

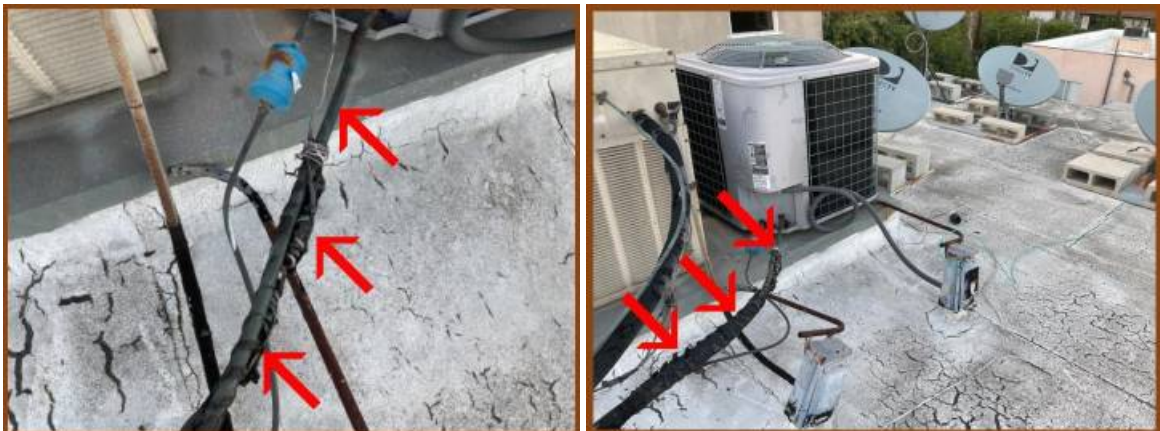
8.6 CONDENSATE LINE:

Needs Attention, The system's condensation's insulation is deteriorated.

- Consult with a qualified and competent specialist for further Review, Repair / Replace as needed.

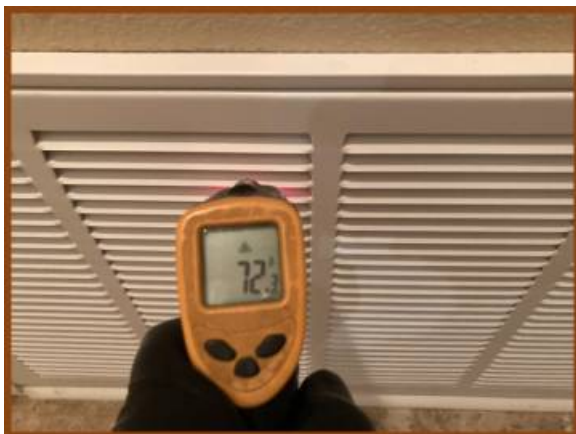
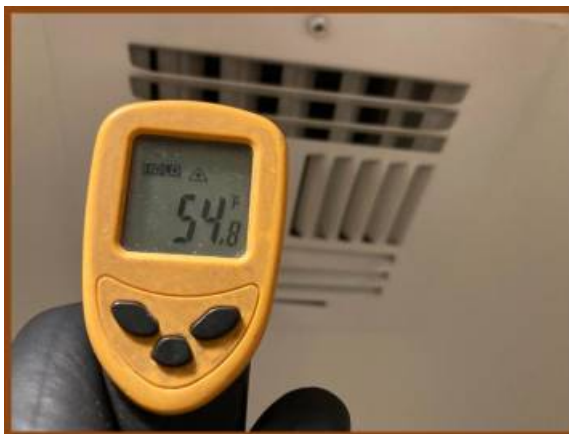
8.7 TEMPERATURE DIFFERENTIAL:

Satisfactory / Serviceable, The temperature difference between the supply air and return air, across the evaporator, is within an acceptable range 72-54.

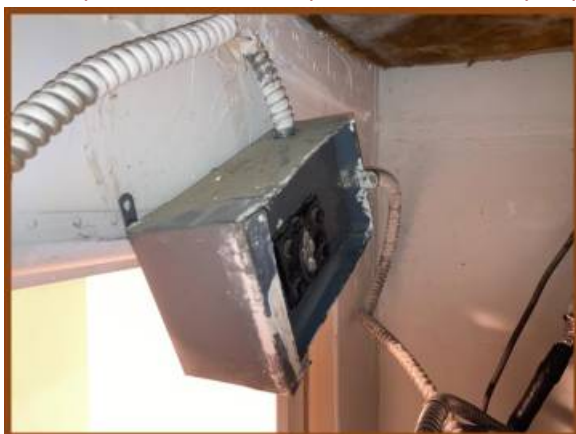
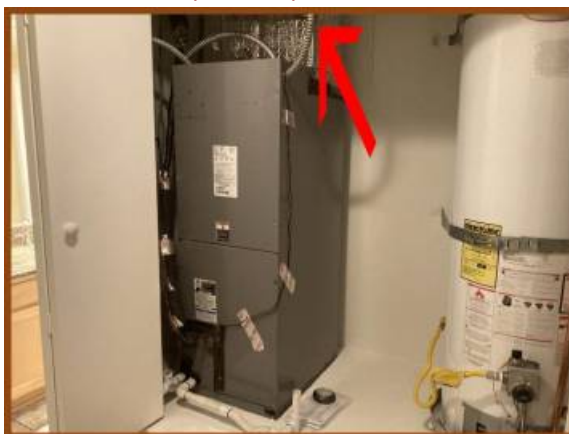
8.8 ENERGY SOURCE DISCONNECT:

Needs Attention, the electrical disconnect is not properly secured and hanging by the conduit.

- Repair / Service or Replace as needed by a qualified and competent specialist.

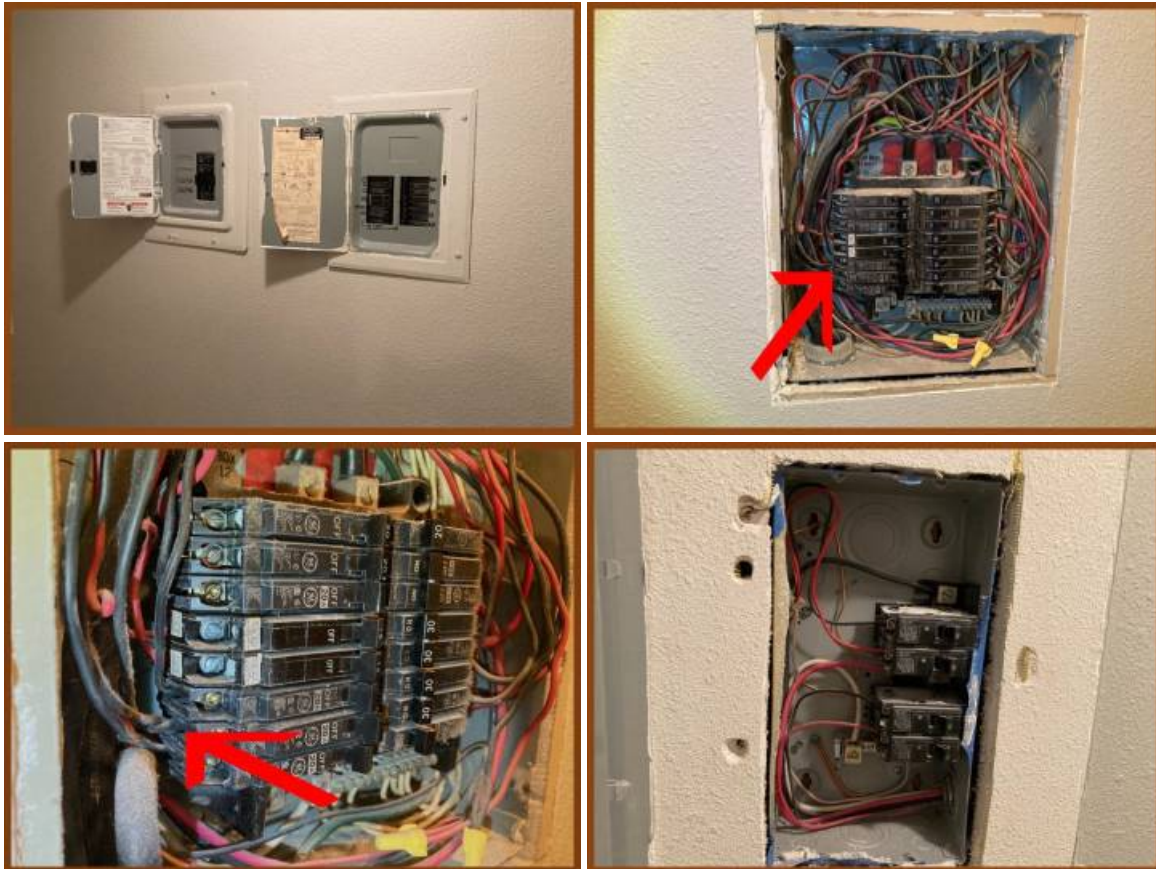
Needs Attention, The sub panel's wiring system is noted with double wiring at a single circuit breaker, which is not recommended as it may cause arc, over heating and other damage(s).

- Consult with a qualified and competent specialist for further Review, Repair / Replace as needed.

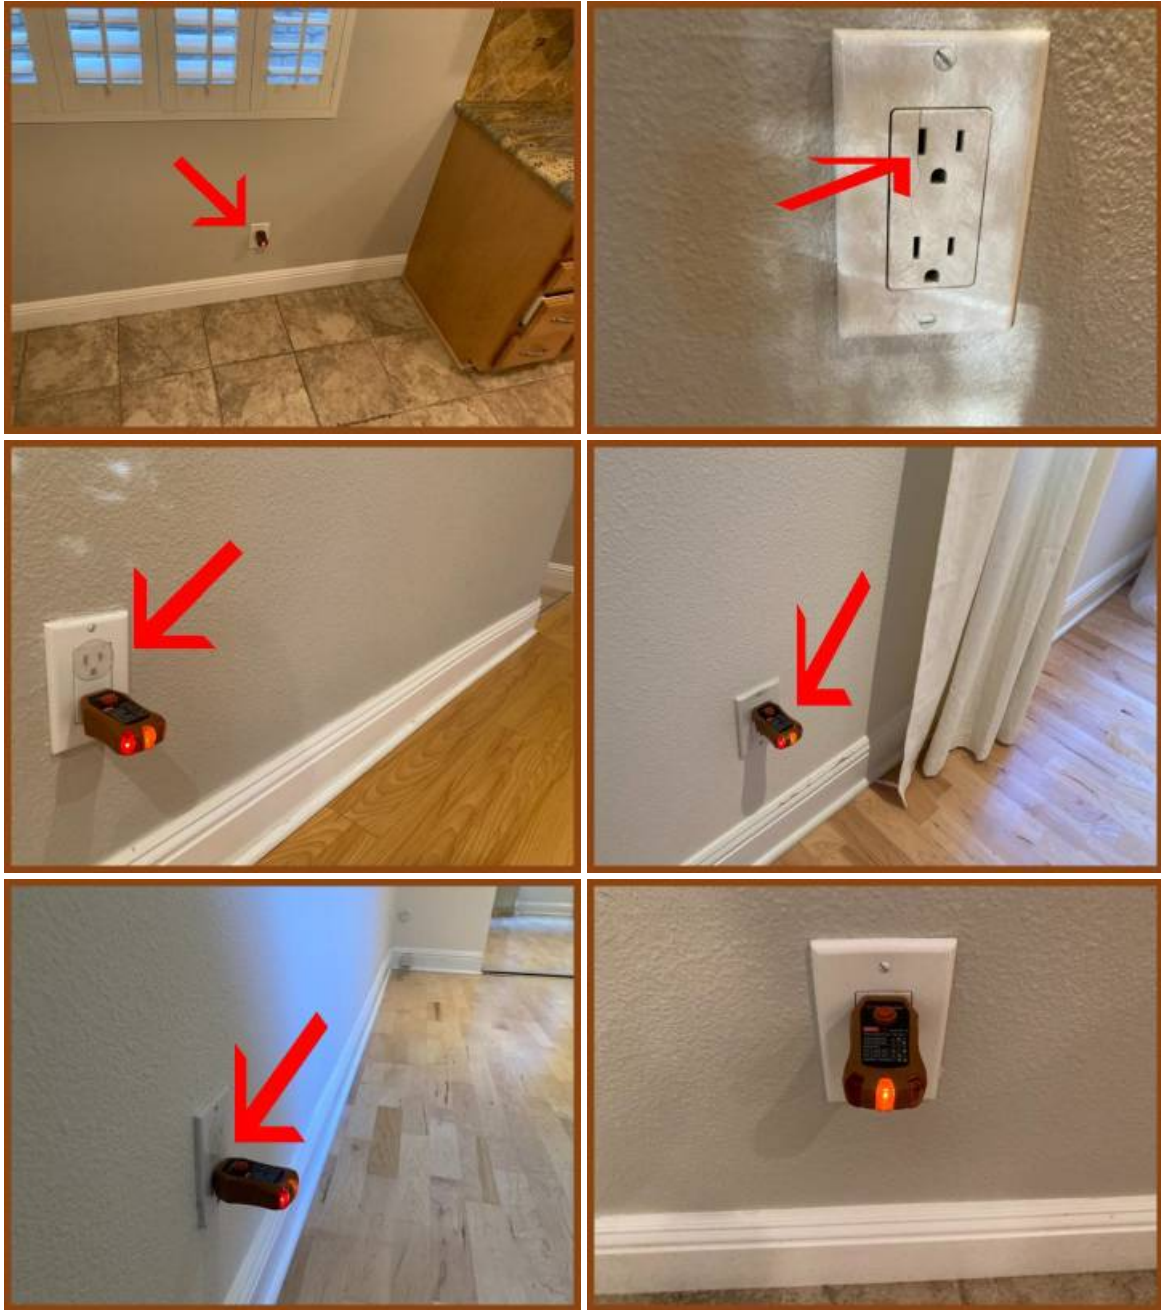
Needs Attention, several receptacles are improperly wired and noted with an open ground and reverse polarity condition in the living room, kitchen and the bedrooms, whereas a living room's receptacle is cracked.

- Repair / Service or Replace as needed by a qualified and competent specialist.

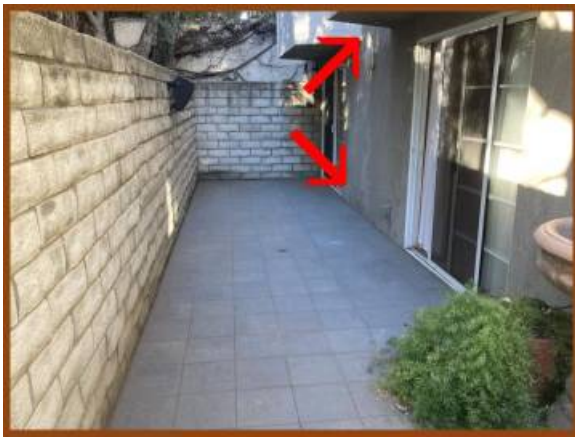
Needs Attention, The structure' s exterior is The color coating on the structure is cracked and bubbling, whereas some areas appears to have been subject to prior repair / modification, however, it is outside the scope of this inspection to diagnose the repairs / modifications' proficiency.

- Request from the selling party to Provide full disclosure / details and HOA' s documents to determine responsibilities of maintenance or repairs of said area / system.
