# Inspection Details

Condominium, ROOFING AND EXTERIORS ELEMENTS; GARAGE AND GROUNDS ELEMENTS; FOUNDATION ELEMENTS - Condominium and Cooperative unit inspections do not include evaluation of exterior and/or common elements. The appropriate Management personnel should be consulted regarding common element maintenance responsibilities, master deeds, or other pertinent pre - purchase information.

Over 40 years

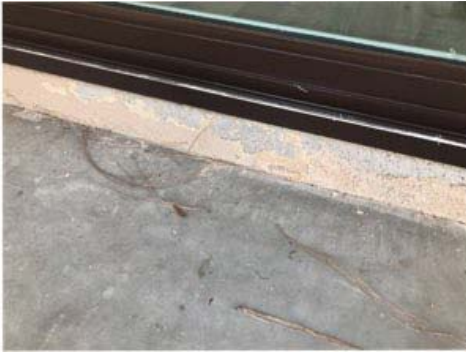
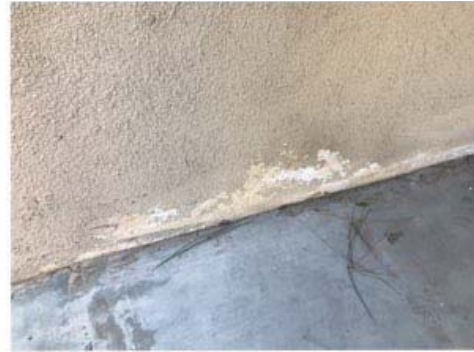
**1.1. Cracked/damaged areas noted at stucco walls. Have it checked and fixed by a qualified specialist.**

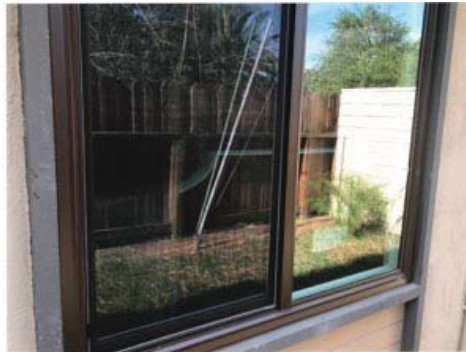
**2.3. Newer replacement type windows noted - Check the records/warranties. Periodic maintenance around the frame/sealant required (to prevent water seepage).**

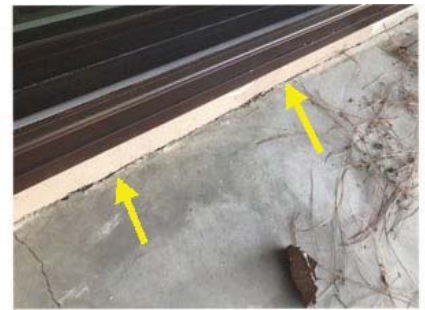
**4.1. Gap noted at exterior door threshold and deck cover/tiles - have it sealed/caulked to prevent water seepage. Have it checked and repaired by a qualified specialist.**

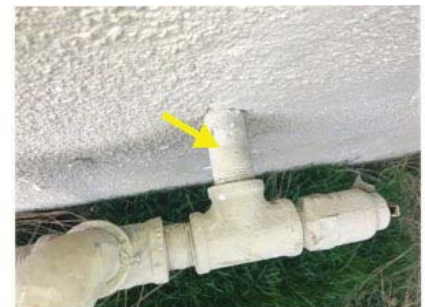
**2.2. Water main is Galvanized pipe - Galvanized pipes are considered to be at or near end of life, with limited remaining life. Recommend to re-pipe. Have it checked by a qualified plumber.**

**2.3. Damaged shut off valve noted. Have it checked and replaced by a qualified plumber.**

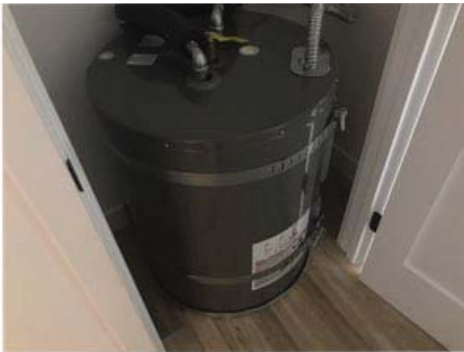
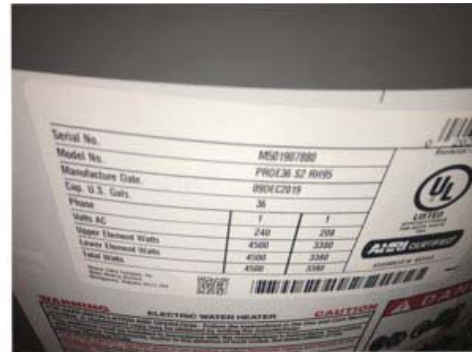
**1.2. Water heater is a newer installation - recommended to check the records/permits/warranties.**

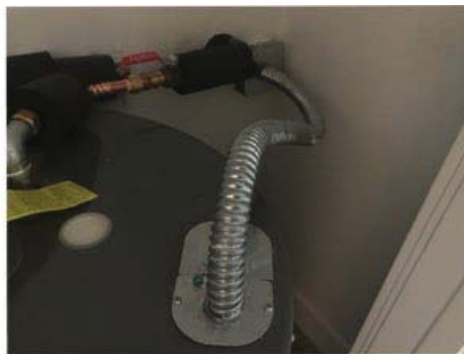
**2.1. Missing service disconnect box - improper, poor workmanship. Recommend to install. Have it checked and installed by a qualified electrician.**

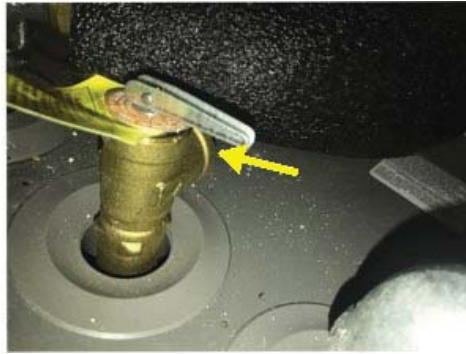
**3.1. TPR valve line terminates unsafely - recommend to extend outside into a safe location. Have it checked and repaired by a qualified plumber.**

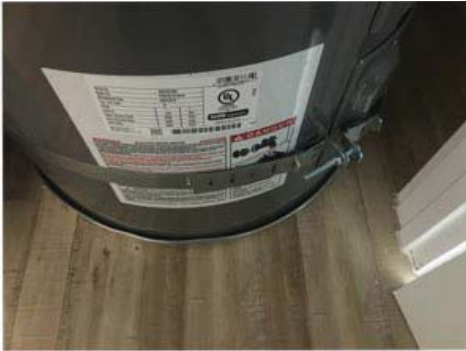
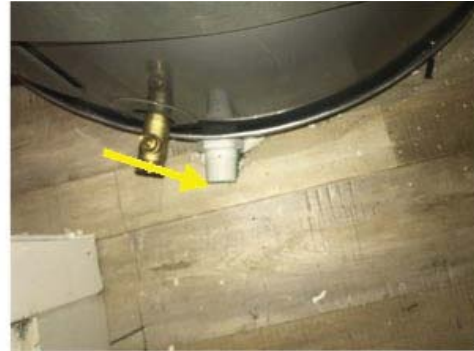
**4.1. Water heater lacks drain pipe at catch pan. Recommend to install and extend to outside.**

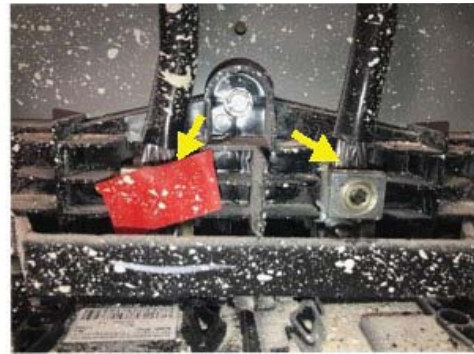
- 3.1. Breakers are not properly labeled for emergency identification. Recommend to have it checked and labeled.
- 3.2. Missing Anti-Oxidant paste at Stranded Aluminium wires. Recommend to install by a qualified electrician.
- 3.3. Newer installation or upgraded panel noted - Recommend to check the records/permits.

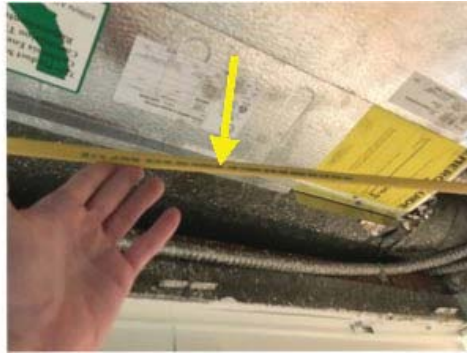
- 4.1. Most of the electric wiring is enclosed within the walls and ceilings and other parts of the structure. It is not visible and its condition cannot be fully determined. No representation is made as to its status.
- 4.2. Newer wiring/fixtures noted - Check the records/permits.
- 4.3. Loose Romex noted at heat pump area. Have it checked and repaired by a qualified electrician.

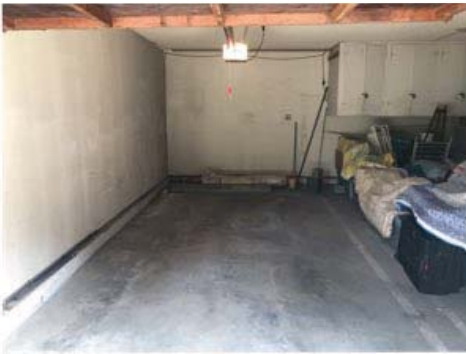
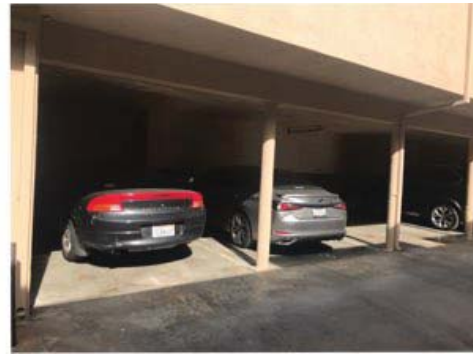
- **GARAGE ELEMENTS** - Condominium and Cooperative unit inspections do not include evaluation of exterior and/or common elements. The appropriate Management personnel should be consulted regarding common element maintenance responsibilities, master deeds, or other pertinent pre - purchase information.
- **Second floor is built over the garage without shear panels ( Soft - Story structure type).** This is typical for age, type of the building. Recommend to retrofit for seismic safety. Have it checked by a qualified structural engineer.

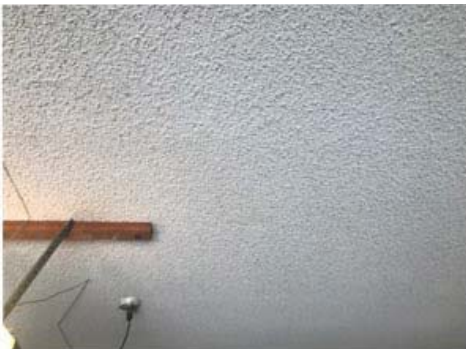
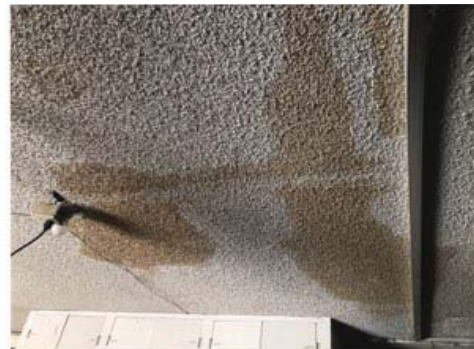
**5.1. Moisture stains/damage noted to the garage ceiling. Have it Checked by HOA and a Qualified Contractor.**

**5.2. Acoustic spray at ceilings noted. Acoustic spray may be asbestos containing type- Recommend further testing for possible abatement as a safety upgrade.**

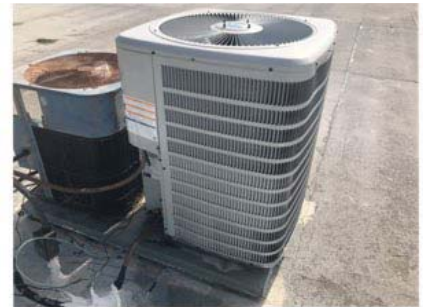
5.4. Unit is not properly secured/strapped to platform/pad. Have it checked and repaired by a Qualified Technician.

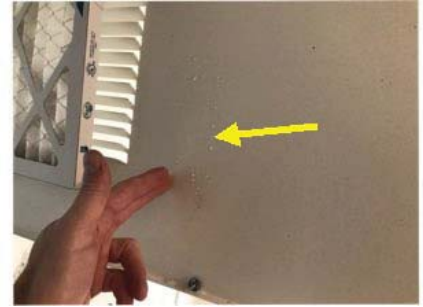
**8.2. Leaking noted at condensation pipe. Recommend further evaluation/fixed by a Qualified HVAC Specialist.**

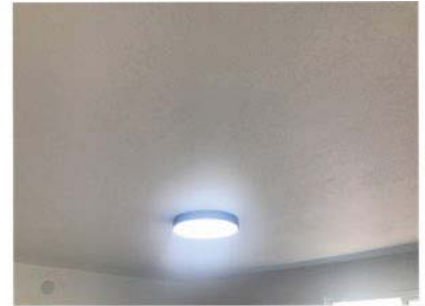
**1.1. Common cracks were noted at the ceilings.**

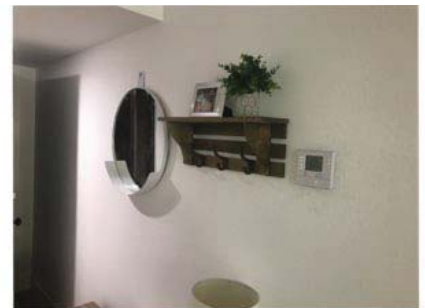
**2.1. Common cracks were noted at the interior walls.**

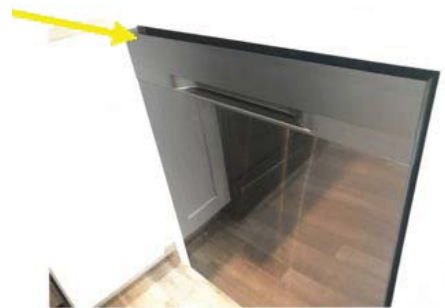
#### 6.2. Dishwasher offset from counter. Recommend further evaluation/fixed/repaired by a Qualified Contractor.

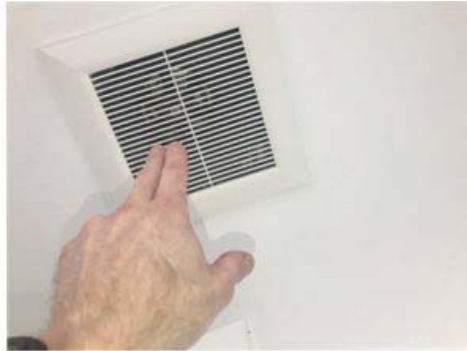
**7.1. Exhaust fan did not work - in need of repair/replacement. Have it checked and fixed/replaced by a qualified specialist.**

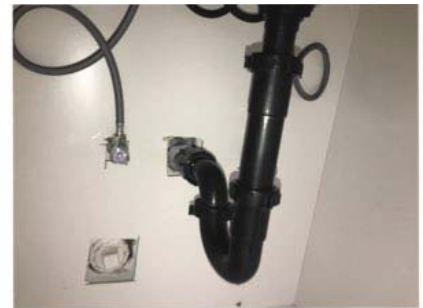
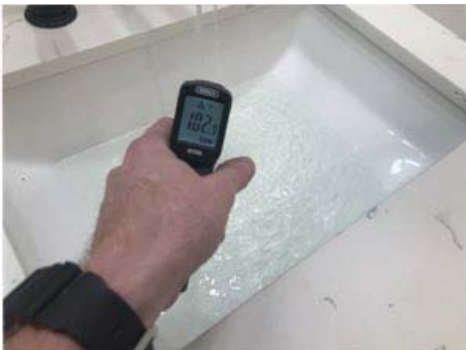
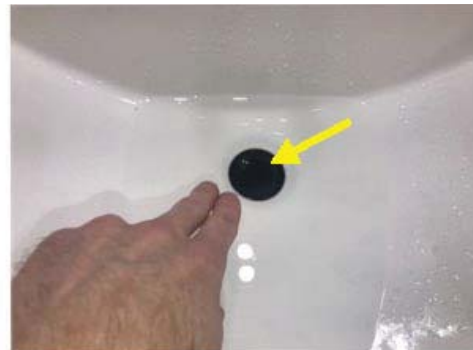
2.2. Defective sink stopper noted.

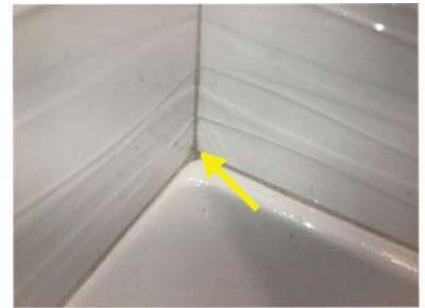
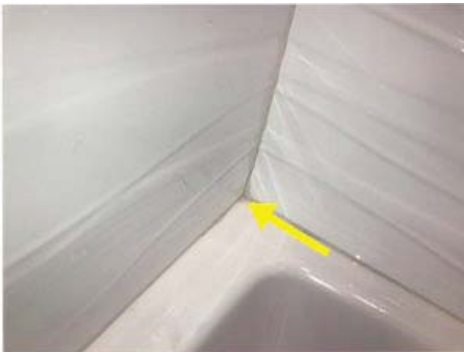
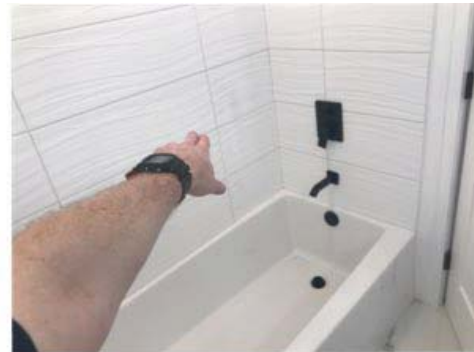
- 4.1. Enclosure was not installed/ missing at the time - check the records.
- 4.2. Recommend to re-caulk at tub tiles and enclosure.

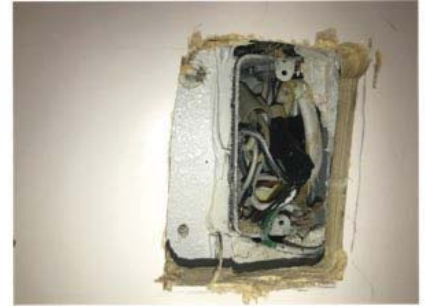
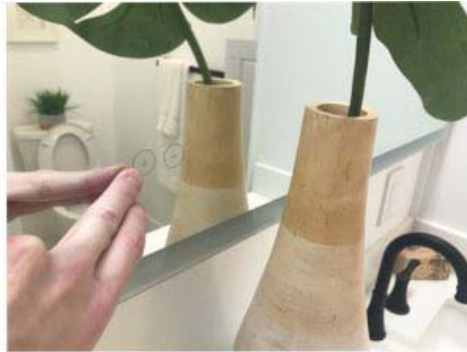
- 5.1. Defective GFCI outlet and or wiring noted - have it checked by a qualified electrician.
- 5.2. Defective Light/mirror noted - have it checked and fixed.
- 5.3. Exposed splices, missing box covers... noted bathroom. A fire hazard, safety concern. Have it checked and fixed by a qualified Electrician.

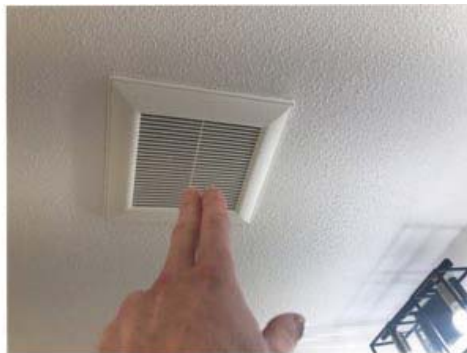
**6.1. Exhaust fan did not work - in need of repair/replacement. Have it checked and fixed/replaced by a qualified specialist.**
