## Bad UX design in Eindhoven by Vasil Todorov

Kitchen hood switch design

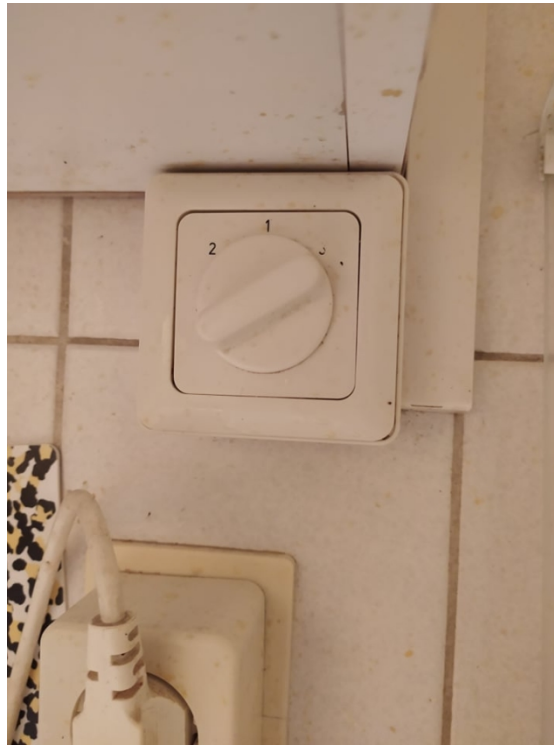
What we have here is the design of a kitchen hood switch found in a home in Eindhoven. What makes this a bad UX design the way the functions are ordered. On the most left we have “setting 2” in the middle “setting 1” and on the right most “setting 3”. Setting 1 is for turning the hood off, setting 2 for functioning at minimal capacity and setting 3 is for maximal capacity.

The first thing that we notice is that there is not 0 setting. This can be confusing to some people since we are used to knowing that 1 means that we have 1 thing that we have something even if it is little and 0 means nothing. Most electric stoves are turned off at the 0 setting and have 1 as the minimal just to give another example of how this can be confusing.

Next we have the way the numbers are arranged. Most often what we have is from left to right from the lowest number to the highest one. Sadly, this is not a thing here. The middle is the OFF function without any explanation why. In the case that the setting paint is scratched off (just how it has started happening to the setting 3) it would be very confusing for a person to find out which setting mean what.

What I recommend be done here is to change the numbers to 0 ,1 and 2 and to order the settings from left to right 0, 1 and 2. Also to mark the numbers not only with pain but to also engrave them slightly in the box of the switch so that the even if the paint scratches off a person can recognize the settings.
