## TESTING HIGH INTENSITY DISCHARGE LAMPS FOR BREAKAGE FROM THERMAL SHOCK

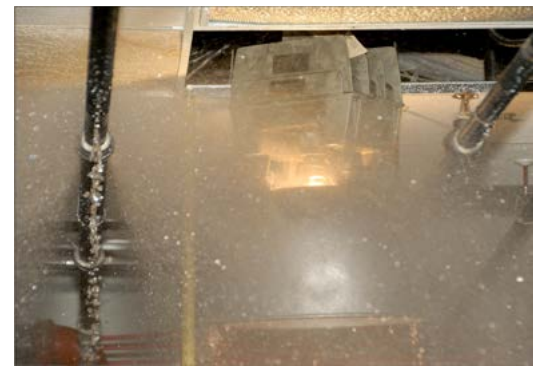
from 43 inches (where the operating lamp experienced a gentle misting) to 25 inches (where the spray water shook the luminaire, striking the ballast housing and reflector, running down the socket and over the outside of the lamp - Figure 1).

*Figure 1:  
A sprinkler head discharging directly against and into an operating metal halide luminaire*

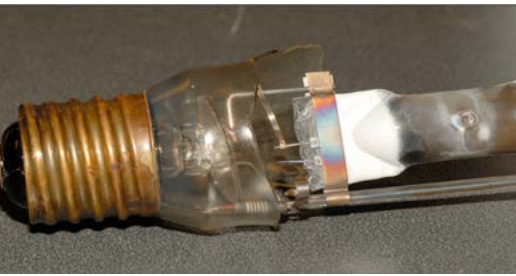
Two lamps were tested: one brand new and the other near the end of its rated life.<sup>3</sup> The lamps were completely unaffected by the mist and never broke when hit by the cold sprinkler water.<sup>4</sup> However, the outer envelope of the new lamp finally broke while drying out after its third wet/dry exposure cycle. Interestingly in that one instance, the outer envelope of the lamp broke fairly cleanly near the stem of the bulb just below the socket (Figure 2). That outer envelope broke further when it hit the concrete floor although the arc tube remained intact and operating generating potentially harmful UV light.

*Figure 2:  
The outer envelope of an operating lamp repeatedly heated and doused with water eventually sheared off rather cleanly near the stem while the inner arc tube remained intact.*

The water-induced break in the outer envelope was quite different from the breakage we have observed resulting from arc tube ruptures. When an arc tube at full operating conditions violently ruptures, it usually shatters the bulbous part of the outer envelope through multiple radial penetrations at the elevation of the arc tube (Figure 3).

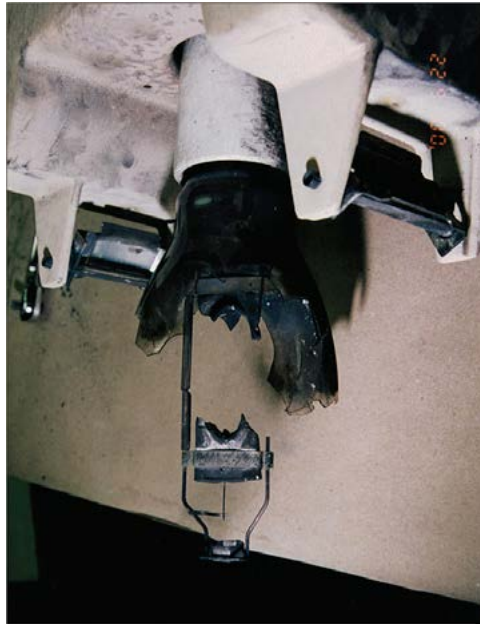
*Figure 3:  
A metal halide lamp that caused a fire had a shattered arc tube and the outer envelope was penetrated radially at that elevation.*

Infrequently, the rest of the outer envelope may even remain intact with just one or a couple of holes through the outer envelope where the chunks of the ruptured arc tube penetrated.
