# Bathing Water Profile - Grattan Road Beach (2013)

Bathing Water:	Grattan Road Beach
Bathing Water Code:	IEWEBWT170_0700_0100
Local Authority:	Galway City Council
River Basin District:	Western
Monitoring Point:	128908E, 223718N

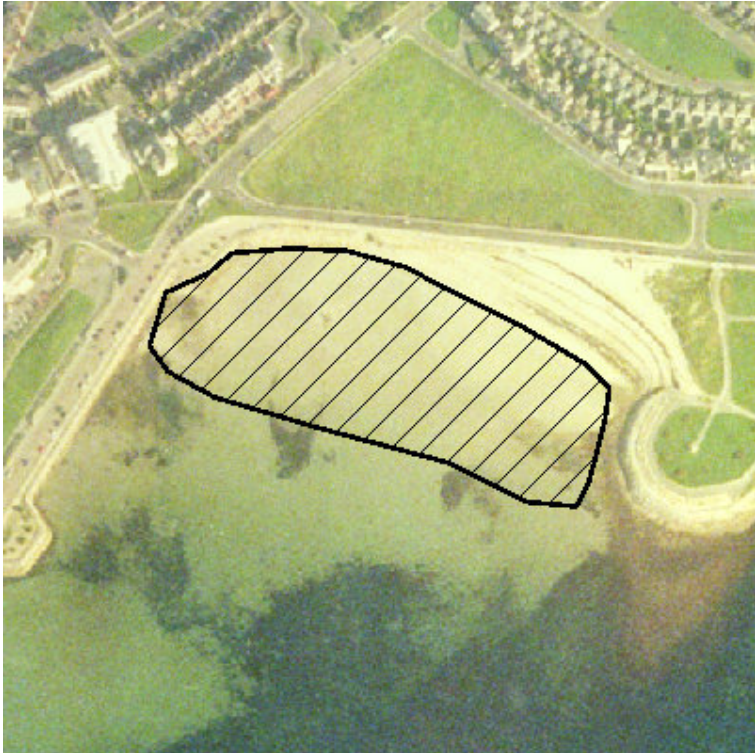
Map 1: Bathing Water Location & Extent

Grattan Road Beach is located to the west of Galway City, close to Salthill. It is a popular neighbourhood bathing area in the city, and is the closest beach to the city centre. It is particularly suited to families with young children and residents of the Whitestrand, Grattan Road and Claddagh areas. The beach was not a designated bathing area under the old bathing water regulations. The beach is approximately 180m in length and average number of daily bathers during the bathing season is estimated at approximately 500 on weekdays and 1000 on weekends.

The beach itself faces directly out to Galway Bay and boasts breathtaking views stretching for miles across the bay to County Clare and the Aran Islands. It is accessed from the Grattan Road. Limited free parking is available along the promenade adjacent to the beach, however there is additional parking at Toft park, which is in close proximity and approximately 750m from the beach.

It has a safe, shallow, sandy beach of approximately 0.18km bounded on one side by a made outcrop and the other by the rock armour along the promenade. It is suitable for swimming at both high and low tide. The beach is used extensively all year round, due to its close proximity to the city centre.

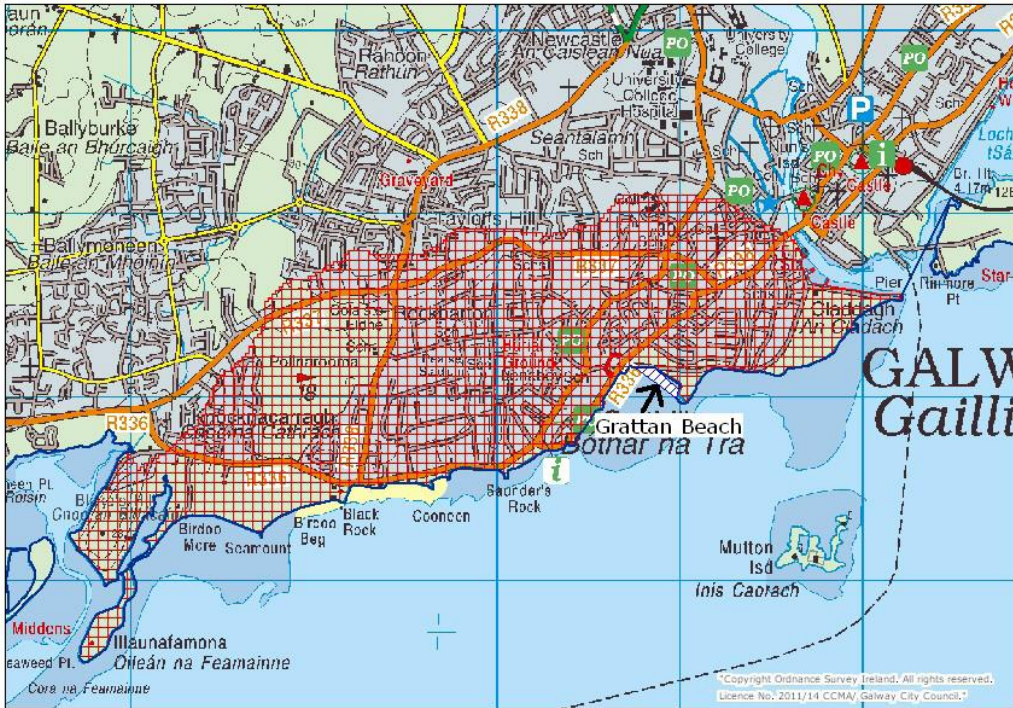
### Map 2: Bathing Water Catchment

Grattan Beach is located in the townland of Townparks, approximately 1.2km from Galway City centre. It is located in the Corrib Estuary coastal water body (WE\_170\_0000), in the Western River Basin District. The contributing catchment is approximately 5.2 km sq in area. The entire beach area lies within the Inner Galway Bay Special Protected Area, and Galway Bay Complex, a Special Area of Conservation and houses a number of habitats of high conservation status, being listed in Annex I of the EU habitats Directive. Water Bodies Draining to Bathing Water There are no streams/rivers discharging directly to the bathing water however there are a number of surface water outfalls which discharge surface water from the surrounding catchment.

<b>Description:</b>	The mutton island waste water treatment plan services the city of Galway and is located on Mutton Island, 1.2 km from the beach. There is a potential risk of pollution due to failure of equipment, an overflow discharge, significant pressure on the plant or insufficient wwtp capacity.
<b>Source:</b>	Mutton Island Waste Water Treatment Plant
<b>Type:</b>	Waste Water Treatment plant
<b>Short Term Pressure:</b>	Yes
<b>Nature:</b>	Low Risk
<b>Frequency:</b>	<2 per season
<b>Duration:</b>	< 48 hours
<b>Risk Assessment Methodology:</b>	risk assessment methodology is as recommended in the EPA Guidance for Development of Bathing Water Profiles.
<b>Risk Assessment Results:</b>	The discharge is considered a long outfall. There is full treatment at the plant therefore the microbial pollution potential is very low. The 95th percentile monitoring result for intestinal enterococci for the period 2009-2012 is between 41-200, therefore the WQI grade is B. The microbial pollution risk (MPR) for this discharge is therefore very low.

<b>Description:</b>	There are a number of surface water outfalls which discharge close to the bathing water. In addition there is a storm overflow, connected to the surface water outfall to the west of the beach. During periods of very heavy rainfall, the combined system overflows through the storm overflow pipe to the surface water system which outfalls to the west of the beach. There has been evidence of a link between very heavy rainfall and pollution at the beach.
<b>Source:</b>	Surface Water Outfalls/CSO discharges
<b>Type:</b>	Rainwater discharges
<b>Short Term Pressure:</b>	Yes
<b>Nature:</b>	High Risk
<b>Frequency:</b>	< 2 times per season
<b>Duration:</b>	< 48 hours
<b>Risk Assessment Methodology:</b>	Risk assessment methodology as recommended in the EPA Guidance for Development of Bathing Water Profiles.
<b>Risk Assessment Results:</b>	Discharge considered short outfall. WQI - B MPP - High (conservative assessment)
