SUNShINE

Renovation of multifamily buildings using Energy Performance Contracting

Documenting deep renovation

PROJECT REPORT

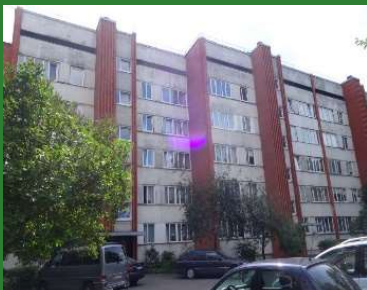
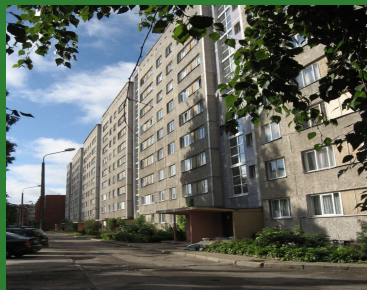
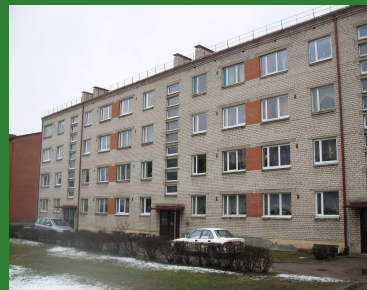
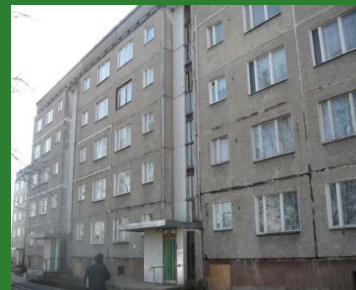
Typical multifamily buildings in Latvia as they were built

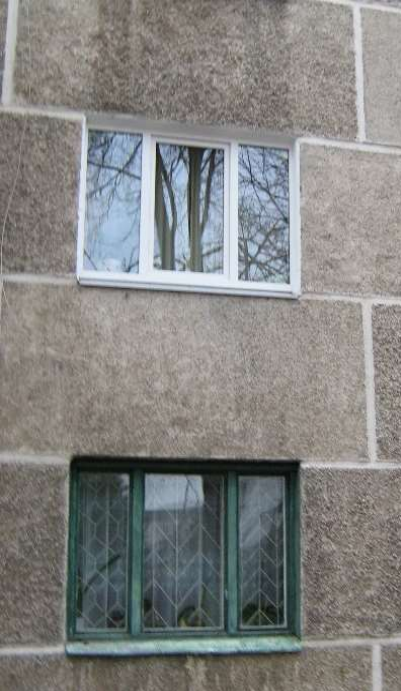
There are two different types of windows installed in this building:

- double-glass window units with plastic frames, recently replaced by apartment owners with heat transfer coefficient ranging from 1.1 to 2.4 W/(m²K).
- double-glass windows with joined wood frame flap with a heat transfer coefficient of 2.8 W/(m²K).

These last types of windows are outdated and warped, therefore cannot be closed properly and allow great air leakages.

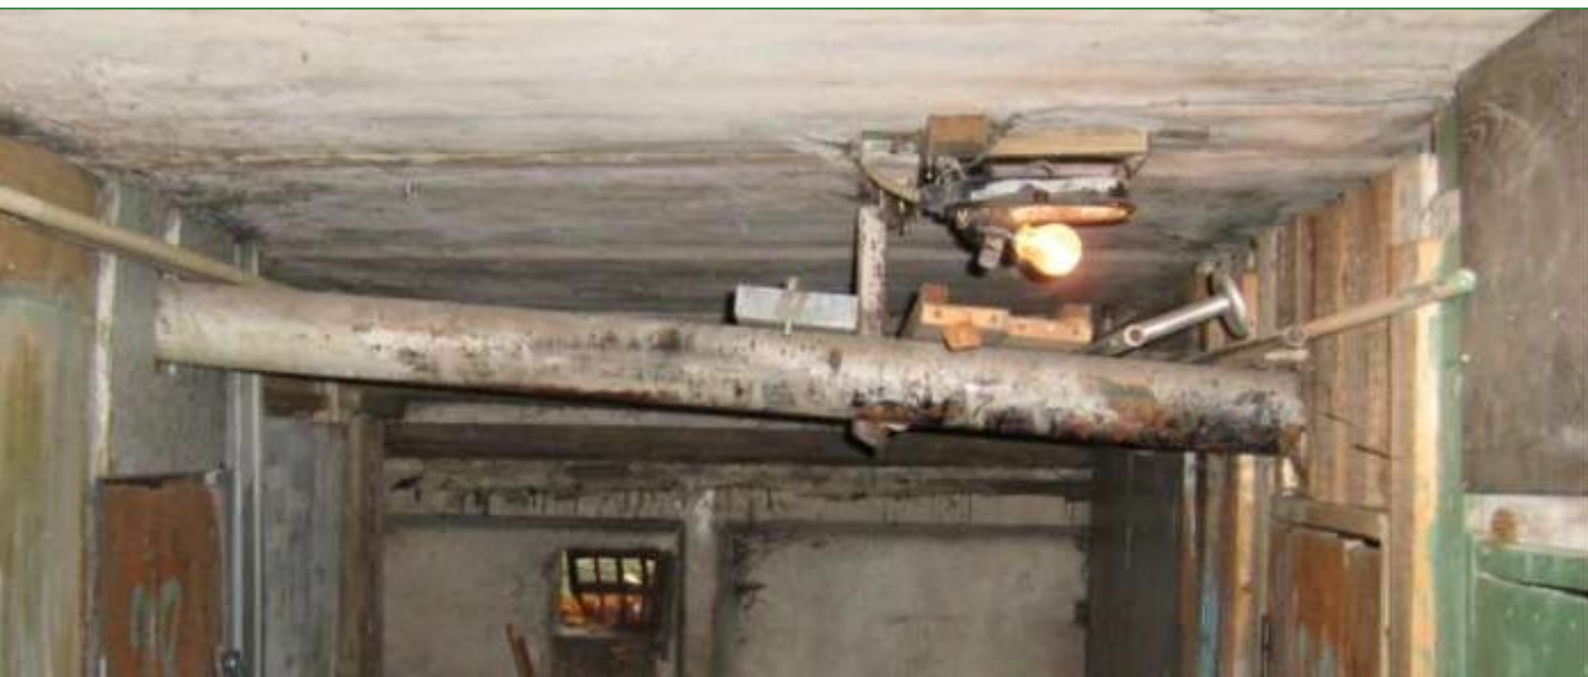
1.5 Space heating system

The space heating system of most of multifamily buildings in Latvia is called “one-pipe system”, because the heat transfer elements are connected to the heat source by a single, one-way, hydraulic loop. The main elements of the system are:

- Heat substation,
- Heat distribution system,
- Heat transfer element (convector / radiators).

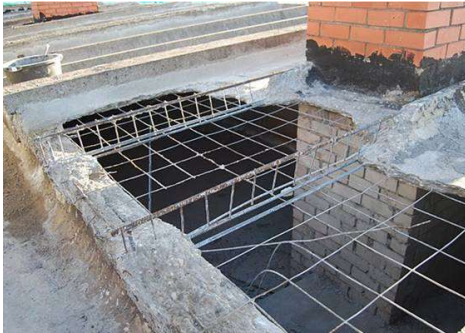
Measure	Description	
Roof renovation	<p>Roof renovation must always be assessed. Installing thermal insulation in the technical attic with a leaking roof is a waste of capitals.</p> <p>Sometimes also structural problem and latent conditions are present. For example, corroded reinforced concrete of the roof slabs is a potential problem.</p>

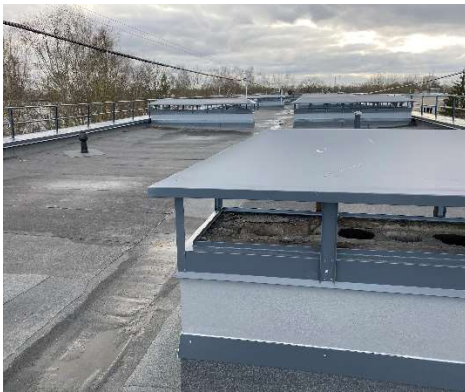
Renovation of ventilation shaft	<p>Ventilation shafts often suffer from deferred maintenance and are in critical technical conditions. In the technical attic shaft are not insulated. Insulation of shafts in the technical attic prevents formation of possible and unwanted cold air lofts.</p> <p>Chimney on the roof shall also be refurbished as part of roof renovation works</p>

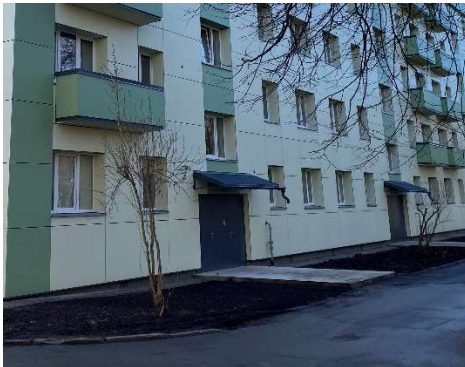
Refurbishment of building entrances	<p>As part of façade renovation works, the renovation of the entrances to the building must be included. If not, this area will be source of future localised problems to the façade. A new walkway for carriages, bikes and disable people shall also be planned, as during the construction works this will be partly removed or demolished.</p>

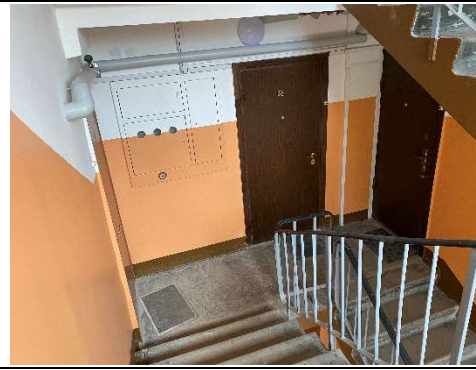
Refurbishment
of the staircase

Windows replacement, piping works for the heating and domestic hot water system, workers waking through means that at the end of the renovation works, the staircases must be refurbished. Re-plastering and painting of the inner walls and deep cleaning of the stairs are needed.

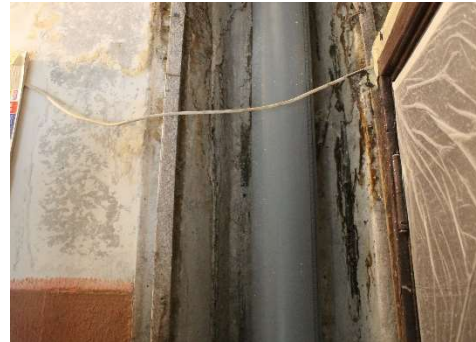
Engineering
networks

The refurbishment of the space heating and domestic hot water systems are obvious energy efficiency measures. However, during a comprehensive building renovation, addressing cold water, sewerage and electrical systems is an option to consider.

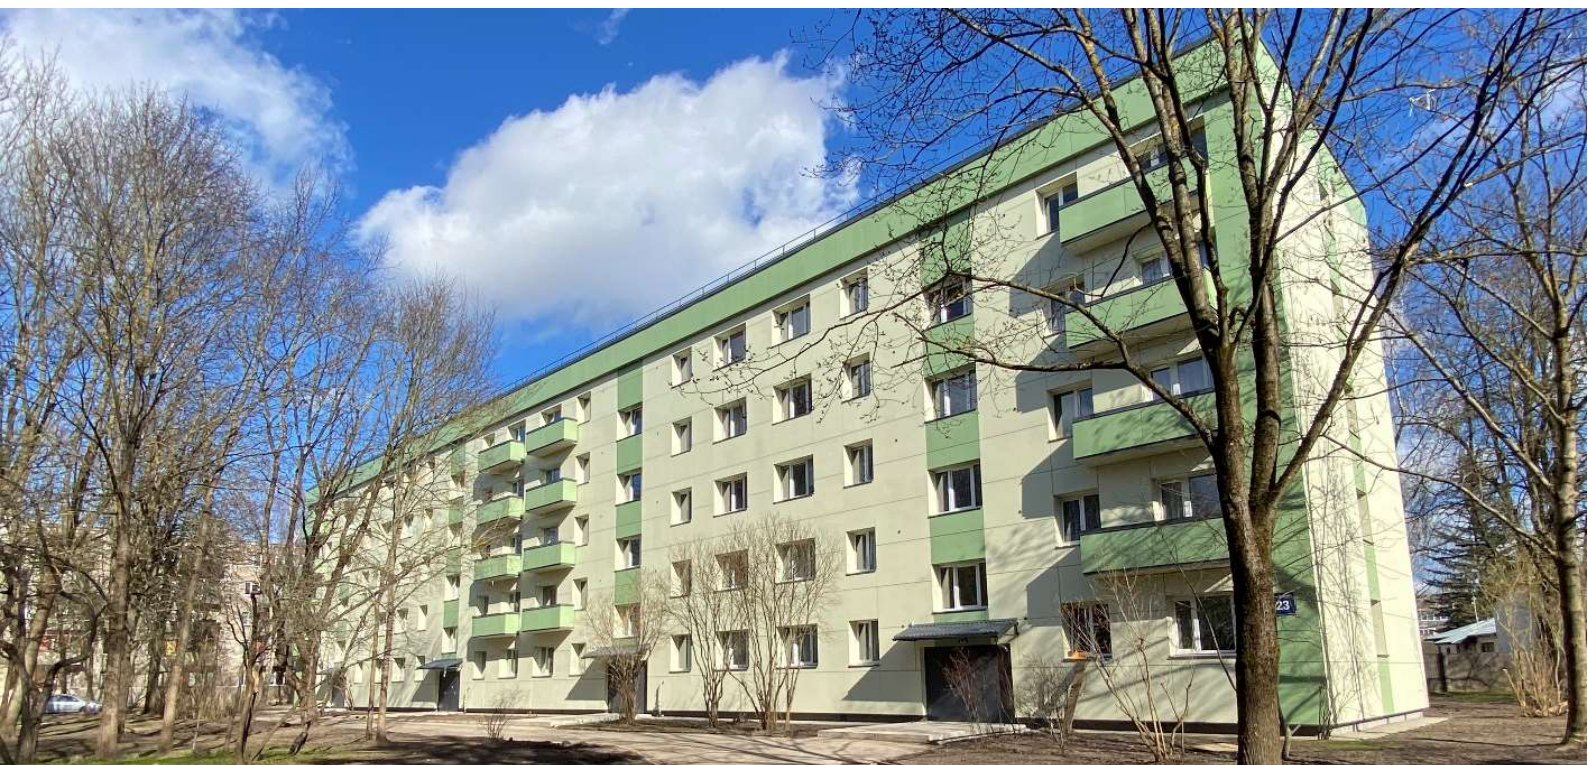
The project cycle for the renovation of a multifamily building is divided between three main phases (see Figure 1):

1. project development,
2. construction and installation phase, and
3. service period.
