Date of Report: October 4th, 2022

BARNES FIRE BURNED AREA REPORT

Barnes Fire off Hwy 395 showing origin near Barnes creek

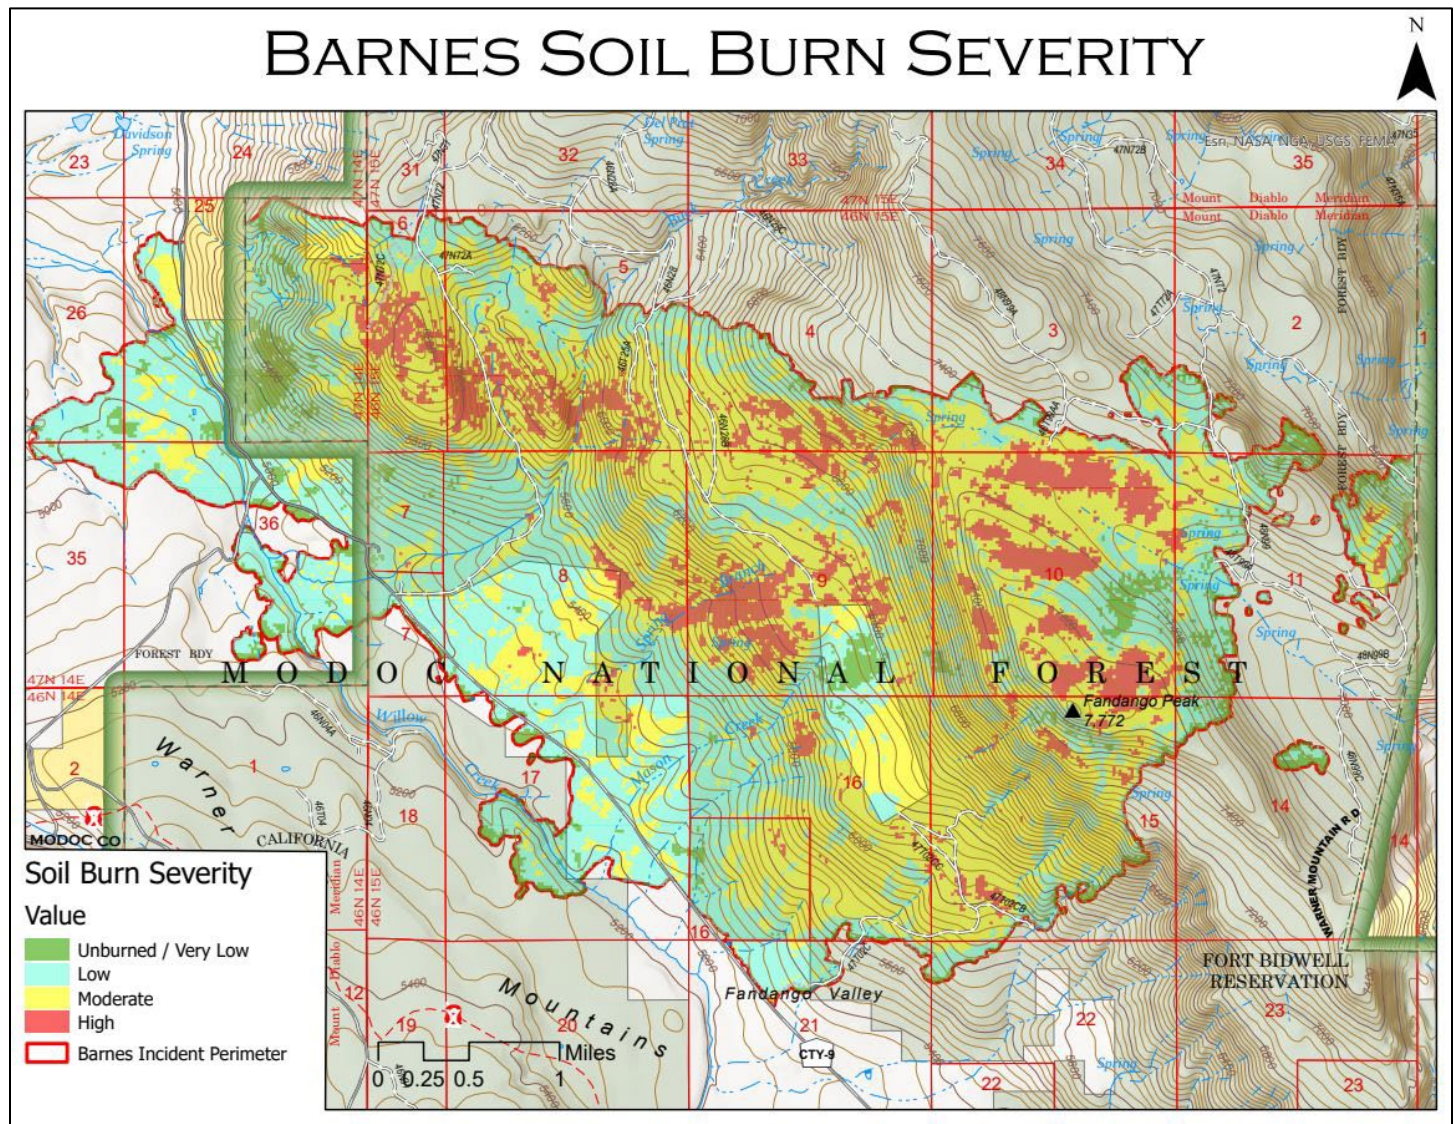
Looking at the soil burn severity map below shows multiple areas that have the majority of moderate and high soil burn severity. These areas are middle Buck Creek, Spring Branch, and north of Fandango Peak.

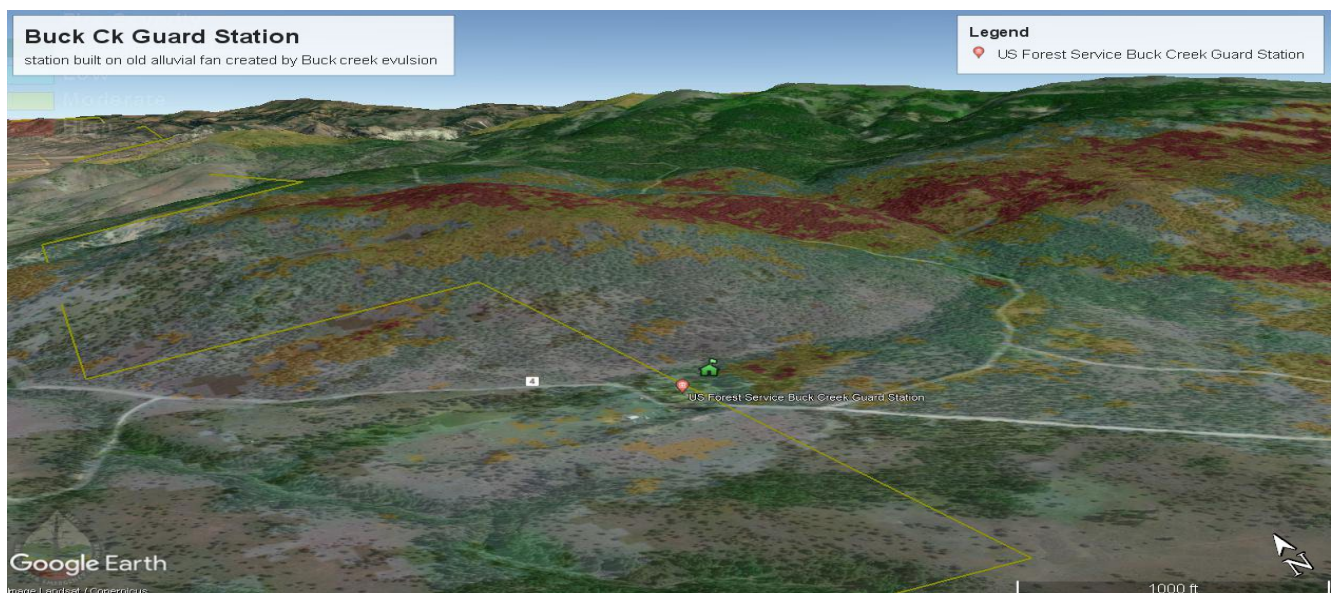
Buck Creek workstation is built on an old alluvial fan from Buck creek (see figure 1 below). Soils are deep gravelly loam on slopes of 2 to 5 percent slope. Buck creek drainage above has slopes of 35 to 50 percent with some historic scarp faces indicating past landslides that probably formed the alluvial fan below. The fan has evidence of braided channels showing evulsion across the fan. With burned out headwalls in both stream reaches the probability of damage to FS infrastructures is **possible** and the magnitude of consequences is **moderate**, thus the resulting risk is **intermediate**.

Figure 2: Buck Creek Guard Station sitting on alluvial fan in proximity to high soil burn severity mid-slope headwalls with Willow Ck below.

- BAER funds are requested to treat these risks for life and safety by storm patrol for the workstation and adjacent county road culvert at the workstation.

In order to reduce likelihood of flooding at both the Buck Creek guard station and at stream crossings along the Del Pratt road (NFS 47N72) and CR 9, it is recommended to employ channel treatments to increase roughness and reduce flow velocity above these values-at-risk. Targeted instream tree placement and staking and hillslope stabilization in Buck Creek to create natural check dams and reduce sediments and stabilize stream banks impinging on the Del Pratt Road (47N72) main culvert and to reduce the likelihood of Buck Creek evulsion out of its main channel towards the Guard Station. Tactical tree felling with force account crews would be utilized, estimated at \$2500. Additionally, in-stream water quality and sedimentation monitoring by FS staff within the Buck Creek Guard Station and above the 47N72 road is recommended.

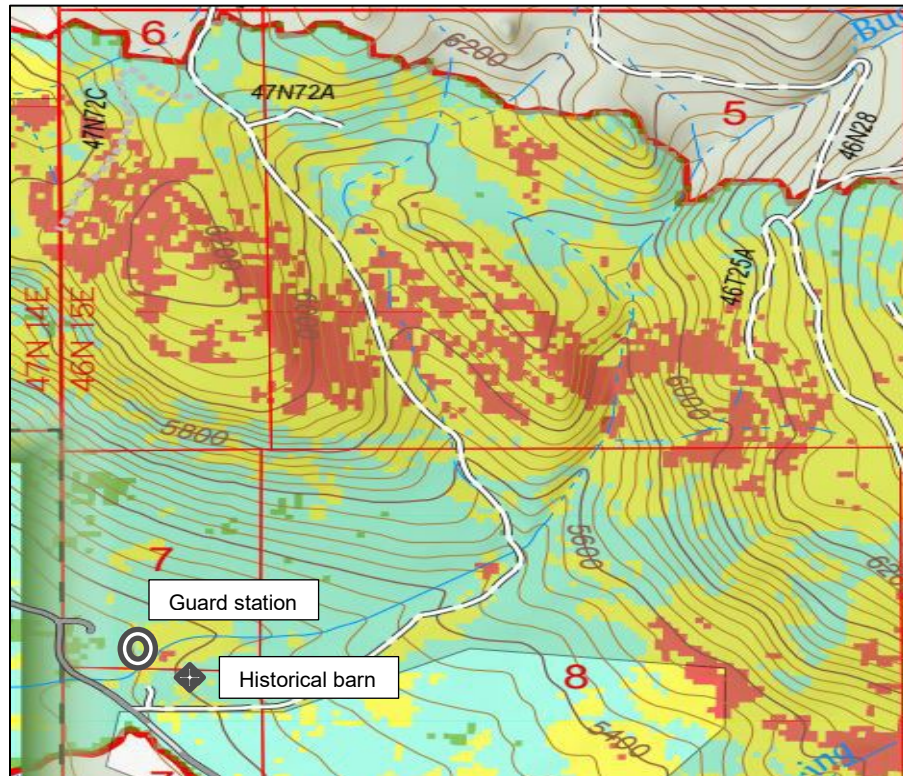
The Buck Creek workstation historic barn was destroyed, leaving an unknown storage site that burned posing a hazmat threat due to burned and released chemicals mixing with gas and oil along with building materials creating a toxic cocktail that could be mobilized. This toxic brew of chemicals could be easily move with heavy rains into Buck creek, an important watershed for water quality and T&E fisheries. Buck creek drains directly into Willow creek below that contains 6 listed forest service sensitive aquatic species (see figure 1 & 2). The probability of damage or loss is **likely**, and the magnitude of consequences is **moderate**, so the resulting risk is **high**.

Figure 3: Soil burn severity above Buck Creek Guard Station and historical barn

- BAER funds are requested to treat these risks by hazmat stabilization of burned storage barn and surrounding area to ensure sediments do not enter Buck Creek.

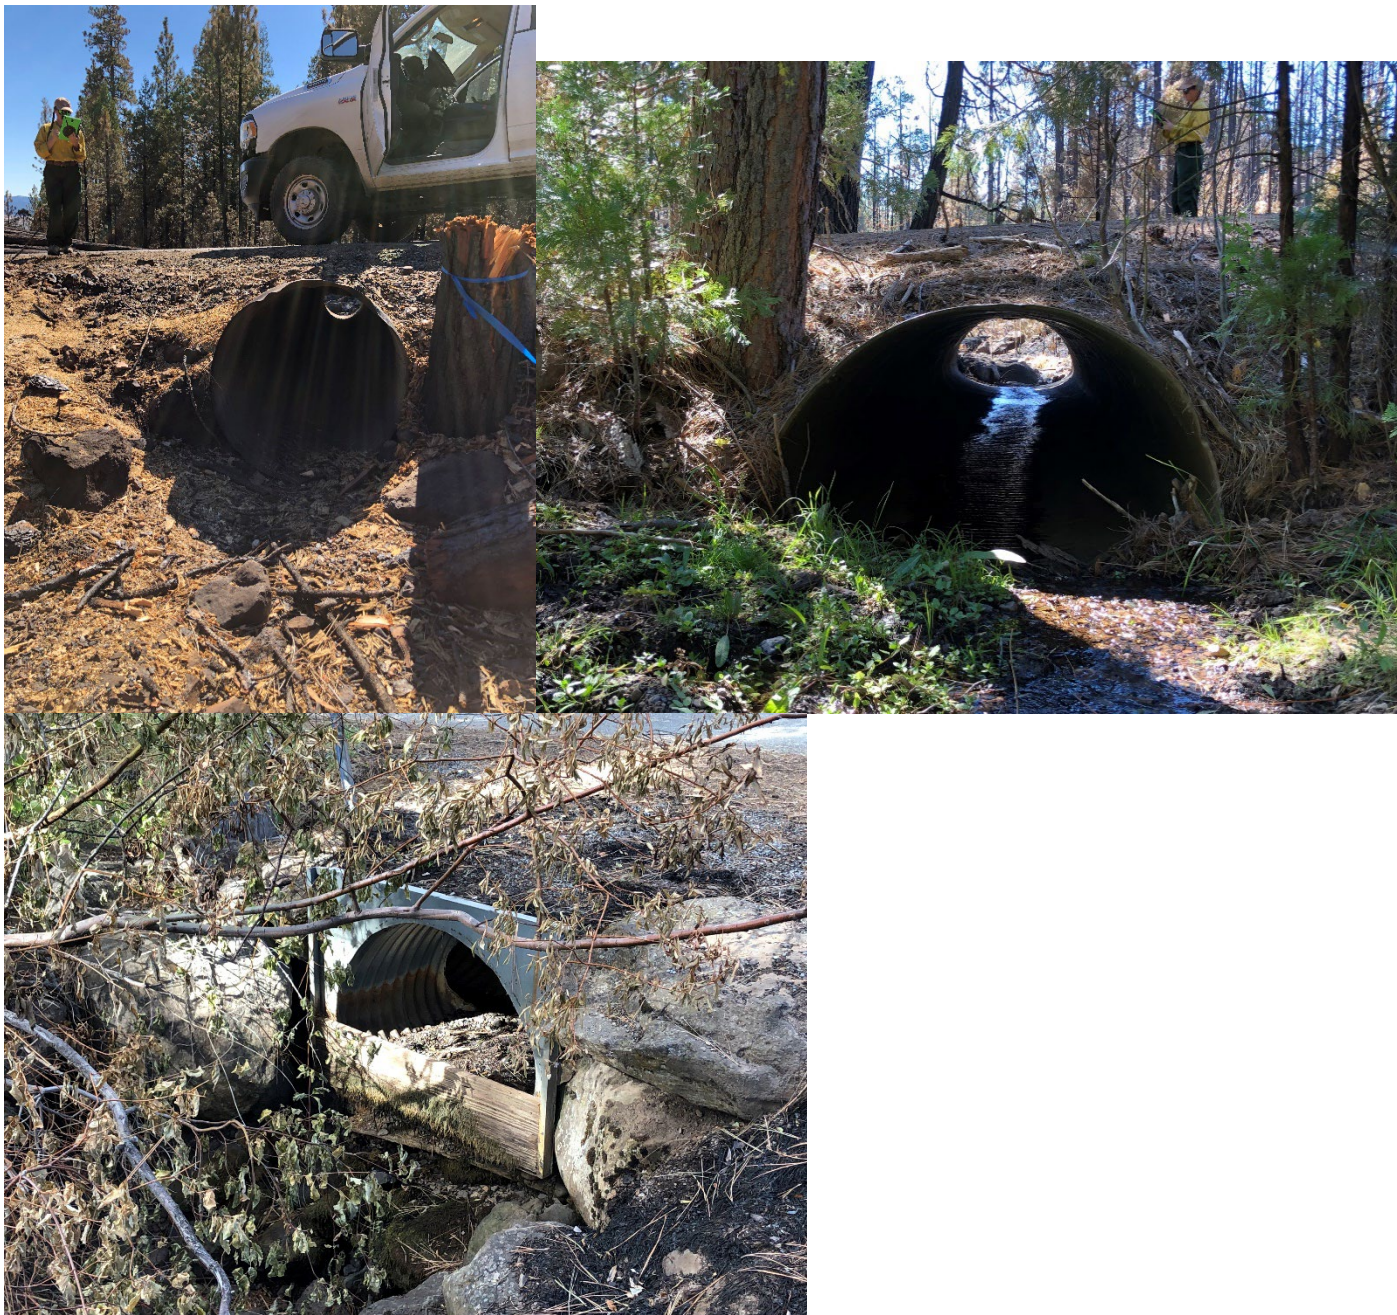
Figure 4: The three crossings of roads over Buck Creek in the fire footprint.

Debris racks would be constructed on site at each of the three main culvert crossings of roads over Buck Creek, utilizing local wood and treetops from cut and decked timber. Also, culvert inlets and outlets would be cleaned and brushed to maximize capacity during storms and reduce plugging potential. Finally, cleanup and stabilization with mulch would be employed at the burned barn and water tank areas east and uphill of the station, to ensure no hazmat and pollution reaches Buck Creek. Modoc County Road Dept. would also be notified of particular crossings to pay attention to during storms, including Buck Creek and Mason Creek.
