Date of Report: 10/6/2022**BURNED-AREA REPORT****PART I - TYPE OF REQUEST****A. Type of Report**

PART II - BURNED-AREA DESCRIPTION**A. Fire Name: NPC 2022 Fires**

The Bitterroot National Forest experienced numerous lightening caused fires during August thunderstorm events within the Selway-Bitterroot and Frank Church-River of No Return Wilderness areas. Four of these fires impacted the Magruder Corridor Fires and were appropriately sized to consider BAER assessment. These fires varied in acreage from 560 to 8953.

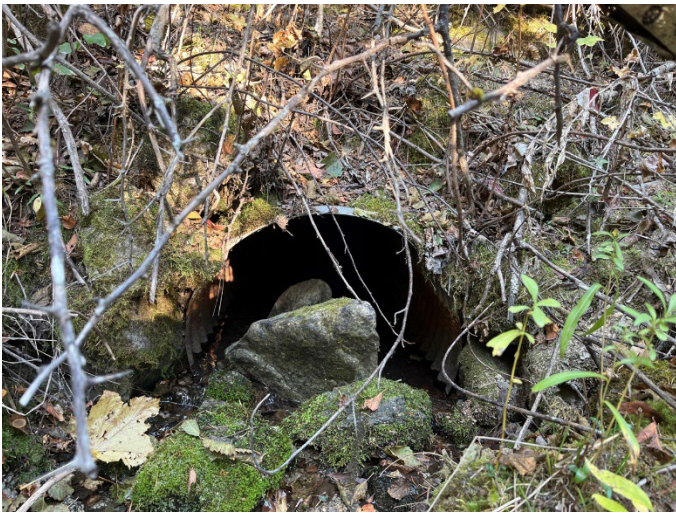
Figure 1. Inlet-24" cmp

Steep Gulch Culvert on Magruder Corridor below extensive burned area (Indian Ridge Fire)

The existing stream crossing culvert at Steep Gulch is currently inadequately sized for the anticipated 2-year post-fire storm event hydrologic flows (50 cfs) and additional expected bulking debris that would double to 100 cfs. The depth of fill on the road is 30 feet, with a 10 foot inlet depth. The drainage area is 533 acres, 70% of which burned with high severity in this steep catchment. See Appendix A for photos and map. The culvert is at very high risk for failure with subsequent damage to Forest Service Road 468 and closing off vital access in this remote setting. Options considered for increasing the drainage capacity and protecting FSR #468 included closing the road, installing critical dips on either side of the crossing, and replacing the culvert with a drivable low-water crossing that would pass debris. The following were eliminated from consideration:

Road Treatments	Units	Unit Cost	Quantity	Total
R11. Upsize culvert the existing 24" diameter culvert to 72" squash pipe. The Depth of Fill is 30', the inlet depth is 10', and the Road Width is about 20'. The price includes removal of existing pipe, mobilization, and installation of the new pipe.	each	\$85,500	1	\$85,500
