PROPERTY INSPECTION REPORT

Concerning: 1809 Wooten Park dr., Austin, TX
(Address or Other Identification of Inspected Property)

By: Peter Robinson, Lic #21105 05/11/2016
(Name and License Number of Inspector) (Date)

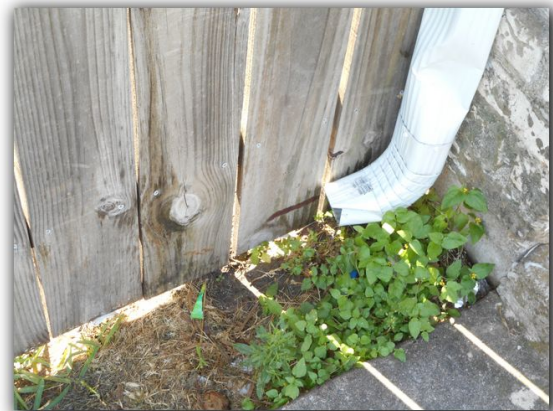
Comments: Gutters should extend 36 inches from the foundation and exterior walls and there should be 6 inches of clearance between the ground and the exterior wall siding to prevent insect and termite damage.

☒ Gutters draining too close to the structure

☒ Inadequate grading clearance to exterior wall surface

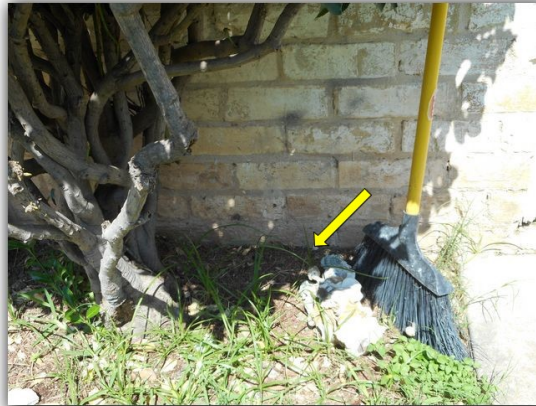
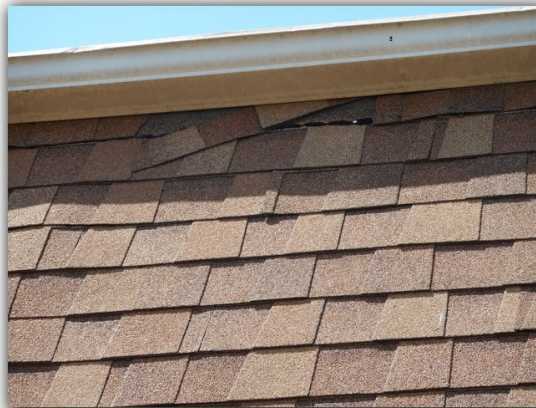
Comments: The roof showed signs of granule loss, water ponding, and leaking. It had rained the night before but the water had not drained off the roof adequately at the time of the inspection. I recommend replacement of the roof

☒ Torn, damaged, perforated or missing shingles

☒ Roof decking deflection and / or sagging

The roof is defective and there is substantial leaking and should be replaced.

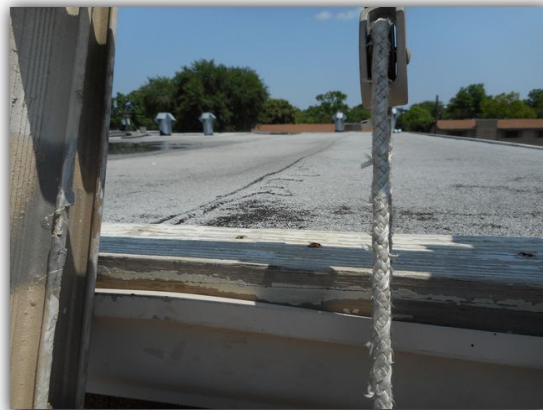
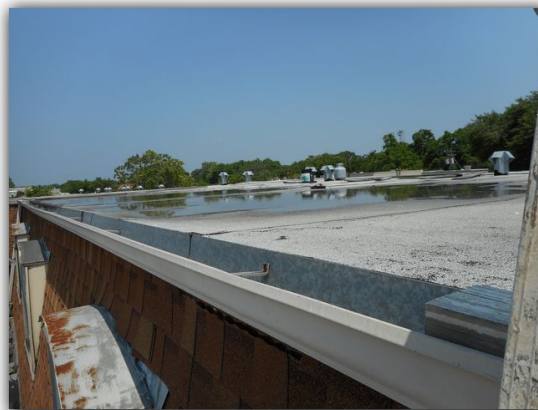
- ☒ Indication of water ponding
- ☒ The roof covering is in need of replacement or extensive repairs, a Certified Roofing Company should be consulted

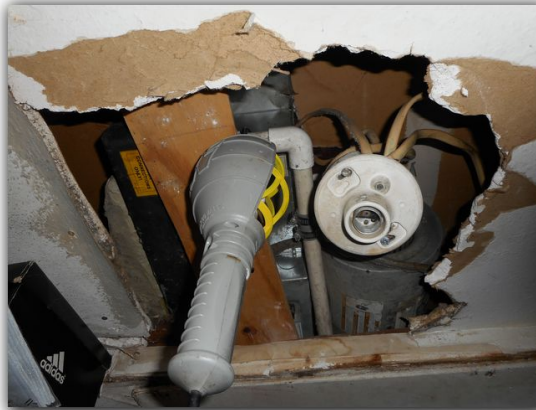
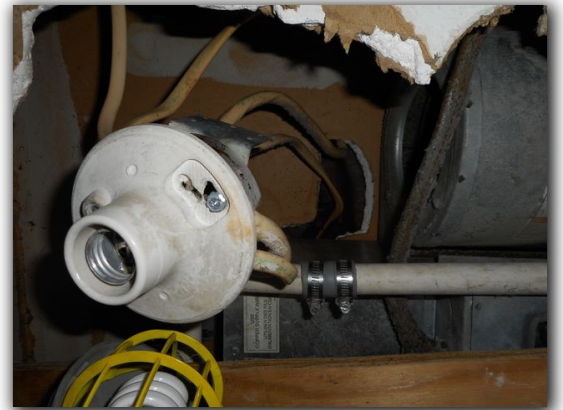
Comments: There was no attic entry at the time of the inspection but as you can see from the pictures there's significant water damage and the roof needs to be replaced.

- ☒ Evidence of moisture penetration

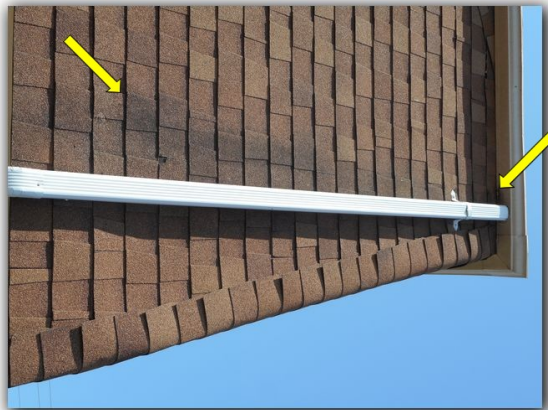
gutters/downspouts

☒ Loose, missing or damaged

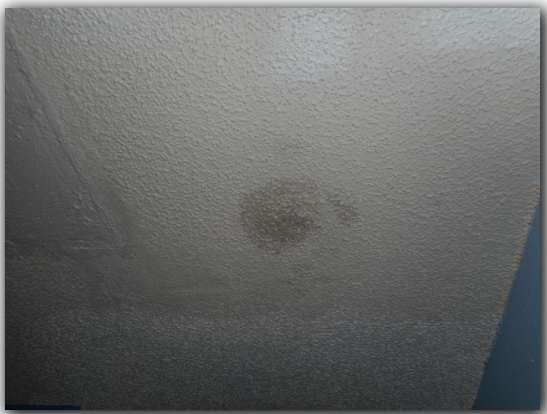
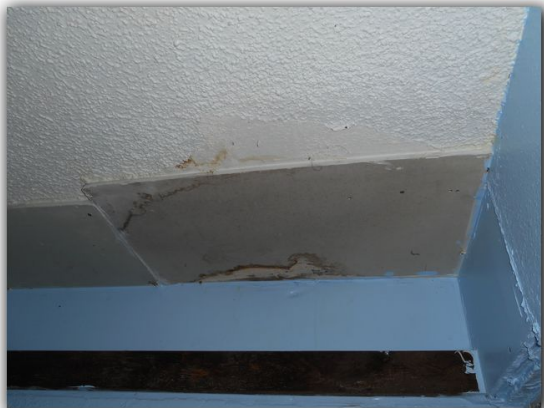
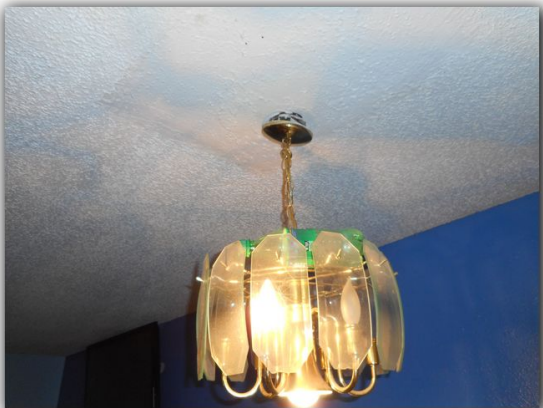
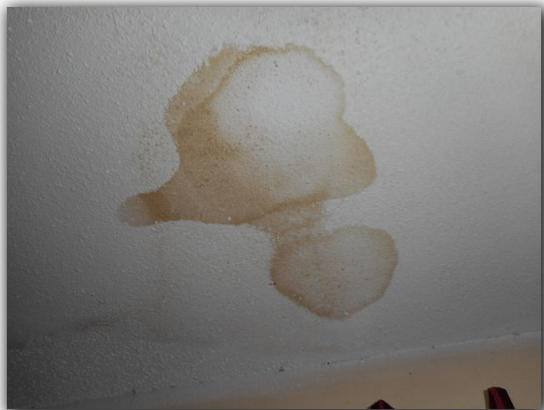
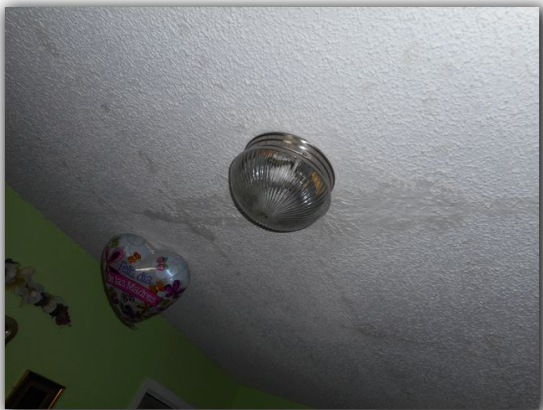
Comments: At the time of the inspection there was significant signs of water damage, some past and some present. The wood trim around all the exterior windows showed signs of water and weather damage.

☒ Water stains on walls and/or ceilings

☒ Freshly Painted

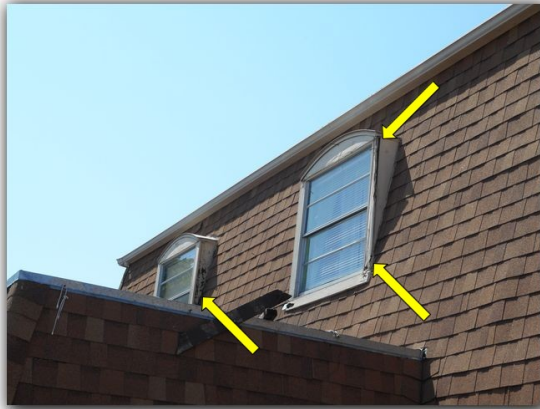
- ☒ Fascia / trim boards are water damaged at several areas

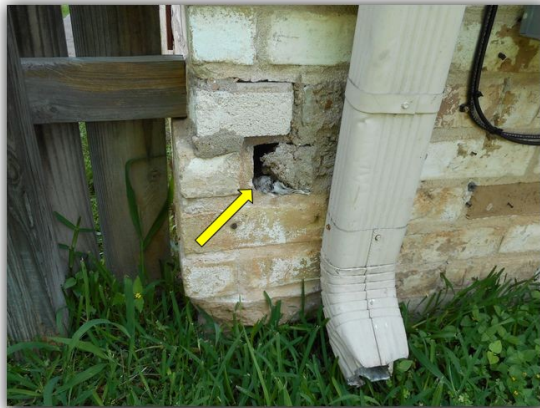
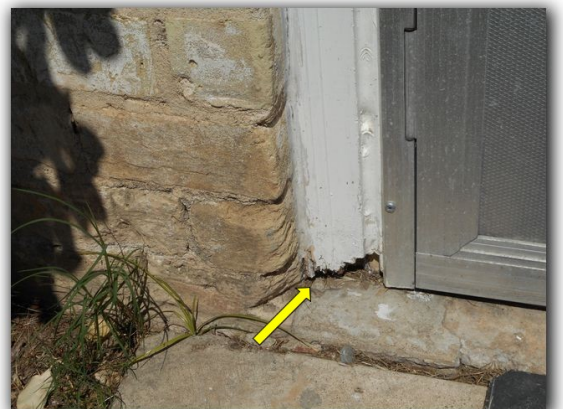
- ☒ Caulking / sealant is separated or missing in some areas

- ☒ Wood siding is water damaged in some areas
☒ Weep holes not open and/or improper spacing

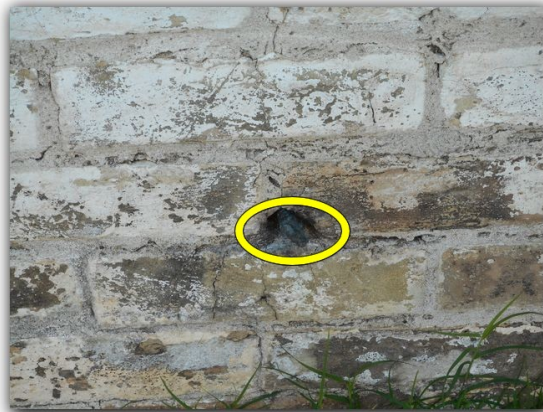
the purpose of weep holes is to let trapped moisture escape from behind the siding and they should not be blocked

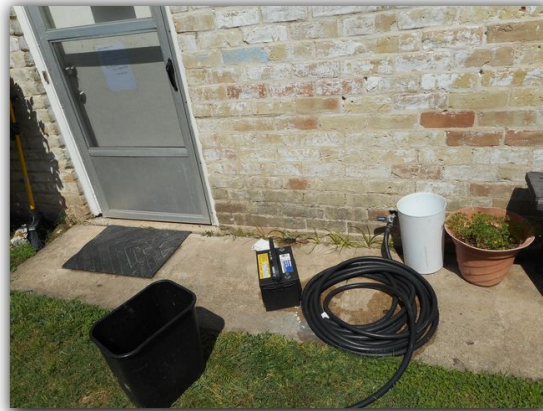
- ☒ Inadequate clearance between siding and grade

There should be a clearance of 4 to 6 inches between exterior siding and grade level to prevent insects from entering and moisture damage

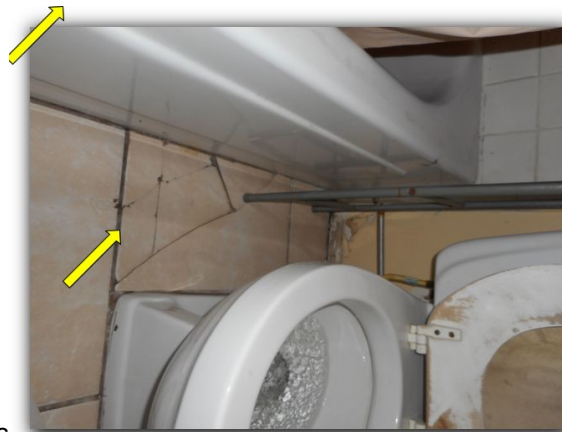
Comments: There were water stains through out the units and the floor crack in the bathroom should be monitored to make sure it's not structural

- ☒ Water stains on ceiling

- ☒ Floor cracks in some areas

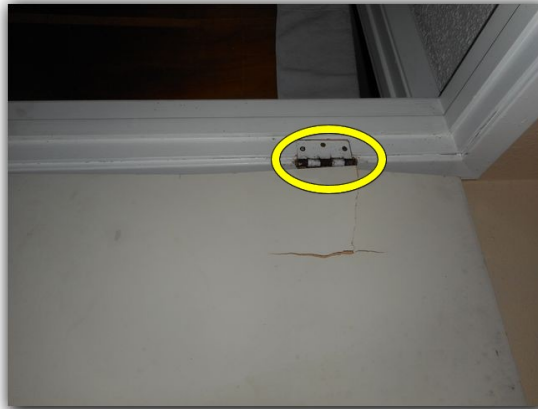
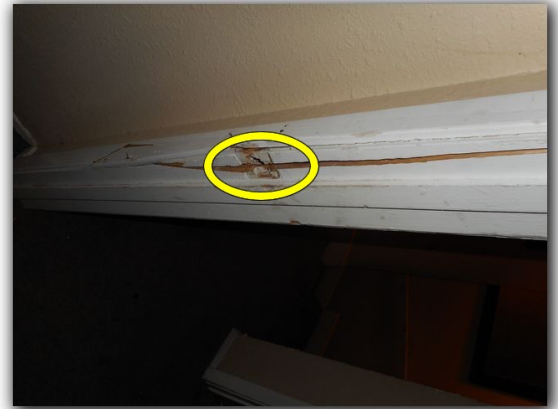
☒ Damaged doors: _____

looks like a door got kicked in and there were a few holes punched through the wall by this door at the time of the inspection

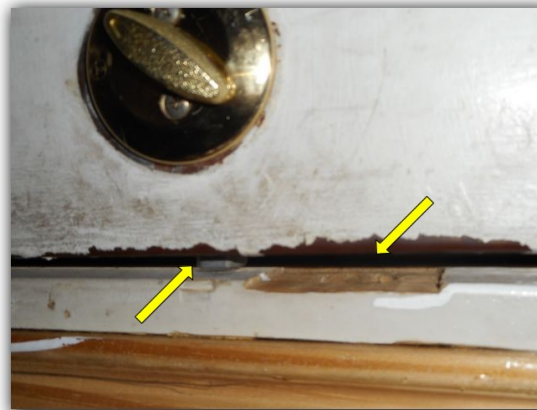
☒ Sliding screen door is missing / or damaged

☒ Deficient Hardware
door did not line up

the second latch on this

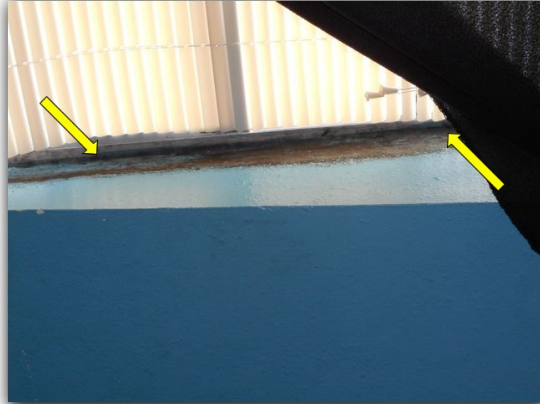
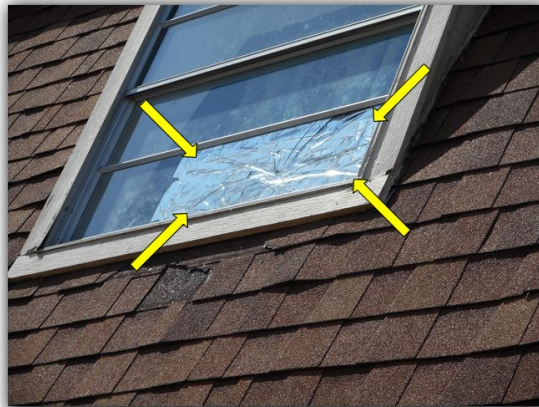
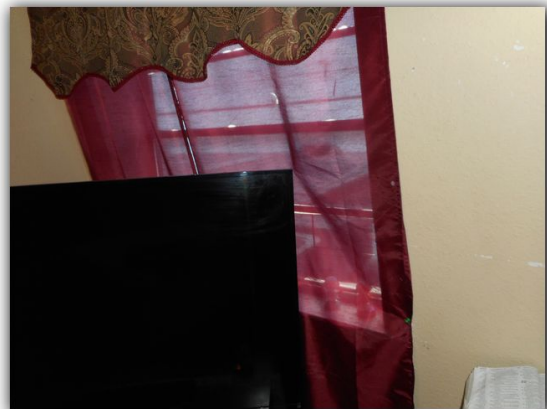
Comments: The springs on all the windows were defective and there were no screens. One of the windows in unit 101 was leaking water and I would recommend a certified mold inspection

☒ Some glass panes are loose, damaged or missing

☒ Some window lift supports are loose, damaged or missing

☒ Inspection of the windows was limited
shades were nailed on some of the windows

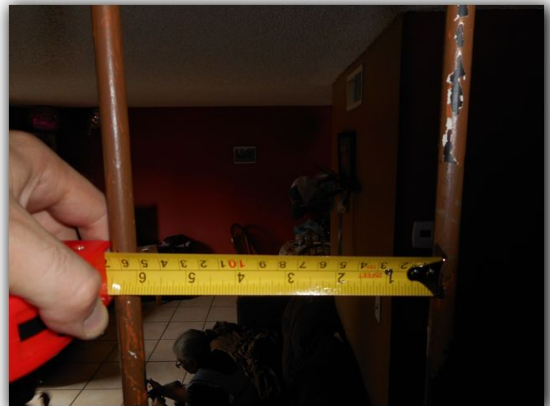
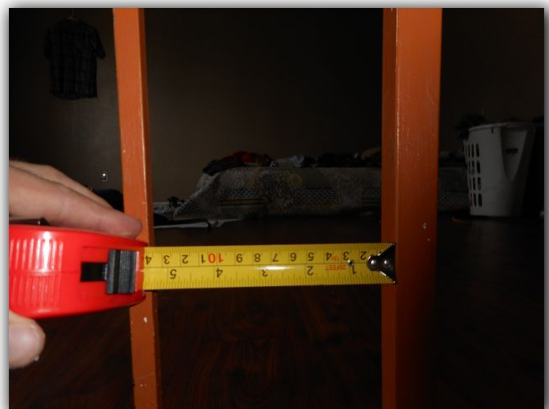
Comments: It is considered a safety hazard if the balusters of the stairs permit an object greater than 4 inches to pass through

☒ Baluster Spacing on steps Exceed 4 3/8"

☒ Vertical railing spacing is greater than 4"

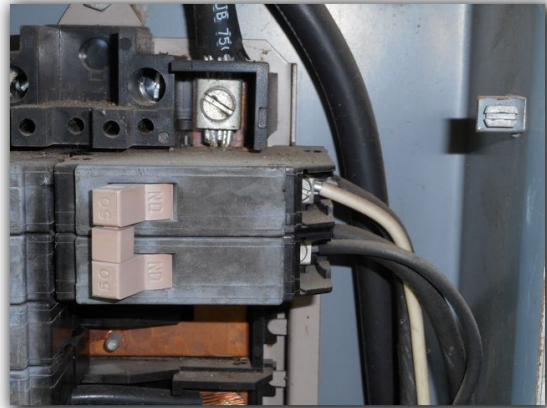
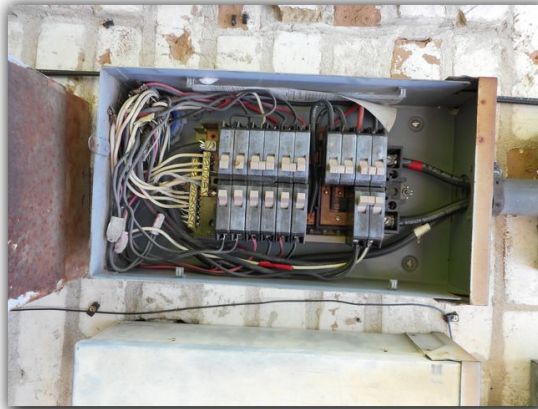
Comments: there should be 10 feet of clearance at the service entrance above any walkways and there should be a drip loop before the entrance to prevent water from getting in. There is aluminum circuit wiring so I recommend a licensed electrician come in and evaluate it.

- ☒ Doubled lugged breakers / Fuses
- ☒ Ground wire / rod / CWB could not be verified
- ☒ Service line has inadequate clearance to ground
- ☒ Lack of anti-oxidants on aluminum conductor terminals

- ☒ A/C condensing unit #1:
Specifies max amp breaker of __60 and a 60__ amp breaker is in use
- ☒ A/C condensing unit #2:
Specifies max amp breaker of ____60 and a ____60 amp breaker is in use

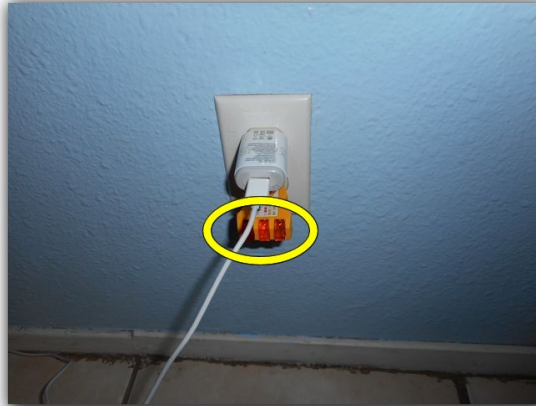
- ☒ Loose, damaged, missing outlets / switches / covers
- ☒ Test indicate open circuit, no power at various outlets

open ground at one outlet

- ☒ Lack of anti-oxidants on aluminum conductor terminals
- ☒ Recommend any aluminum branch circuit be thoroughly evaluated by a licensed electrician for compatibility of wiring devices , appropriate connections, and treatment.

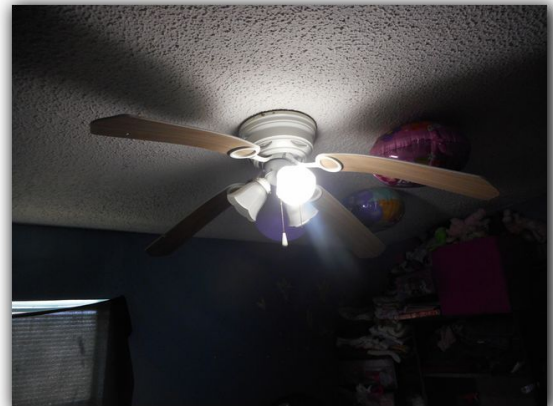
- ☒ Ceiling fans inoperable or in need of repair

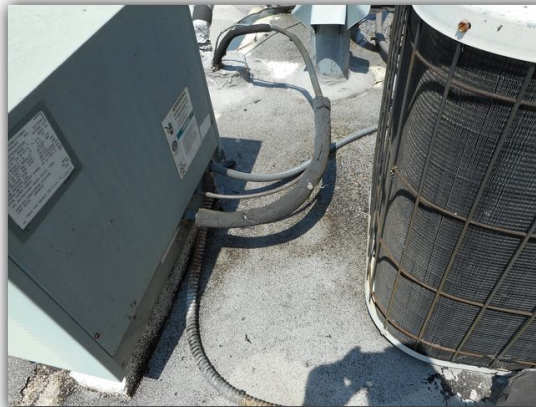
- ☒ Refrigerant lines not properly insulated at Evaporative Coil

Insulation looked brittle

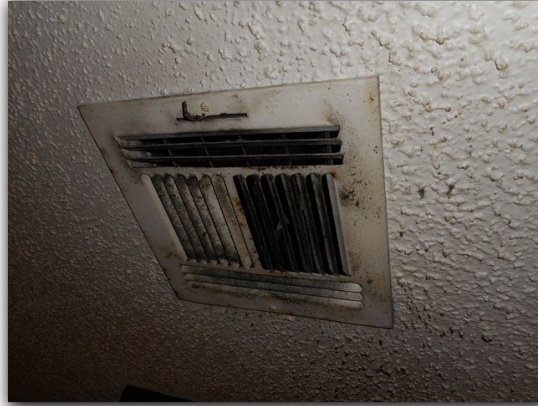
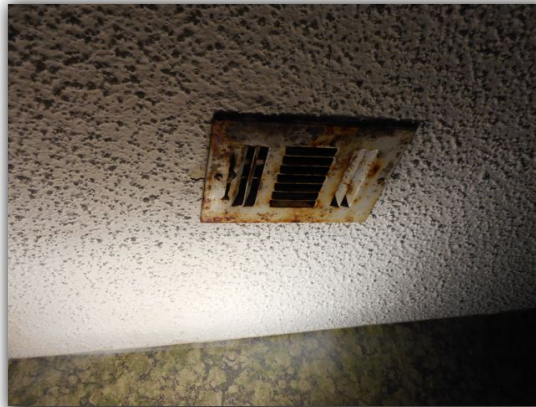
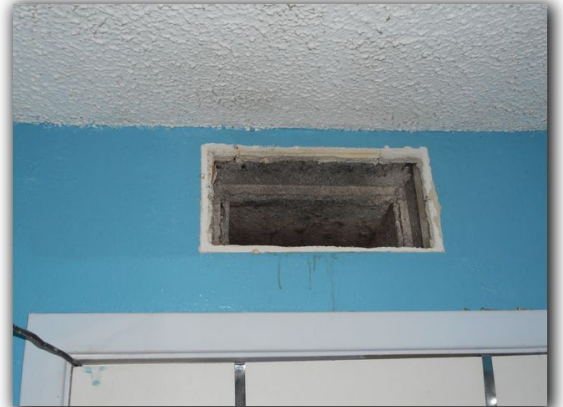
Comments: I wasn't able to see the ducts due to no attic access. The hvac system need to be evaluated and cleaned by a licensed professional and there were signs of excessice moisture at

the time of the inspection

this one's missing a cover!

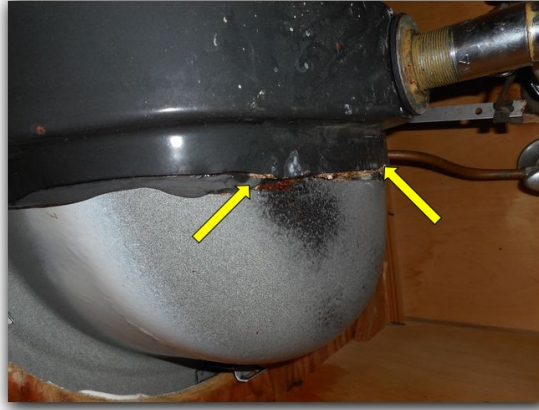
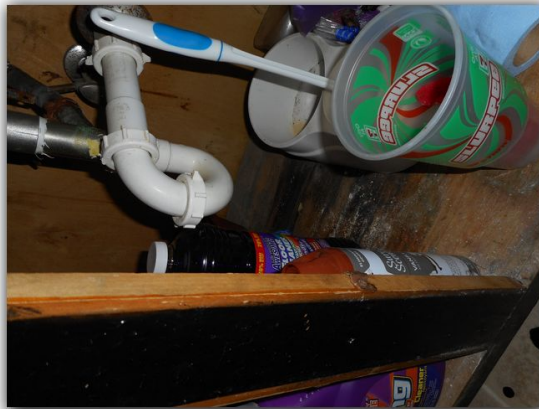
Comments: All of the sinks showed sign of either past or present water damage underneath, the first picture is the worst. It's from the upstairs bathroom in unit 102 and the ceiling underneath has workmanlike repairs but extensive water damage

☒ Sink leaks into cabinet below

☒ Leakage around sink(s)

Comments: I recommend a licensed plumber and a handyman repair the leaks under the sinks and the water damage in all the cabinets below the sinks and a mold inspection for the upstairs shower and around the window.

All the leaks under the sinks should be fixed and water damage repaired under the sinks and on the ceilings.

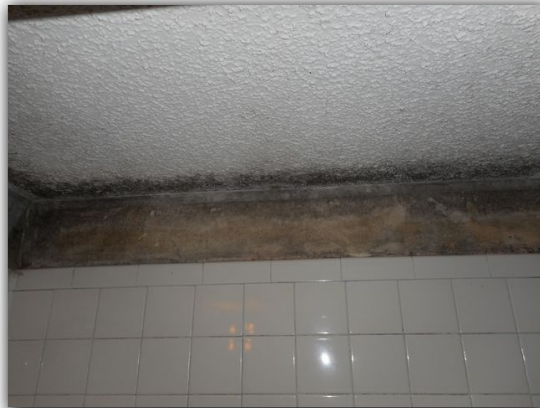
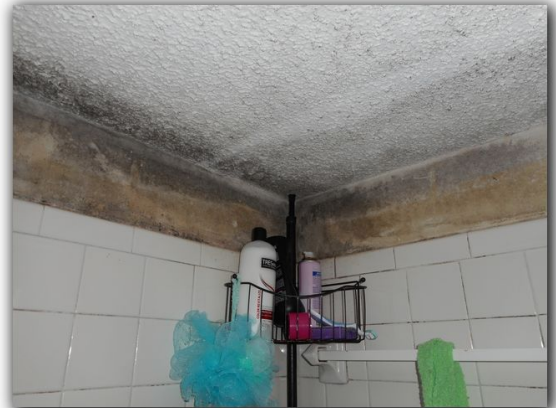
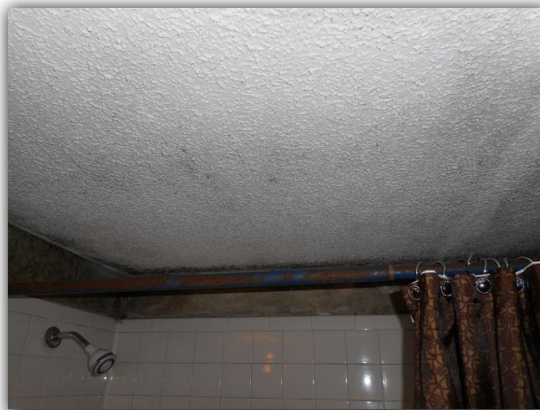
Comments: The shower in unit 101 wasn't fully operable, recommend a mold inspector evaluate around the bathtub

☒ Caulking or grout missing or damaged

☒ Drain stop inoperable

A mold inspection should be performed around the shower, the window and anywhere else that appears to be a hazard.

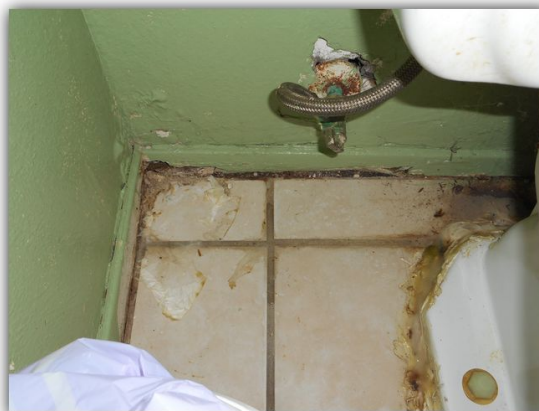
Comments: unit 103 the downstairs toilet leaks

☒ Leakage around commodes

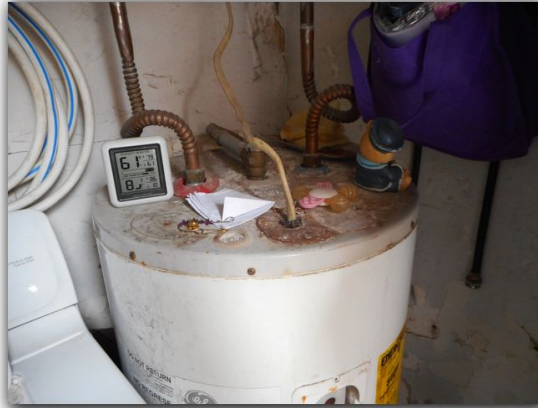
☒ Corrosion and / or signs of an intermittent leak at isolation valve or plumbing connections

this was leaking from the roof above and has caused corrosion on the water heater and probably should be replaced soon
