Dimensional Roofing & Diagnostics

REPORT DETAILS: INTRODUCTION

4113 Threadgill St
Austin TX, 78723

Report #: 55862313

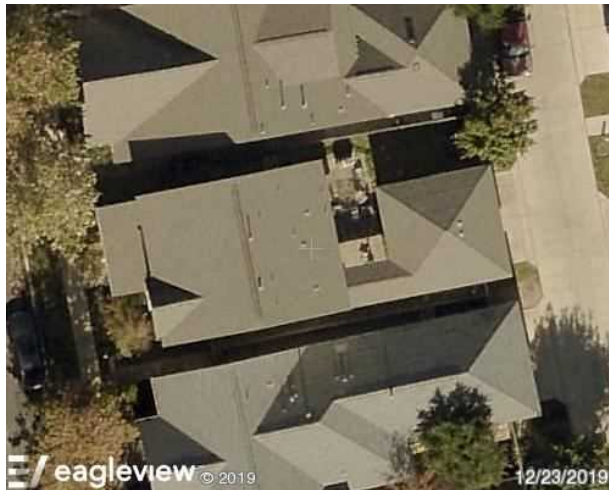
NAME	TOTAL
Roofing	2,286 sqft
Unset	N/A ft
Ridge	58 ft
Hip	66 ft
Valley	31 ft
Eave	180 ft
Rake	121 ft
Step Flashing	30 ft
TOTAL PLANES:	10

PITCH (TOP 7)	TOTAL	%
6	2011.6 sqft	88%
3	176.8 sqft	7.7%
9	97.2 sqft	4.3%
