Digital Twins to Support Track Maintenance Decisions for Sound Transit

RAIL TRANSIT SEMINAR

August 26-28,
2025

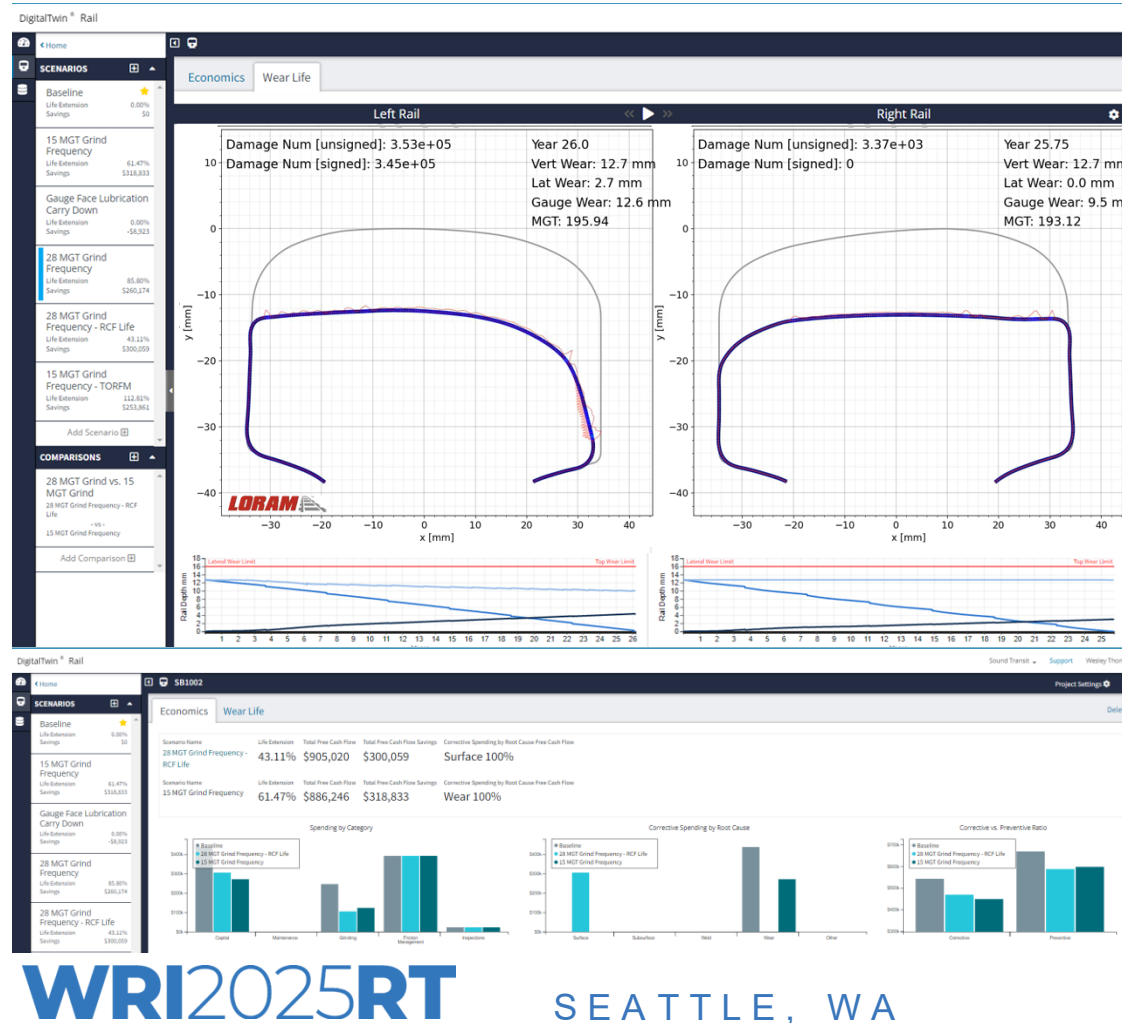
Year 1 – Grind Strategy in Digital Twin

Grind Plan

Grind frequency was inconsistent across network.

Recommended grind strategy for long-term scheduling

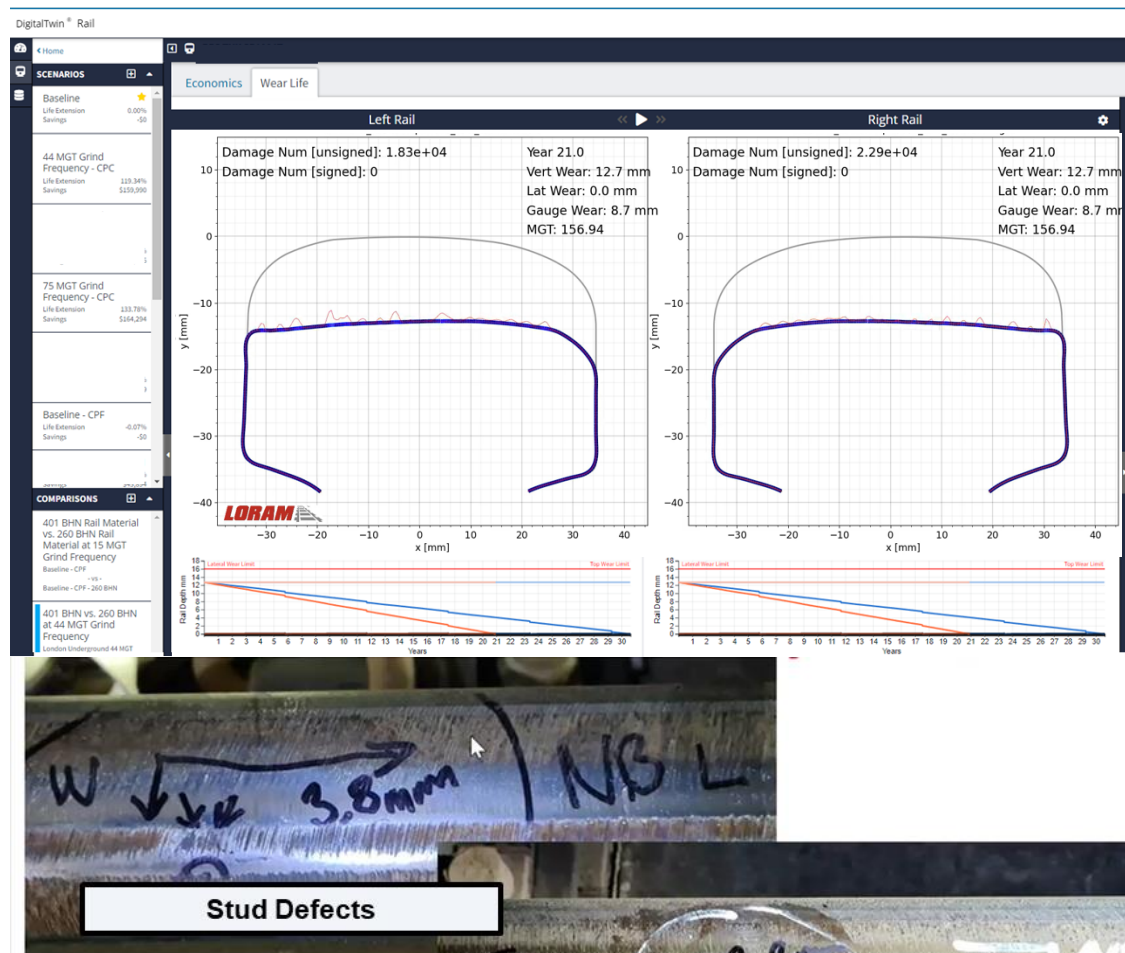
Year 1 – Rail Material to Address Studs

Stud Remedy

Stud defects were persistent before grinding

Did not recommend reduce rail hardness to prevent based on ROI

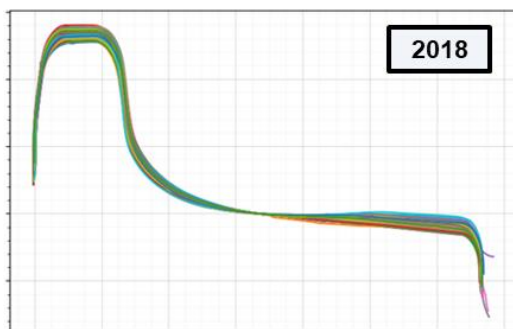
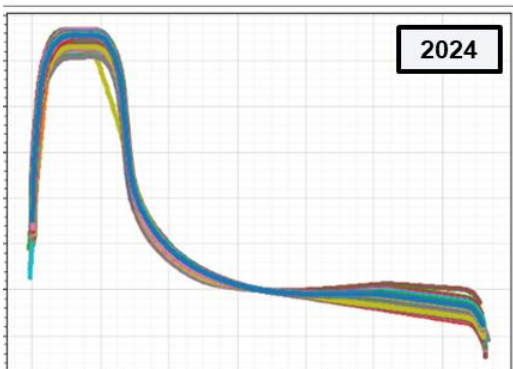
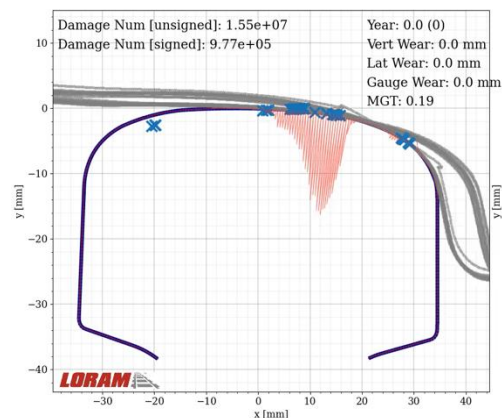
Year 2 – Verify with Actual Vehicles/Wheels

Wheel-Rail Interaction

Updates to the wheel profiles and vehicle model to represent Sound Transit rolling stock replicated wheel-rail interaction

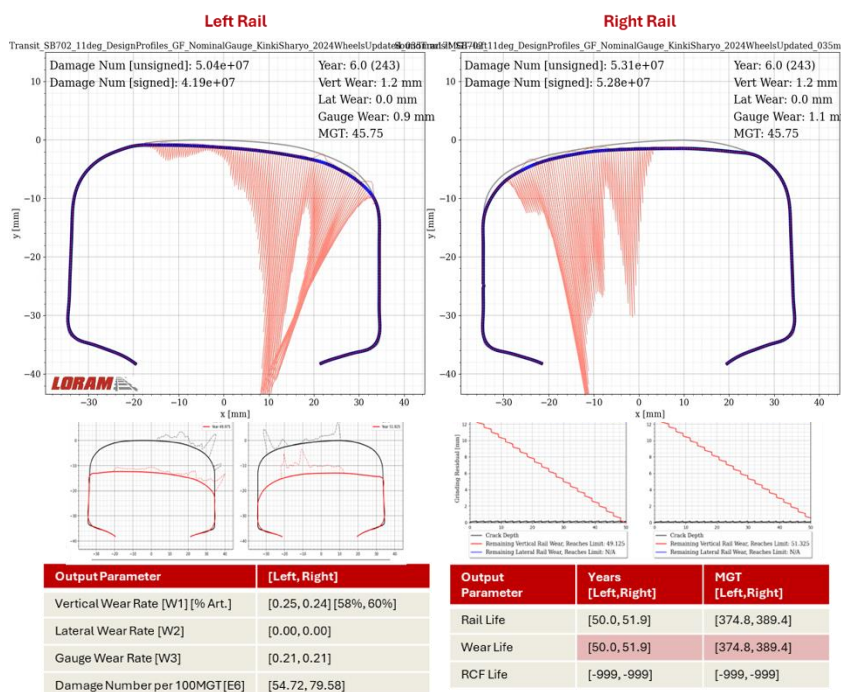
Year 2 – Verify with Actual Rail Condition

Rail Condition

Twelve virtual test sites were established on Sound Transit showing similar wheel-rail interaction, wear, and surface damage as observed
