Probing the Frontal Deformation Zone of the Chihshang Fault with Boreholes and High Resolution Electrical Resistivity Imaging Methods: A Case Study at the Dapo Site in Eastern Taiwan

■ *The Electrical Resistivity Imaging Methods*

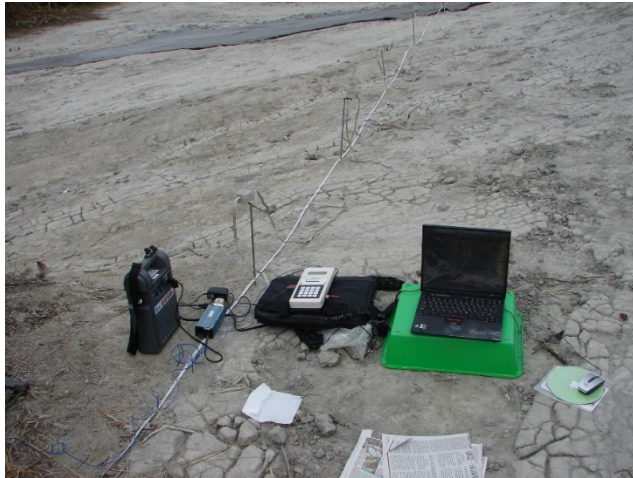
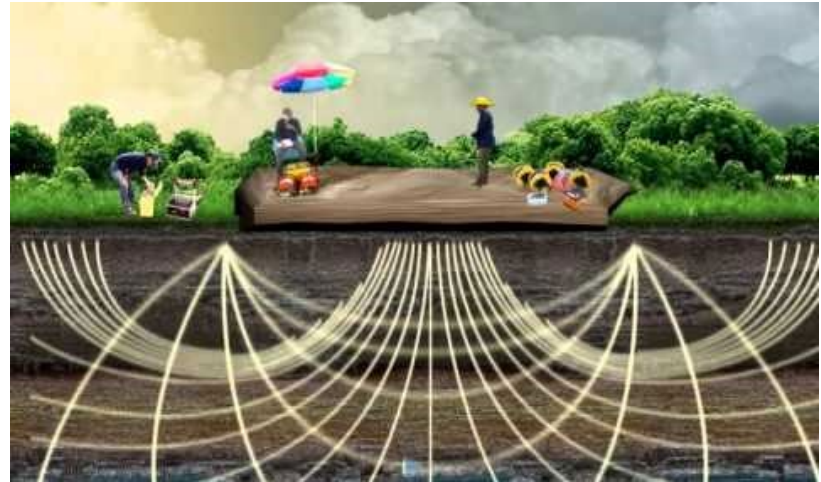
- Low-frequency electrical currents are injected into the subsurface and the variation of the potentials can be measured at pairs of electrodes of different locations
- One can get the resistivity images by inverting the measurements with the physical relationships.
- Subsurface structures/ lithology can exhibit different resistivity performance, and therefore can be shown in the resistivity images.

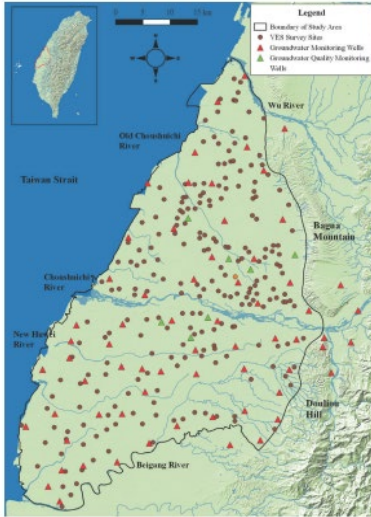
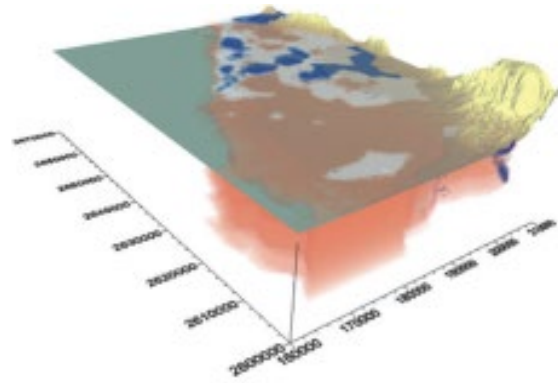
3D model for the Choushui Plain

■ *Geological models that built from the Resistivity models*

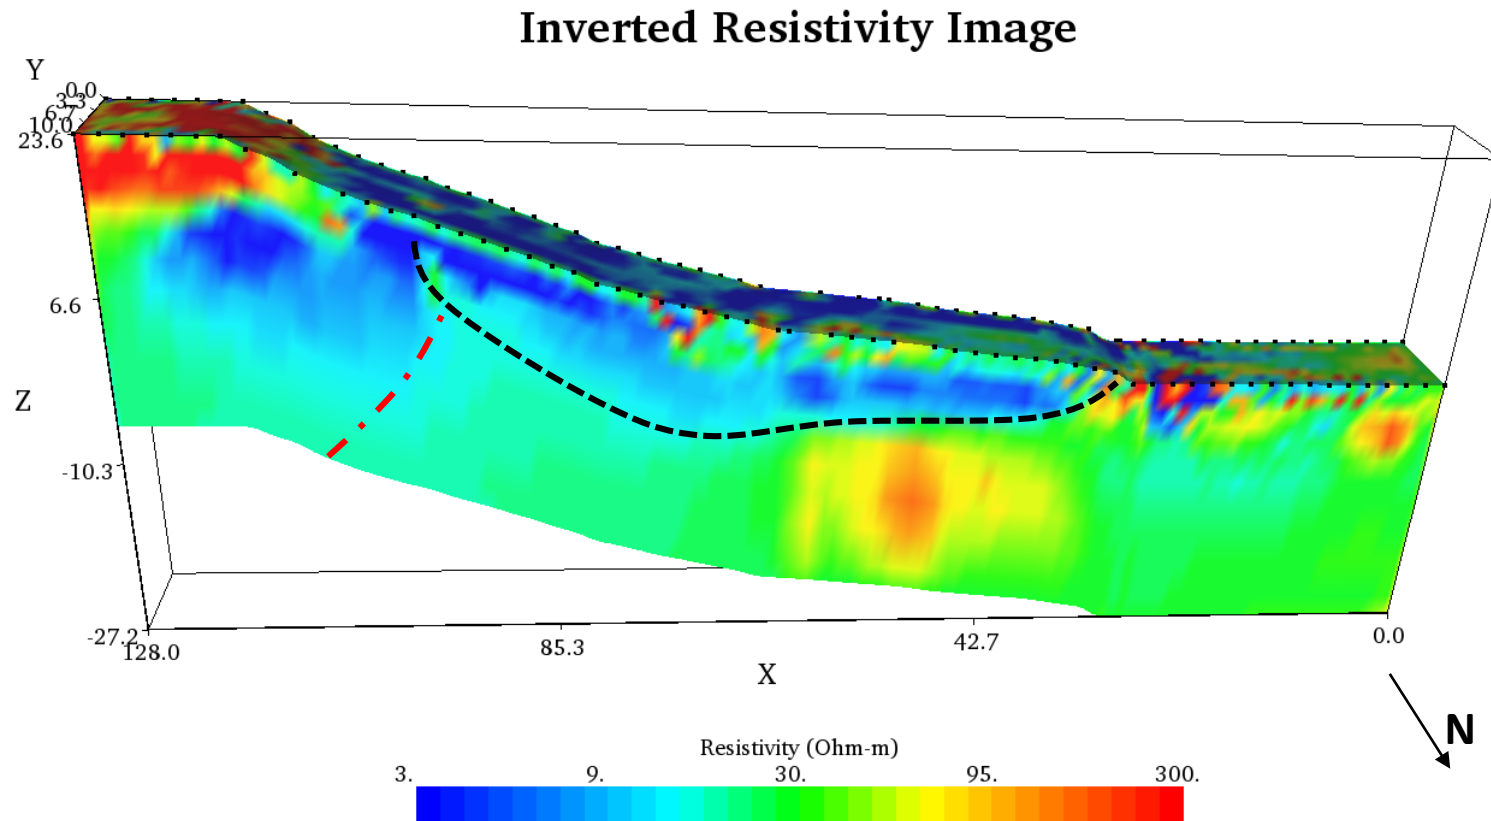
- *The 3D resistivity model and explanations for the frontal deformation zone at the Dapo site.*

- Previous studies suggested that the fault plane of the Chihshang Fault is outcropped at the toe of the hillslope at the Dapo elementary school.
- However, we discovered that a tongue-like body of the Lichi mélange is actually the slumping results from the high resolution resistivity images, the borehole logs, and the monitoring measurements from the borehole SAA tiltmeter.
- The actual fault trace shown in the resistivity images seems to be truncated by the rupture surface of the slumping body.
- The topographic modification by the **aseismic mass movement** causes the difficulty to identify the actual fault traces in the regions suffered by heavily weathering and transportation effects.
