A. Double hull size

B. Strength characteristic

C. Failure strain

D. Hardening value

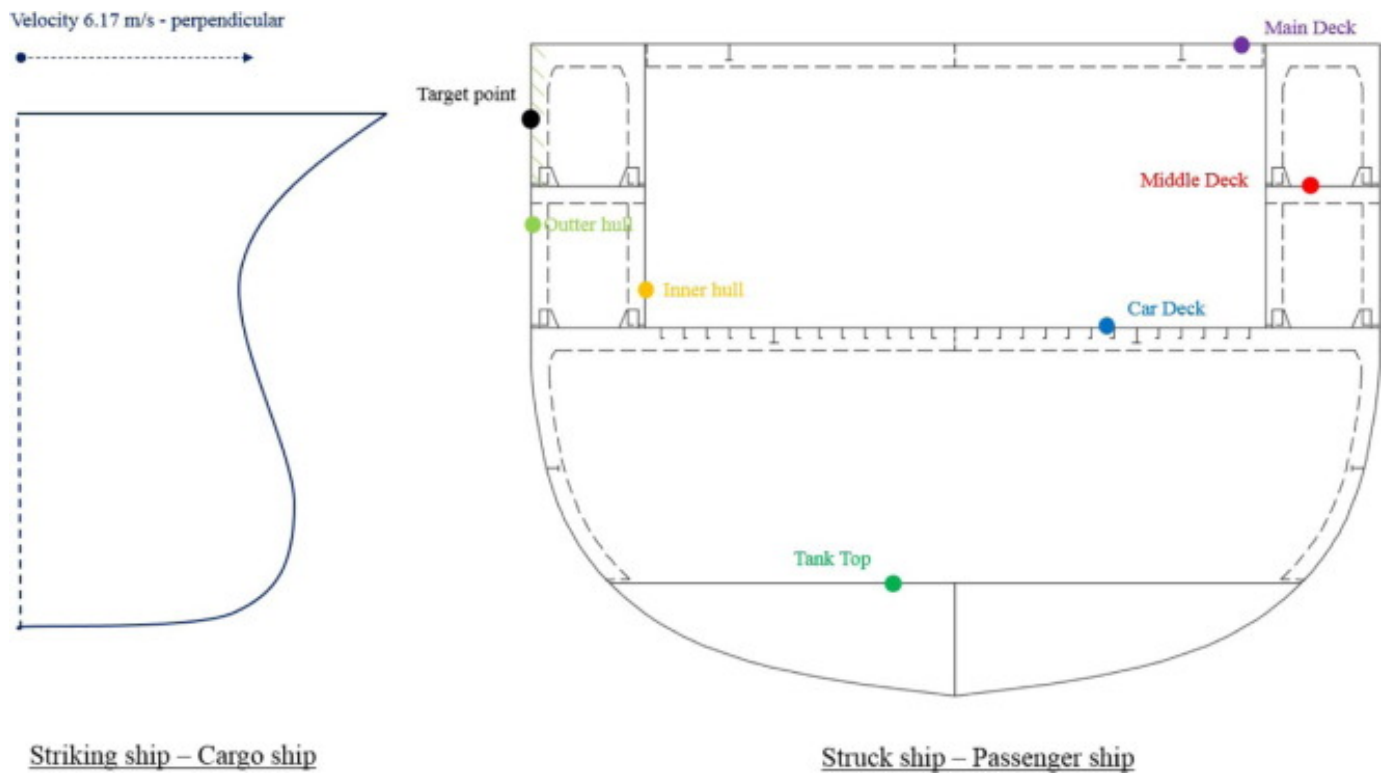
Figure 1: Illustration of side collision. Bullets highlight location of pointed components.

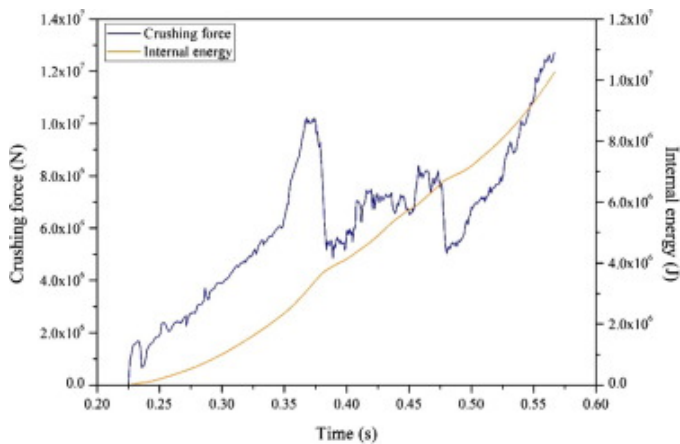
Figure 2: Crushing force and internal energy for double hull configuration 1.50m.

3.5 m in width. Contrast with this situation, the narrower double hull (1.5 m in width) showed rising trend line as penetration went further. This situation addressed the situation of the inner hull of this hull was slowly deformed plastically. Illustration of this phenomenon is presented in Fig. 7 and Fig. 8 for both hulls. The presented contours in these figures are von Mises stress which represent failure stress. In 1.5 m double hull, stress on the inner hull was found distributed on the area of penetrated hulls. Stress concentration was clearly indicating failure if penetration was continued on this location.

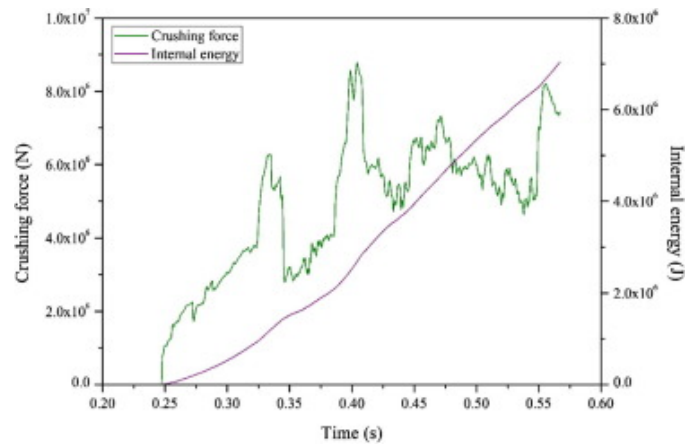
Figure 3: Crushing force and internal energy for double hull configuration 3.50m.

Safety standard of a ship against various forms of impact load (e.g. collision and grounding) can be evaluated from condition of the inner hull after resisting such damage. Breach of the inner hull can be considered fatal since damage occurs not only on ship structure, but also already reach ship cargo. Calculation results based on different hull configurations are presented in Fig. 5 and Fig. 6. Internal energy in these graphs are defined as energy that is needed to plastically deform or even destroy the involved structures in impact. In this case, the struck ship as the deformable object is observed. Energy to deform side hull with narrower space was indicated higher as both hulls (outer and inner) were significantly damaged by the striking ship during penetration. Indication of higher internal energy is not solely dictated a structural configuration has better resistance against impact load. Crushing force in the figures is defined as force fluctuation during destruction of the involved objects take place by certain impact load. The force for wider space on the struck ship was observed go down in the end of collision process as the destruction was focussed on the outer hull. Major deformation or even hole on the inner hull could be avoided as large space was provided by double hull with size

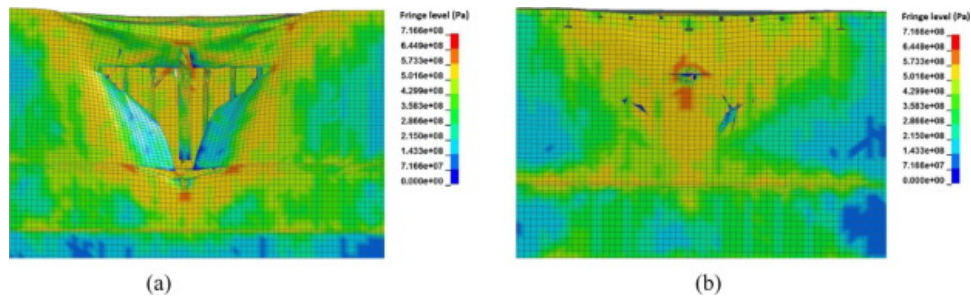
Figure 4: Damage pattern on the double hull structure with space 1.50 m: (a) outer hull, and (b) inner hull.

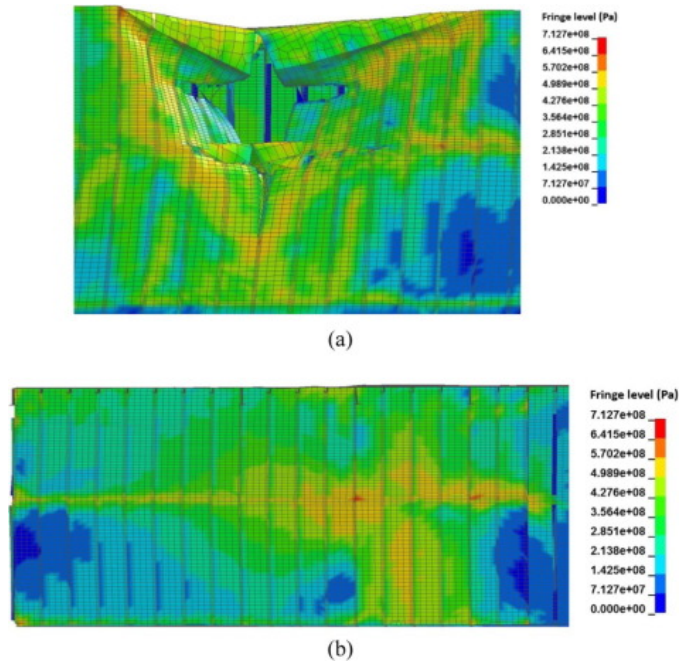
Figure 5: Damage pattern on the double hull structure with space 3.50 m: (a) outer hull, and (b) inner hull.

Stress on inner was widely distributed on the inner hull for the larger double hull. This hull size provided adequate time during penetration to deliver the stress to other structural components. Initial conclusion based on this discussion that narrower double hull space more susceptible to failure during collision. Therefore, double hull with space 1.5 m would be used in further analyses and simulations accounting for material configurations.

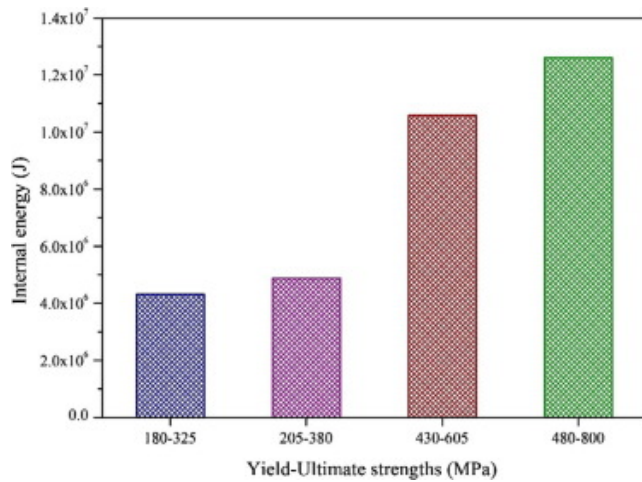
Figure 6: Internal energy for different applied material strength on the double hull structure.

Material is inseparable element in structural analysis. In this work, this parameter is taken into consideration with deploying material with different strength magnitude. The energy results of this study indicated that the internal energy was equally perpendicular with magnitude of yield and ultimate strength. Material with higher strength needed more energy to be destroyed during penetration. Difference in yield strength

between the first and second materials was found 12% and internal energy introduced 12% distinction. The third and fourth material showed difference 50 MPa in term of yield strength with energy comparison between both materials indicated 27% discrepancy. Between the first and second materials,

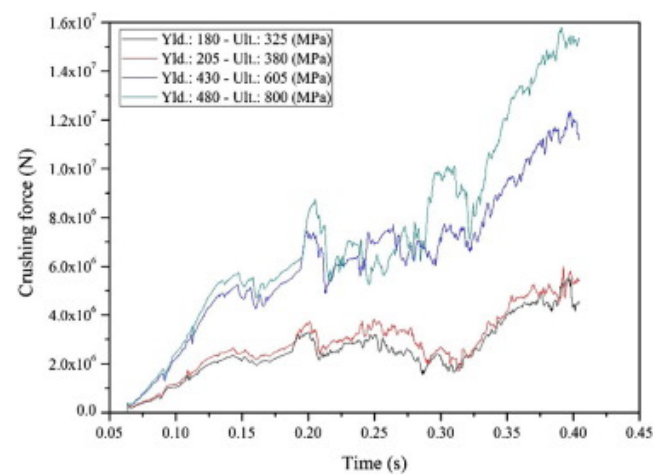
Figure 7: Characteristic of crushing force on the double hull structure with different strengths.

Difference was relative lower than the third and fourth materials, that contribution of tensile strength was taken into consideration as the third and fourth materials had bigger disparity. Behaviour of crushing force also provided good correlation since higher material strength, higher stress that would be experienced. These results are presented in Fig. 9 and Fig. 10, consecutively. Damage extents in Fig. 11 were presented by Tresca stress indicated that the higher strength would reduce casualties on the inner hull after collision process. This material was proven provide better resistance for side hull against collision by the striking ship. However, attention should be paid in term of material treatment. Higher strength tends to need more costly treatment in building and repairing processes which lead to increase of maintenance cost.

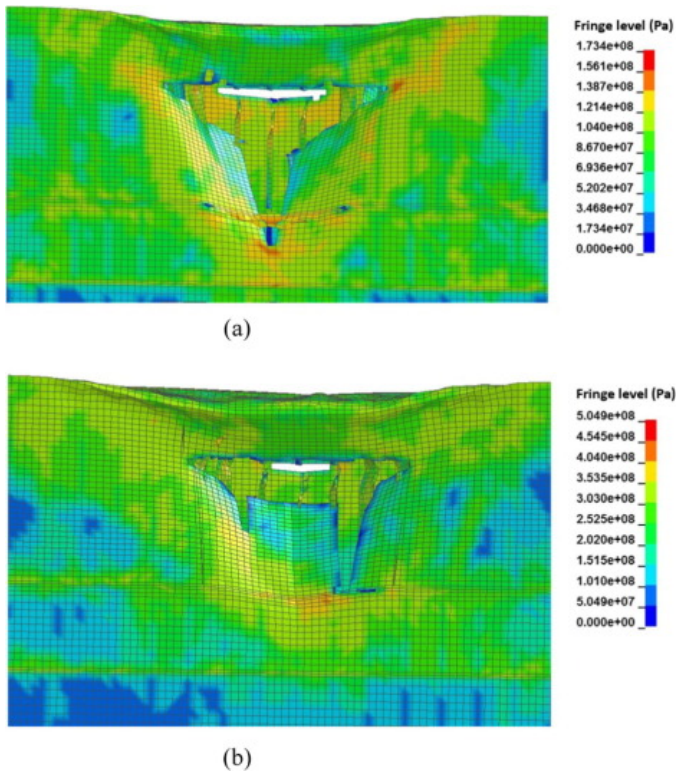
Figure 8: Damage pattern on the outer and inner hulls: (a) yield 180 MPa, and (b) yield 480 MPa.

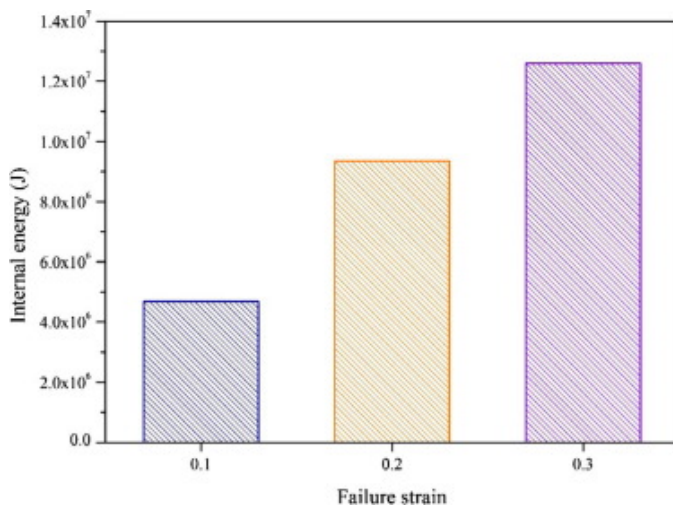
Figure 9: Effect of failure strain constant to internal energy during ship collision.

In analysis using strain-dependent material to predict failure pattern on the involved objects, it was considered important to evaluate how far failure strain affected calculation results. Three different strain constants were applied on the deformable structure. Calculation results in Fig. 12 indicated that the internal energy was gradually increasing for the proposed strain constants. The target structure was shown better strain capability during penetration and made the structure was harder to experience failure. Illustration in Fig. 13 was presented wide area with was wrinkled as effect of collision load in structure with strain constant 0.3. Compared with the smallest constant which the inner hull was successfully breached and tearing was found that the striking ship cleanly tore the both hulls, the strain constant 0.3 delivered better capability to resist penetration by the striking ship. Benchmarking study can be considered as good method to estimate reasonable strain constant for applied material properties in analysis.

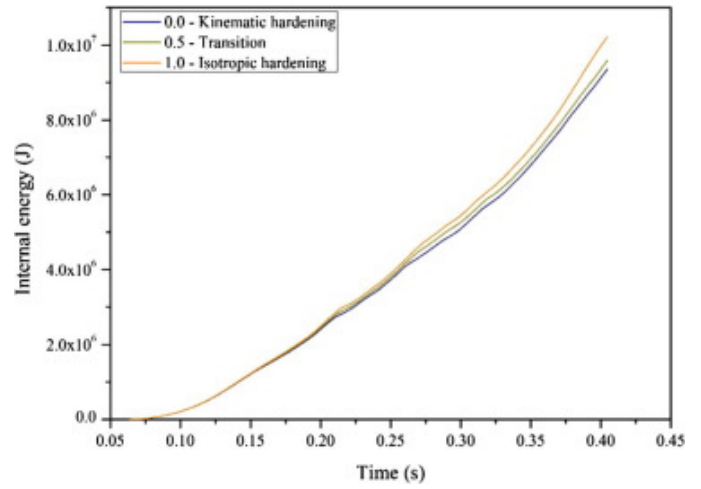
Figure 10: Internal energy for proposed assumption of yield surface. Significance is not found on the results.

Hardening was taken into consideration to observe different assumption in position of yield surface during penetration. Kinematic hardening with constant 0 indicates that the radius of the yield surface is fixed but the center translates in the direction of the plastic strain, which means it can be move as translated direction of plastic strain. In opposite of the first assumption, if the yield surface is fixed and works as function of the plastic strain, this definition is called isotropic hardening with constant 1. The transition constant 0.5 was considered in the analysis to provide intermediary comparison for kinematic and isotropic results. In term of internal energy (Fig. 14), significant difference was unlikely found for all proposed assumptions. Trend line and value were also showing similarity in term of crushing force as presented in Fig. 15. Both responses indicated that isotropic hardening produced higher results than kinematic hardening with no remarkable characteristic. Results of the transition value 0.5 was found between kinematic and isotropic magnitudes.

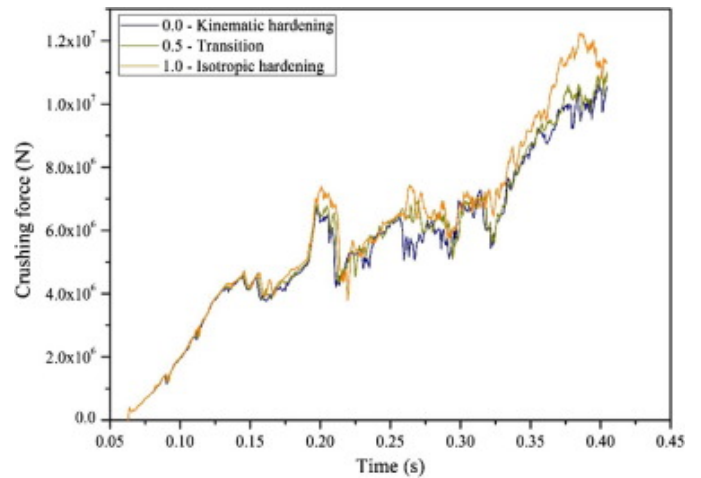
Figure 11: Crushing force during penetration by the striking ship with different assumed yield surfaces.
