A. Double hull size

B. Strength characteristic

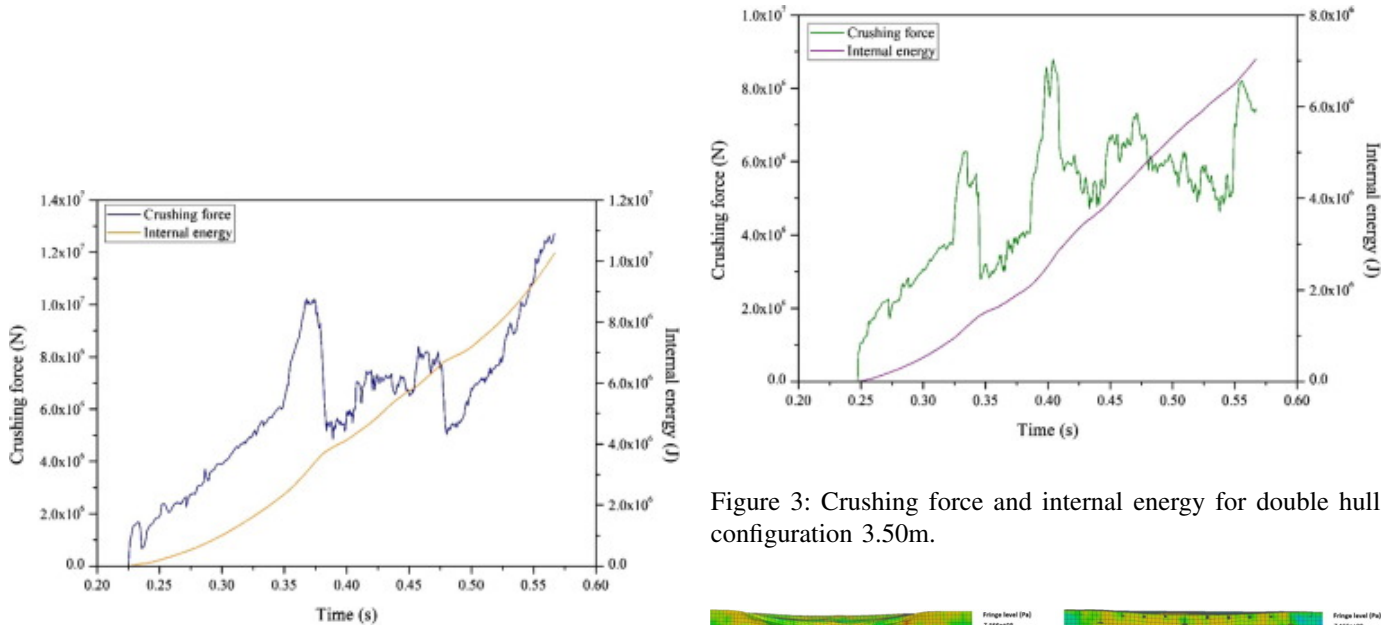
Figure 3: Crushing force and internal energy for double hull configuration 3.50m.

Figure 2: Crushing force and internal energy for double hull configuration 1.50m.

Safety standard of a ship against various forms of impact load (e.g. collision and grounding) can be evaluated from condition of the inner hull after resisting such damage. Breach of the inner hull can be considered fatal since damage occurs not only on ship structure, but also already reach ship cargo. Calculation results based on different hull configurations are presented in Fig. 5 and Fig. 6. Internal energy in these graphs are defined as energy that is needed to plastically deform or even destroy the involved structures in impact. In this case, the struck ship as the deformable object is observed. Energy to deform side hull with narrower space was indicated higher as both hulls (outer and inner) were significantly damaged by the striking ship during penetration. Indication of higher internal energy is not solely dictated a structural configuration has better resistance against impact load. Crushing force in the figures is defined as force fluctuation during destruction of the involved objects take place by certain impact load. The force for wider space on the struck ship was observed go down in the end of collision process as the destruction was focussed on the outer hull. Major deformation or even hole on the inner hull could be avoided as large space was provided by double hull with size

3.5 m in width. Contrast with this situation, the narrower double hull (1.5 m in width) showed rising trend line as penetration went further. This situation addressed the situation of the inner hull of this hull was slowly deformed plastically. Illustration of this phenomenon is presented in Fig. 7 and Fig. 8 for both hulls. The presented contours in these figures are von Mises stress which represent failure stress. In 1.5 m double hull, stress on the inner hull was found distributed on the area of penetrated hulls. Stress concentration was clearly indicating failure if penetration was continued on this location. Stress on inner was widely distributed on the inner hull for the larger double hull. This hull size provided adequate time during penetration to deliver the stress to other structural components. Initial conclusion based on this discussion that narrower double hull space more susceptible to failure during collision. Therefore, double hull with space 1.5 m would be used in further analyses and simulations accounting for material configurations.

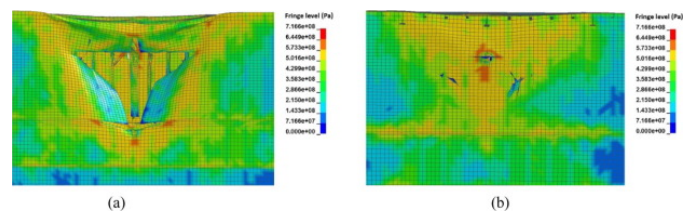
Figure 4: Damage pattern on the double hull structure with space 1.50 m: (a) outer hull, and (b) inner hull.

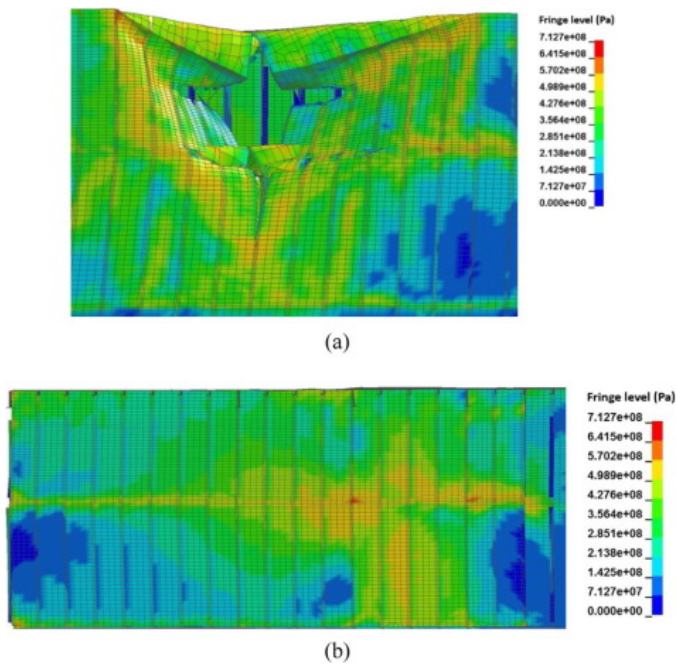
Figure 5: Damage pattern on the double hull structure with space 3.50 m: (a) outer hull, and (b) inner hull.

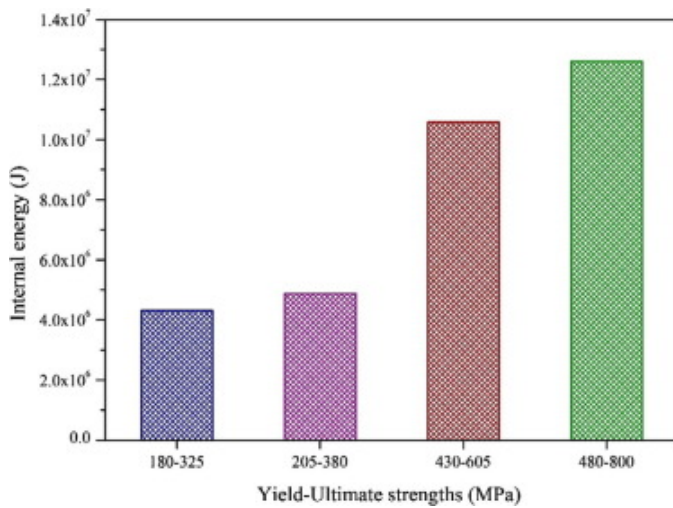
Figure 6: Internal energy for different applied material strength on the double hull structure.

Material is inseparable element in structural analysis. In this work, this parameter is taken into consideration with deploying material with different strength magnitude. The energy results of this study indicated that the internal energy was equally perpendicular with magnitude of yield and ultimate strength. Material with higher strength needed more energy to be destroyed during penetration. Difference in yield strength

between the first and second materials was found 12% and internal energy introduced 12% distinction. The third and fourth material showed difference 50 MPa in term of yield strength with energy comparison between both materials indicated 27% discrepancy. Between the first and second materials,

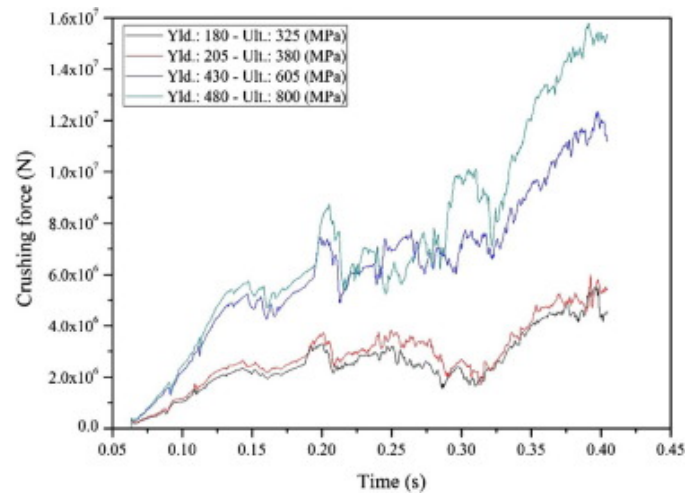
Figure 7: Characteristic of crushing force on the double hull structure with different strengths.

Difference was relative lower than the third and fourth materials, that contribution of tensile strength was taken into consideration as the third and fourth materials had bigger disparity. Behaviour of crushing force also provided good correlation since higher material strength, higher stress that would be experienced. These results are presented in Fig. 9 and Fig. 10, consecutively. Damage extents in Fig. 11 were presented by Tresca stress indicated that the higher strength would reduce casualties on the inner hull after collision process. This material was proven provide better resistance for side hull against collision by the striking ship. However, attention should be paid in term of material treatment. Higher strength tends to need more costly treatment in building and repairing processes which lead to increase of maintenance cost.

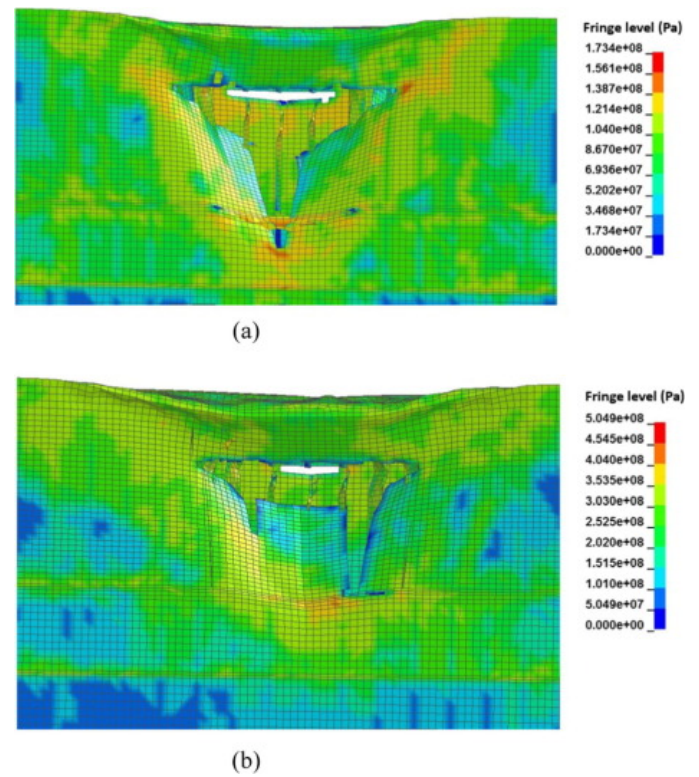
Figure 8: Damage pattern on the outer and inner hulls: (a) yield 180 MPa, and (b) yield 480 MPa.

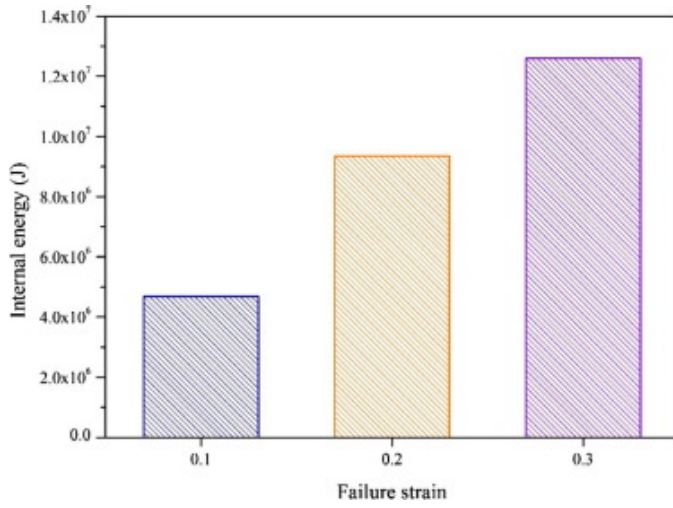
Figure 9: Effect of failure strain constant to internal energy during ship collision.

In analysis using strain-dependent material to predict failure pattern on the involved objects, it was considered important to evaluate how far failure strain affected calculation results. Three different strain constants were applied on the deformable structure. Calculation results in Fig. 12 indicated that the internal energy was gradually increasing for the proposed strain constants. The target structure was shown better strain capability during penetration and made the structure was harder to experience failure. Illustration in Fig. 13 was presented wide area with was wrinkled as effect of collision load in structure with strain constant 0.3. Compared with the smallest constant which the inner hull was successfully breached and tearing was found that the striking ship cleanly tore the both hulls, the strain constant 0.3 delivered better capability to resist penetration by the striking ship. Benchmarking study can be considered as good method to estimate reasonable strain constant for applied material properties in analysis.

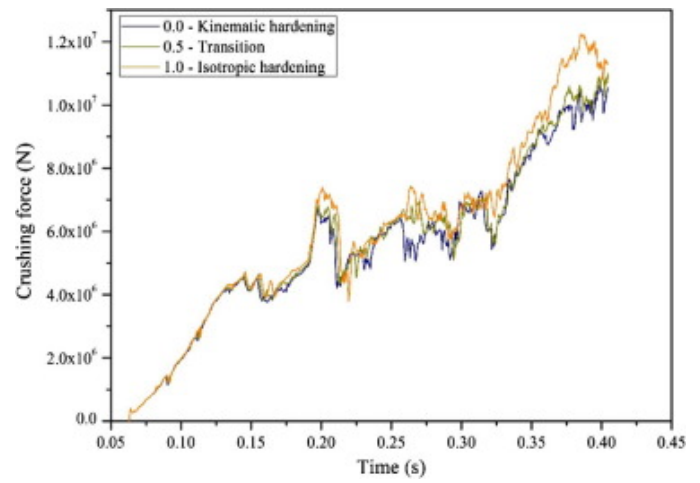
Figure 11: Crushing force during penetration by the striking ship with different assumed yield surfaces.

Hardening was taken into consideration to observe different assumption in position of yield surface during penetration. Kinematic hardening with constant 0 indicates that the radius of the yield surface is fixed but the center translates in the direction of the plastic strain, which means it can be move as translated direction of plastic strain. In opposite of the first assumption, if the yield surface is fixed and works as function of the plastic strain, this definition is called isotropic hardening with constant 1. The transition constant 0.5 was considered in the analysis to provide intermediary comparison for kinematic and isotropic results. In term of internal energy (Fig. 14), significant difference was unlikely found for all proposed assumptions. Trend line and value were also showing similarity in term of crushing force as presented in Fig. 15. Both responses indicated that isotropic hardening produced higher results than kinematic hardening with no remarkable characteristic. Results of the transition value 0.5 was found between kinematic and isotropic magnitudes.

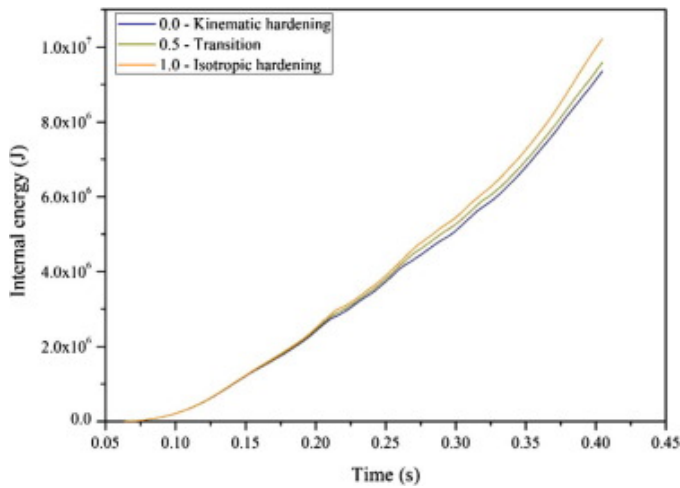
Figure 10: Internal energy for proposed assumption of yield surface. Significance is not found on the results.
