In this section, calculation results by numerical simulation would be presented. Discussion was presented based on each of applied configurations. Several responses on the struck ship was described and evaluated regarding influence degree of proposed parameters to the results.

A. Double hull size

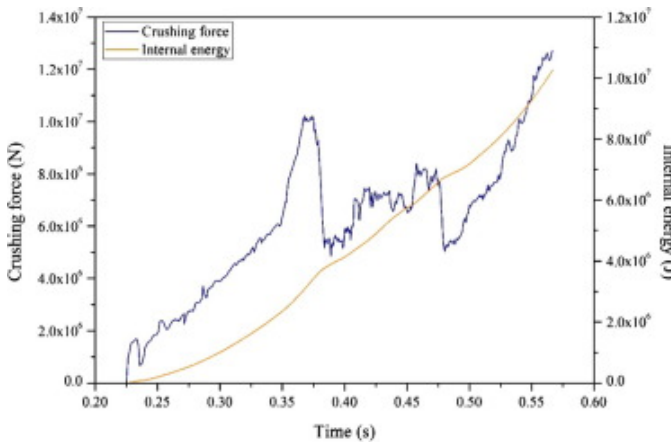
Figure 2: Crushing force and internal energy for double hull configuration 1.50m.

Safety standard of a ship against various forms of impact load (e.g. collision and grounding) can be evaluated from condition of the inner hull after resisting such damage. Breach of the inner hull can be considered fatal since damage occurs not only on ship structure, but also already reach ship cargo. Calculation results based on different hull configurations are presented in ?? and ?. Internal energy in these graphs are defined as energy that is needed to plastically deform or even destroy the involved structures in impact. In this case, the struck ship as the deformable object is observed. Energy to deform side hull with narrower space was indicated higher as both hulls (outer and inner) were significantly damaged by the striking ship during penetration. Indication of higher internal energy is not solely dictated a structural configuration

has better resistance against impact load. Crushing force in the figures is defined as force fluctuation during destruction of the involved objects take place by certain impact load. The force for wider space on the struck ship was observed go down in the end of collision process as the destruction was focussed on the outer hull. Major deformation or even hole on the inner hull could be avoided as large space was provided by double hull with size

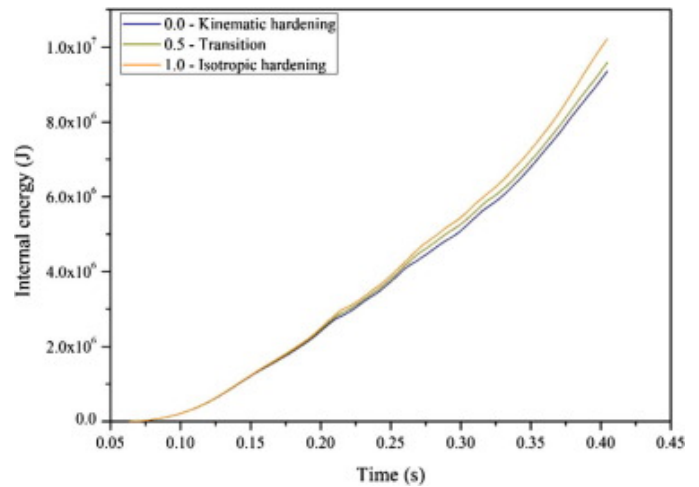
Figure 10: Internal energy for proposed assumption of yield surface. Significance is not found on the results.

function of the plastic strain, this definition is called isotropic hardening with constant 1. The transition constant 0.5 was considered in the analysis to provide intermediary comparison for kinematic and isotropic results. In term of internal energy (??), significant difference was unlikely found for all proposed assumptions. Trend line and value were also showing similarity in term of crushing force as presented in ?? . Both responses indicated that isotropic hardening produced higher results than kinematic hardening with no remarkable characteristic. Results of the transition value 0.5 was found between kinematic and isotropic magnitudes.
