## INSPECTION VISIT REPORT

Number: 8115855766/1001127318 - IVR - 05.12.2018 - A C Ramana - Revision - 0

<b>General:</b>			
<b>TUV SAP &amp; Control Number:</b>	8115855766/1001127318	<b>Branch:</b>	Hyderabad
<b>Notification Name / Number with Date:</b>	Email Dated 03.12.2018	<b>Date(s) of Inspection:</b>	04.12.2018 & 05.12.2018
<b>Project Name &amp; Location:</b>	BS IV Project, IOCL Barauni	<b>Place / Address of Inspection:</b>	Anakapalli
<b>TUVIPL Client Name:</b>	M/s. Heurtey Petrochem	<b>End User Name:</b>	Not Applicable
<b>DEC / PMC / EPC Name:</b> (If applicable)	M/s. Technip	<b>DEC / PMC / EPC Assignment Number:</b> (If applicable)	Not Applicable
<b>Vendor Name &amp; Location:</b>	M/s. Heurtey Petrochem	<b>P.O. Number:</b> (Client on Vendor)	305045 Amd. 1, dated 14.08.2018
<b>Sub Vendor Name &amp; Location:</b> (If applicable)	M/s. Hastalloy India Limited - Anakapalli	<b>P.O. Number:</b> (If applicable - Vendor on Sub Vendor)	Not Applicable
<b>Stages Of Inspection:</b>			
<input type="checkbox"/> Kick Off / Pre Inspection Meeting	<input checked="" type="checkbox"/> Material Identification	<input type="checkbox"/> Interim Stages

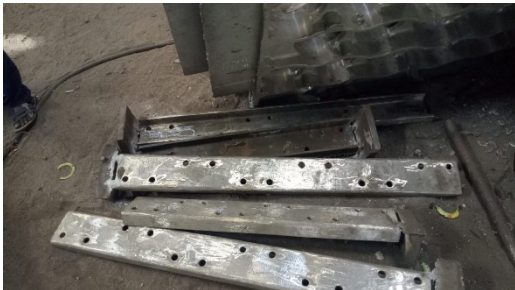
Inspection Pictures:	
Test bar Identification	Mechanical Test Bar

6)	Others (Specify)	Not Applicable	Not Applicable		
Inspection Activities Carried Out :					
Stages Witnessed:					
1)	Verified pouring report of heat numbers 3186A, 3187A, 3188A, 3189A, 3190A, 3191A & 3193A integral test bars identified and hard punched for physical testing

2)	Witnessed Mechanical test duly attested Test Bar with Heat Number 3186A, 3187A, 3188A, 3189A, 3190A, 3191A & 3193A and found satisfactory as per QAP/ITP

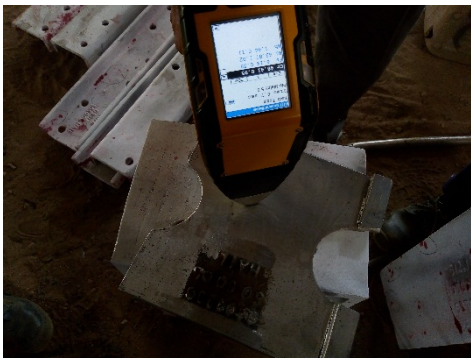
5)	Witnessed PMI for offered material and meet the specification requirements.				
6)	Witnessed Dye Penetrant test 100% on pilot Castings and 10% on production castings - Recordable indications observed. After rework material to be re offer.				
Documents Reviewed:

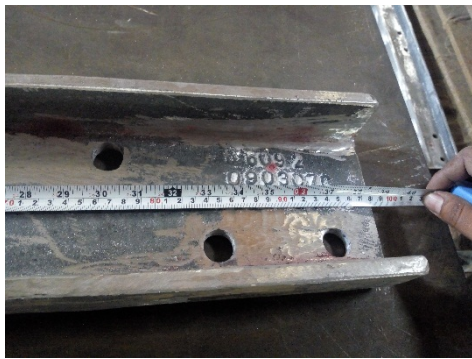
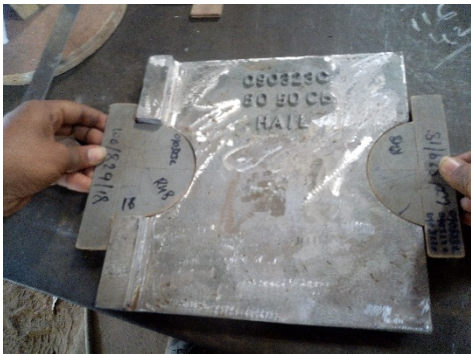
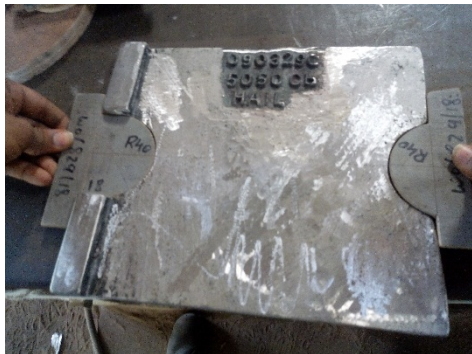
4)	Witnessed Dimensional Inspection 100% on pilot Castings and 10% on production castings and found to meet the drawing/specification requirements.

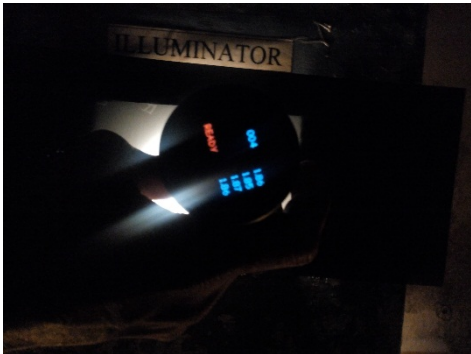
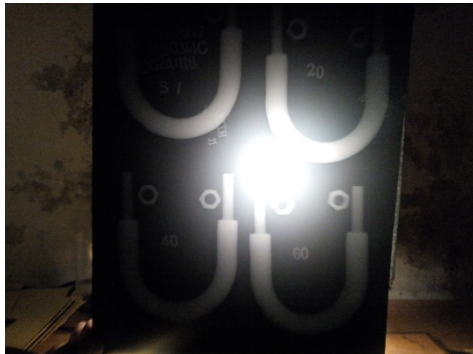
RT Films Review	RT Films Review

1)	Reviewed Pouring report and identified as Heat Nos: 3186A, 3187A, 3188A, 3189A, 3190A, 3191A & 3193A				
2)	Reviewed RT films for offer material - Seal Plates having defects, those defects are not acceptable and same are reported. Remaining material acceptable.
