General:						
TUV India Control Number:(SAP Number)		050104387523/2 (8122095610)		Branch:	Ludhiana	
Notification Number:		Email		Date(s) of Inspection:	12/07/2024	
Project Name & Location:		Inspection of Cylinder Zinc Metallizing at M/s Saboo Cylinders Pvt.Ltd, Kala Amb, Distt. Sirmour (H.P.)		Inspection Location:	Kal Aam	
TUV India Client Name:		Saboo Cylinders Pvt.Ltd.		End User Name:	Oil Companies (IOCL, BPCL & HPCL)	
DEC / PMC / EPC Name: (If applicable)		-		DEC / PMC / EPC Assignment Number: (If applicable)	-	
Vendor Name & Location:		Saboo Cylinders Pvt.Ltd.		P.O. Number: (Client PO on Vendor)	10044119 Dated 15/09/2023	
Sub Vendor Name & Location: (If applicable)				P.O. Number: (If applicable - Vendor PO on Sub Vendor)		
Stages Of Inspection:						
<input type="checkbox"/> Kick Off / Pre Inspection Meeting		<input type="checkbox"/> Material Identification		<input checked="" type="checkbox"/> Interim Stages

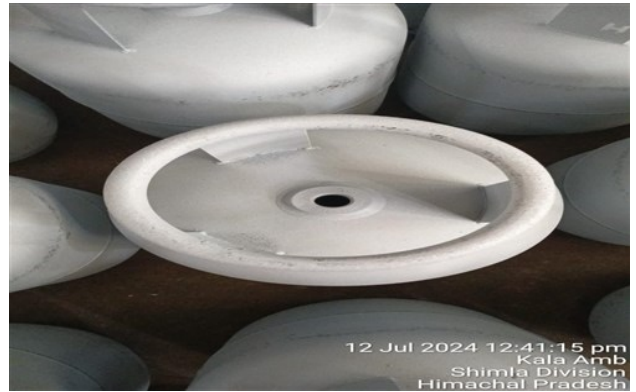
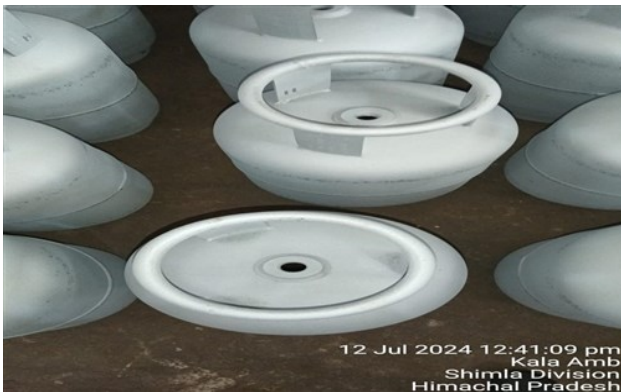
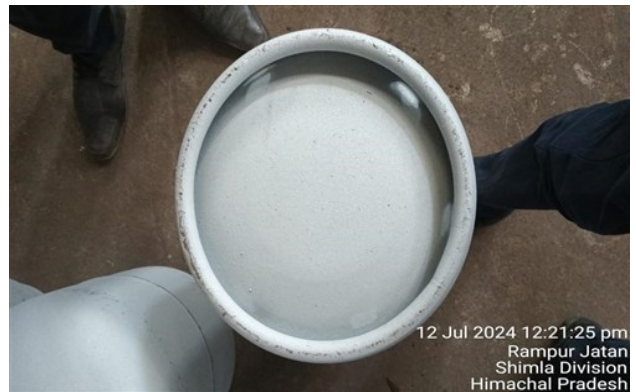
Inspection Activities Carried Out:							
Stages Witnessed:							
1	Visually checked the Metallizing zinc coating of randomly selected Items @ 2% from each sub-lot , offered lot of 3000 cylinders and found meeting requirements. Dirt found embedded during handling in ring and bottom area . Same was cleaned and found in order.						
2	Witnessed Metallizing Zinc coating thickness of random selected samples as per Tender No.: LPG-0/M/PT-04/22-23, Dated: 31.03.2023 "Technical Specifications for 14.2 Kg High Tensile Steel (HTS) LPG Cylinders (Page No.: 70)" requirement and found avg. above 40 microns (Refer attached report).						
Documents Reviewed:							
1	All measuring instruments / equipment were verified for continued suitability for intended use, proper identification, calibration status, traceability to national standards & found acceptable.						
Details of Equipment(s) / Instrument(s) used for measuring / testing During Inspection: (Refer Notes)

VISUAL CHECK

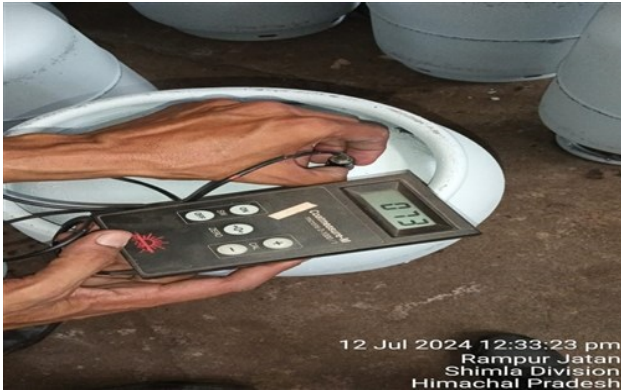
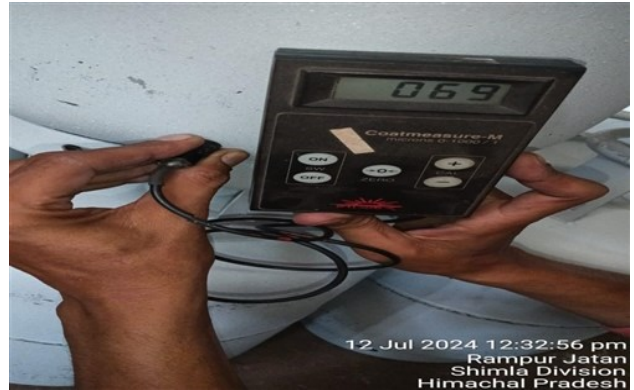
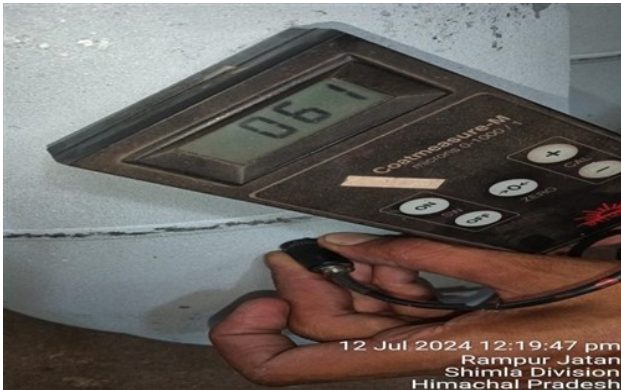
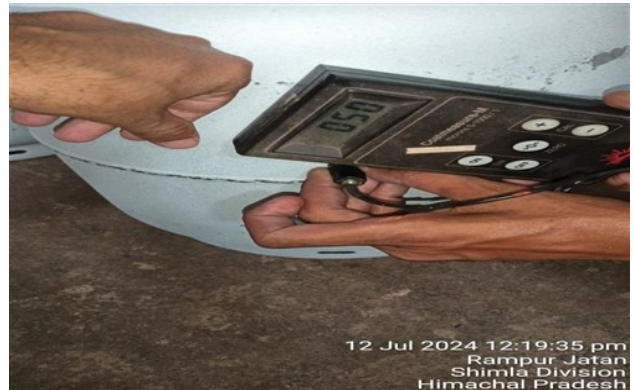
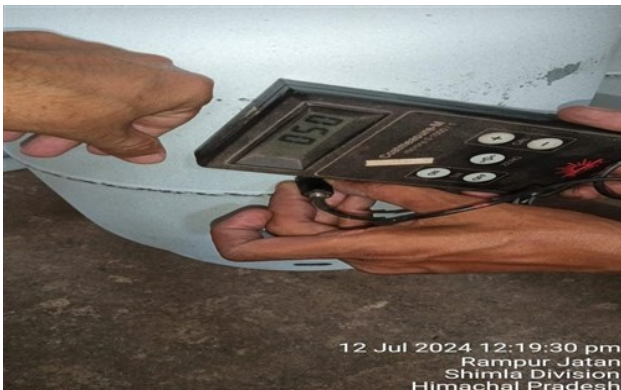
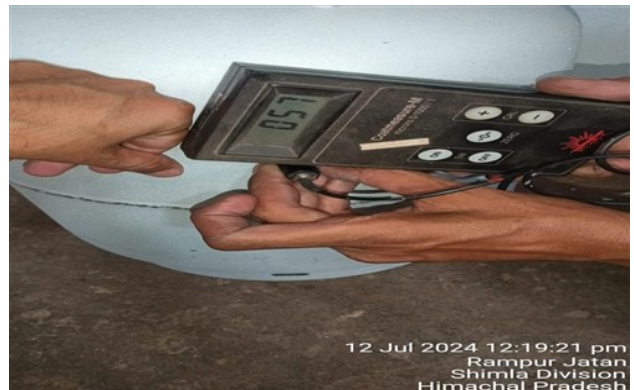
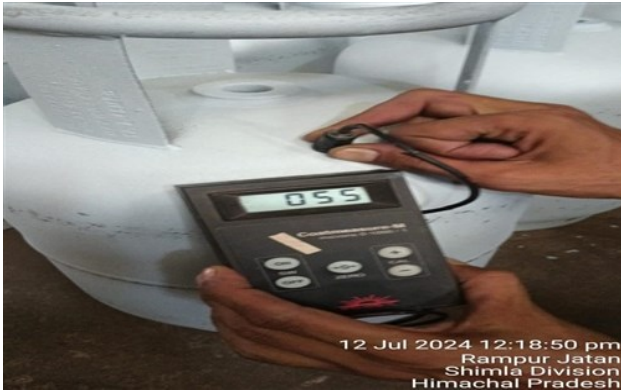
DFT CHECK
