INSPECTION VISIT REPORT

IVR - 8116410127 - - Sr. No.1 - Rev. 00

Item Description:						
P.O. Item No.	Item Code	Item Description	UOM	P.O. Quantity	Offered Quantity	Acceptable Quantity
--	--	Explosion Bonded Clad Plate SA240 TP316 + SB575 UNS N06022 Visual, Dimensional, UT & Flatness inspection. FIM 2895 x 1135 x (33+8)mm Thk. GBS 2785 x 1040 x (32+8)mm Thk. Vendor Job/Plate No: 14002-P1	Nos	1 No	1 No.	1 No (Only UT)
Reference Documents:						
Sr. No.	Document Name	Client Document Number	Vendor Document Number	Approval Status

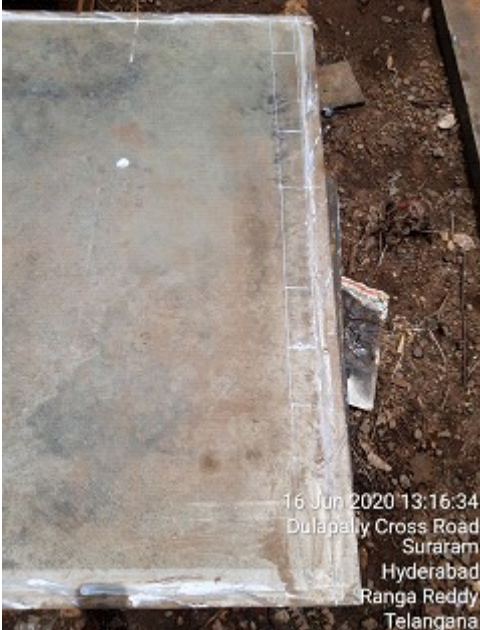
Test samples marking & identification	Test sample identification Plate No & TUV stamp

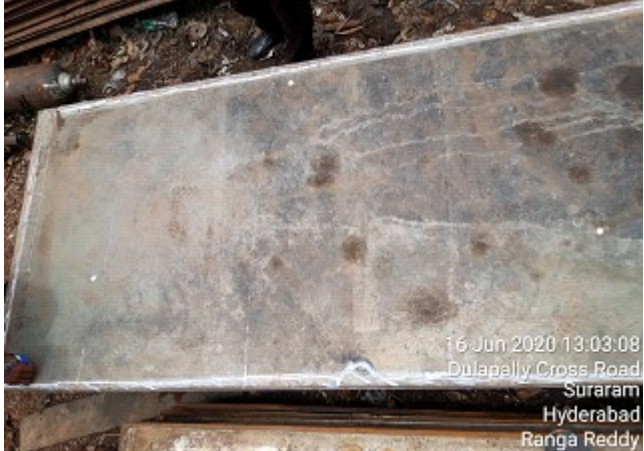
3)	ITP SL.No.4.1 - Flatness verified for above offered plate and found with in tolerance limits of 1.5mm / meter.					
4)	ITP SL.No.4.2 - Ultrasonic Testing carried out for offered clad plate on clad side as per SA578 Level B S1 and found 3 round indications whose dia are 20 mm each at different locations and found Satisfactory to Quality level Class of SA265.

Flatness	3 White spots are non bond indications size dia 20mm.

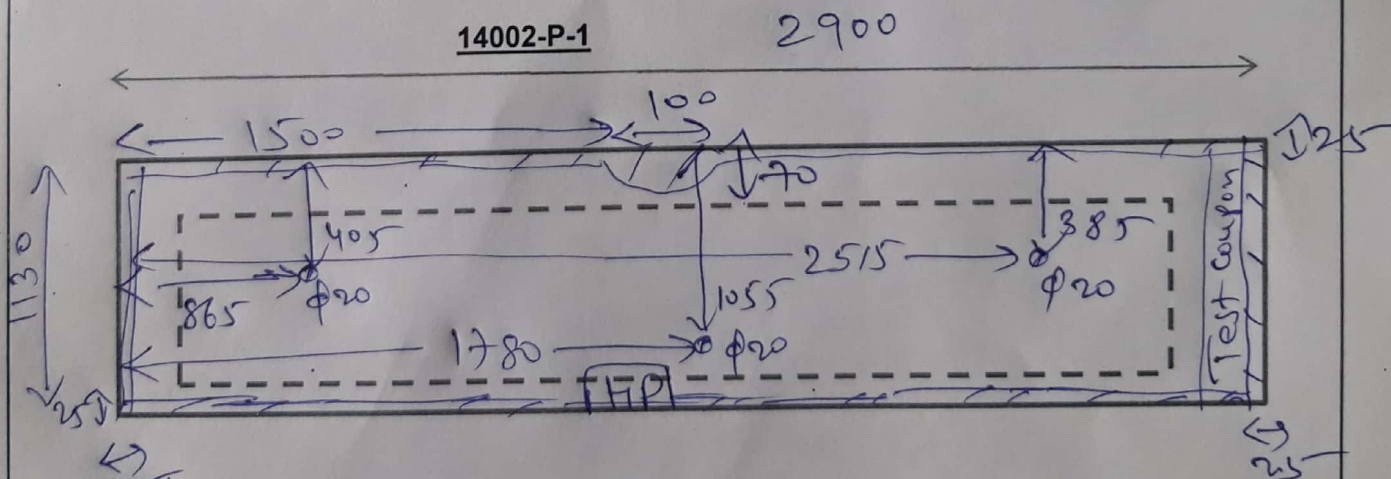
Ultrasonic test has been carried out for above stated clad plate as per SA578 Level.B S1 & Quality Level Class.1 of SA265 and found three discontinuity indications of size Ø20mm observed at clad interface as shown in below sketch and found satisfactory

HP- Clad plate identification hard punch area ,

Nonbond areas
