TUV INDIA PRIVATE LIMITED

INSPECTION VISIT REPORT

IVR-010112014920/37-1-Rev.0

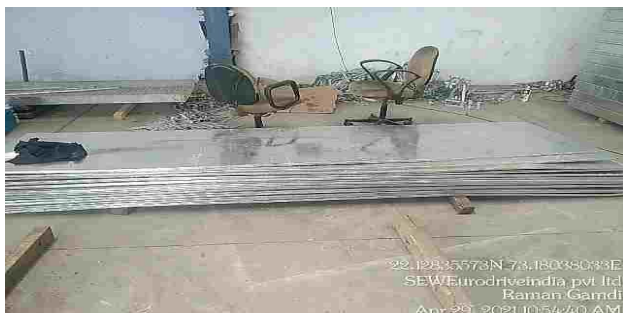
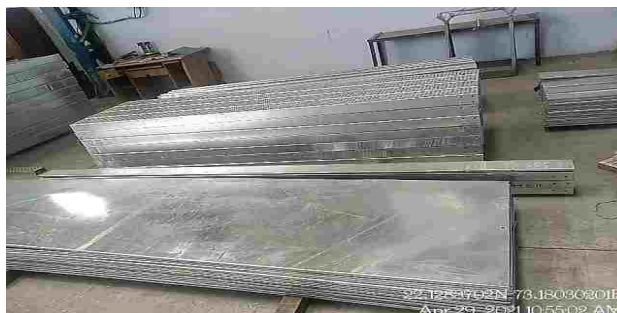
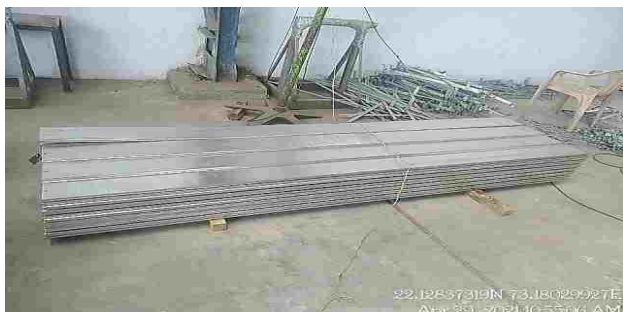
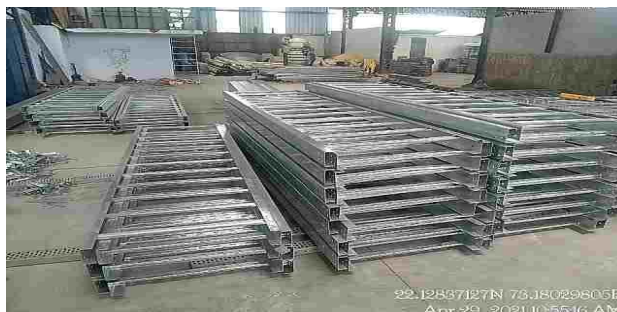
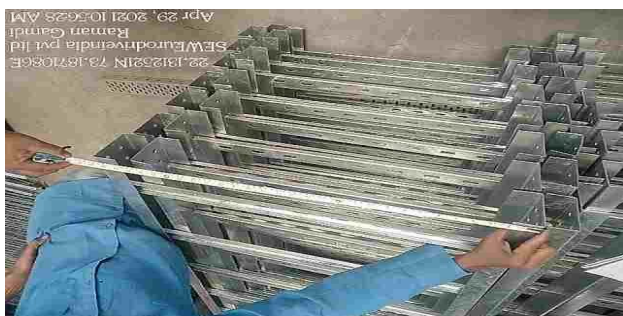
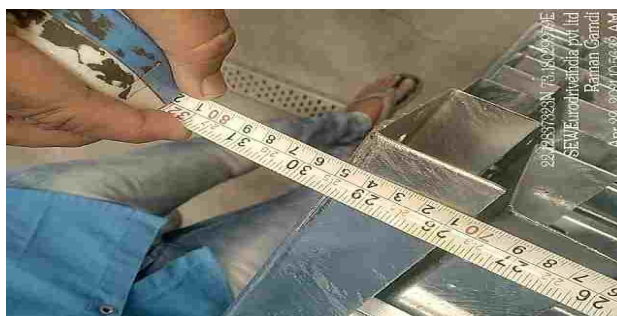
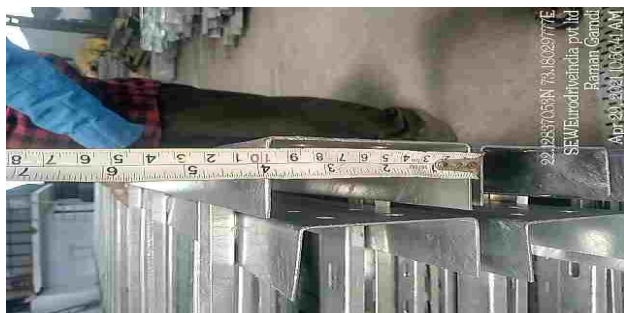
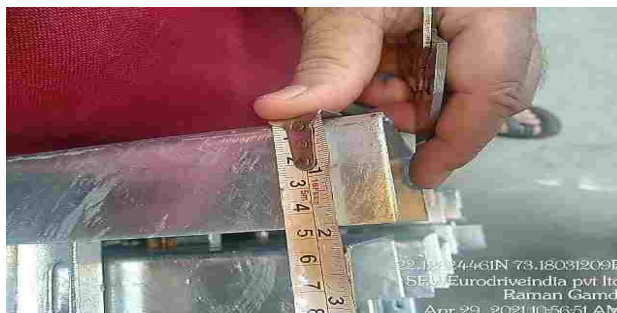
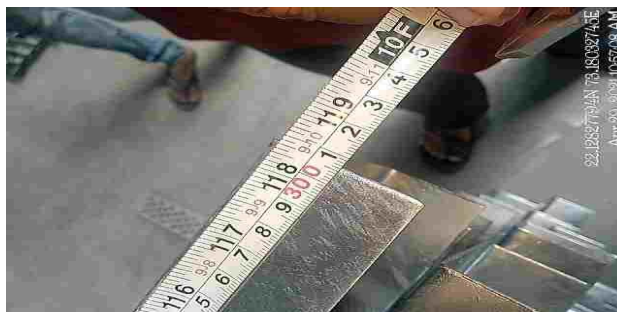
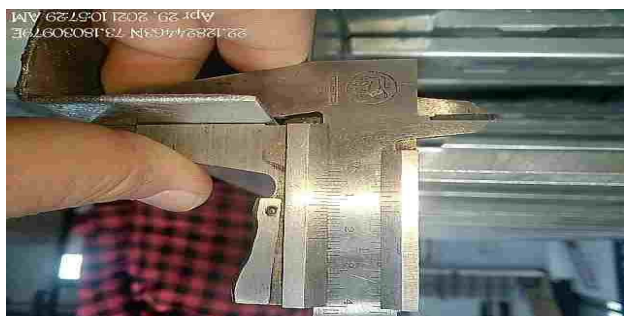
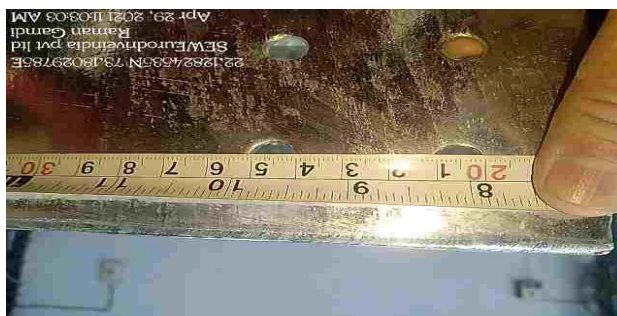
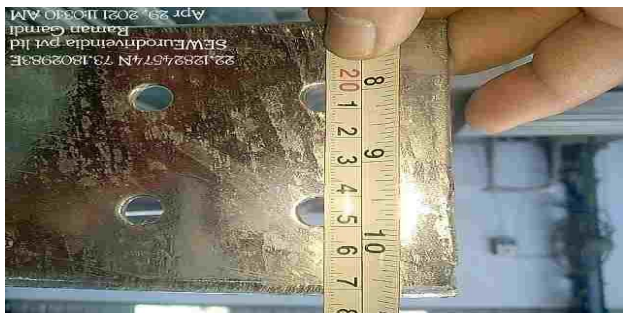
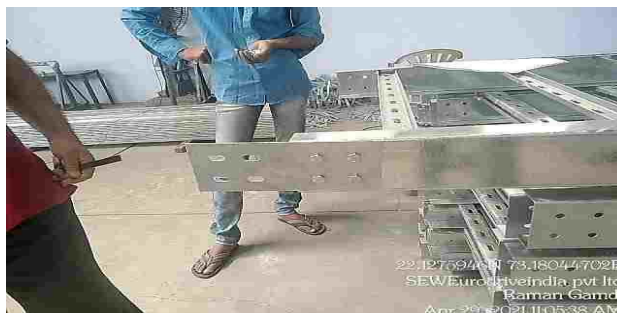
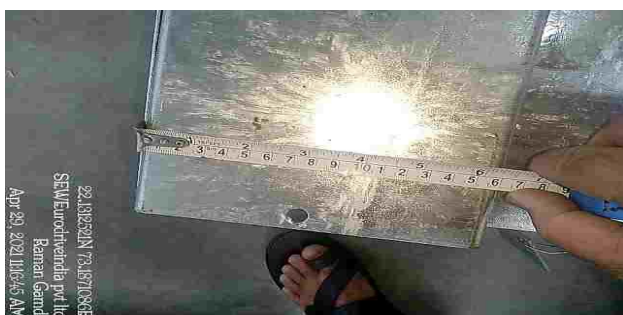
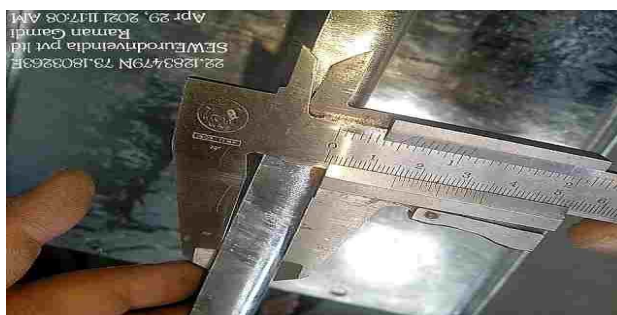
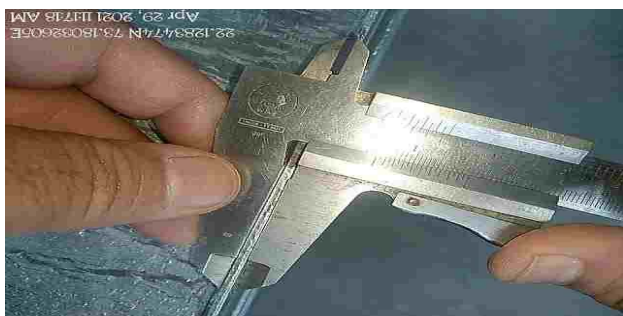
1)	ITP/QAP Sr. No. B2; Dimension inspection carried out for ladder and perforated type cable tray lot wise (one sample each from a lot of 100 Nos) - found to meet the approved drawing and applicable specification requirements

2)	ITP/QAP Sr. No.; B1 Visual inspection carried out for ladder and perforated type cable tray lot wise (one sample each from a lot of 100 Nos) - found burr in slot corner, bend portion in covers, ladder tray & perforated trays galvanizing lumps etc. observed which is need to be rectified before dispatch of material. Note that; Visual points are applicable for 100% quantity and manufacturer need to be rectify all the parts for above mentioned in points (if required).

a) Visual inspection carried out for ladder and perforated type cable tray lot wise (one sample each from a lot of 100 Nos) - found burr in slot

corner, bend portion in covers, ladder tray & perforated trays galvanizing lumps etc. observed which is need to be rectified before dispatch of material

Dimension & Visual inspection of cable tray

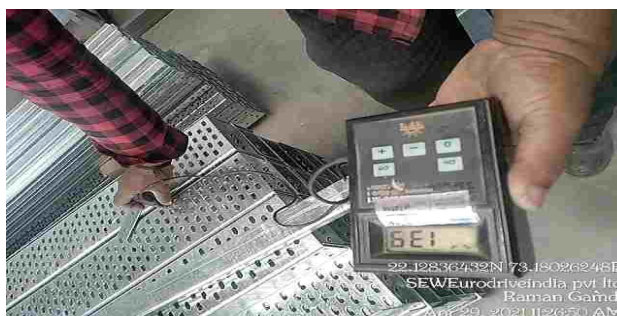
3)	ITP/QAP Sr. No. C3; DFT checked for ladder and perforated type cable tray lot wise (one sample each from a lot of 100 Nos) - Found to meet the approved drawing requirements (Ave, More than 86 Microns for all inspected parts)

DFT Measurements

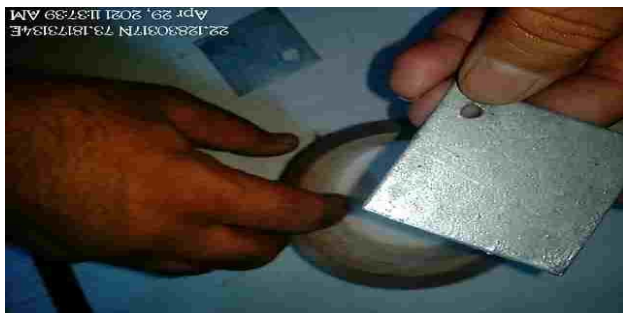
4)	ITP/QAP Sr. No.; C4; hammer test witnessed on sample (one sample from total lot) - no any flaking observed and result found as per applicable specification - acceptable

Hammer Test

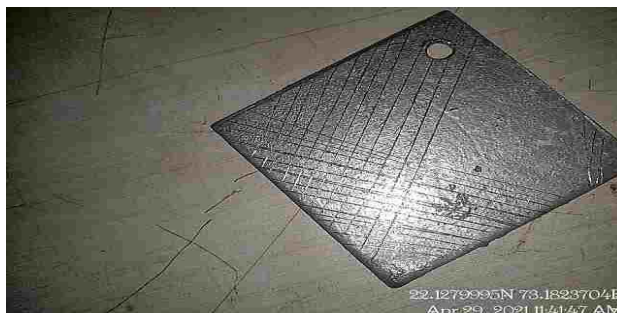
5)	ITP/QAP Sr. No. C5; Knife Test witnessed on sample (one sample from total lot) - No any flaking observed and result found as per applicable specification - acceptable

Knife test
