General:						
TUV India Control Number:(SAP Number)		050101110924/1 (8122525640)		Branch:	Pune	
Notification Number:		Email Notification		Date(s) of Inspection:	02/04/2024	
Project Name & Location:				Inspection Location:	Smash Enterprizes, Bhosari	
TUV India Client Name:		Thermo Engineering India Pvt. Ltd.		End User Name:		
DEC / PMC / EPC Name: (If applicable)		-		DEC / PMC / EPC Assignment Number: (If applicable)	-	
Vendor Name & Location:		Smash Enterprizes		P.O. Number: (Client PO on Vendor)	P14304 Dated 12/02/2024	
Sub Vendor Name & Location: (If applicable)		-		P.O. Number: (If applicable - Vendor PO on Sub Vendor)		
Stages Of Inspection:						
<input type="checkbox"/> Kick Off / Pre Inspection Meeting		<input type="checkbox"/> Material Identification		<input type="checkbox"/> Interim Stages		
<input type="checkbox"/> Document Review		<input checked="" type="checkbox"/> Final Inspection		<input type="checkbox"/> Re-Inspection

2	offered Items ENV-0616 X 30 FT QAH Air Flare Risers--12 Nos. As per QAP Stage No. 3.0- Final Inspection - (Visual Check Of Parts / Verification As per Drg. & Visual

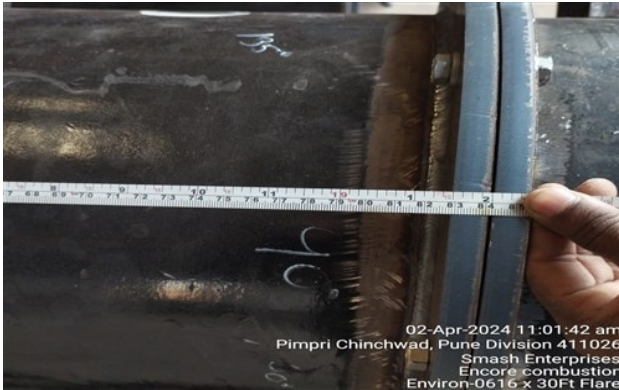
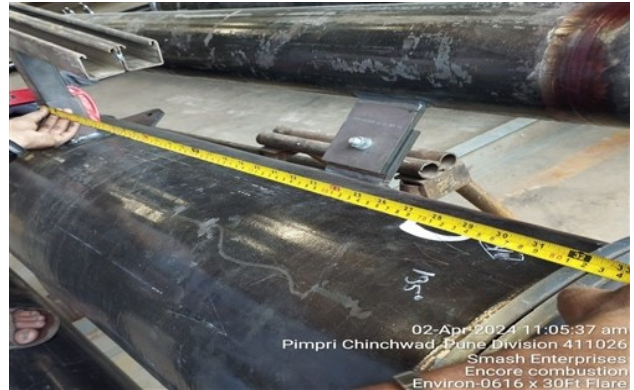
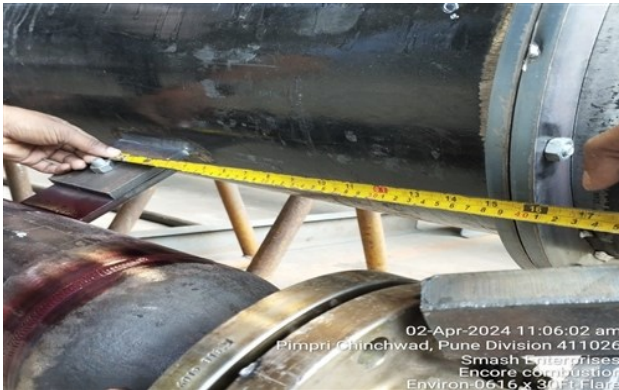
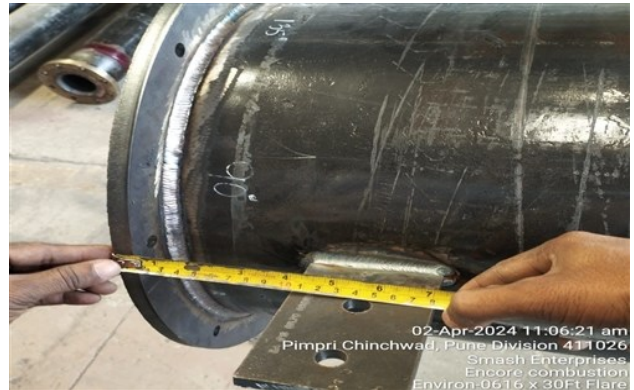
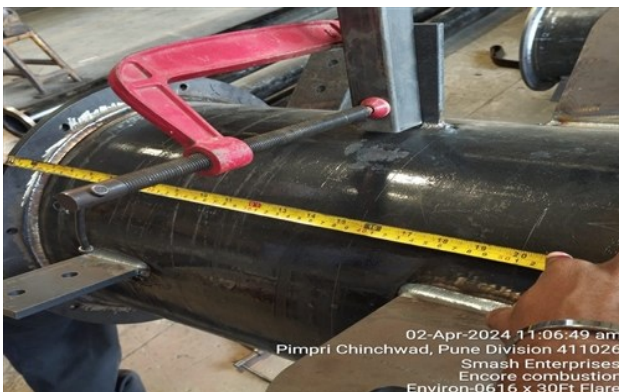
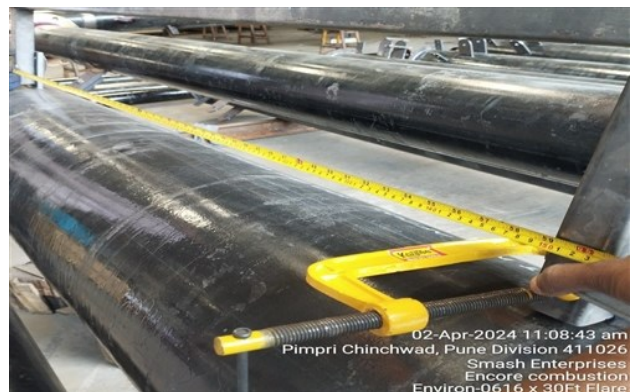
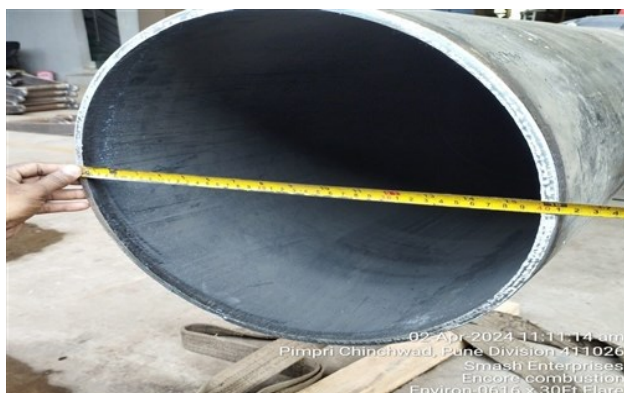
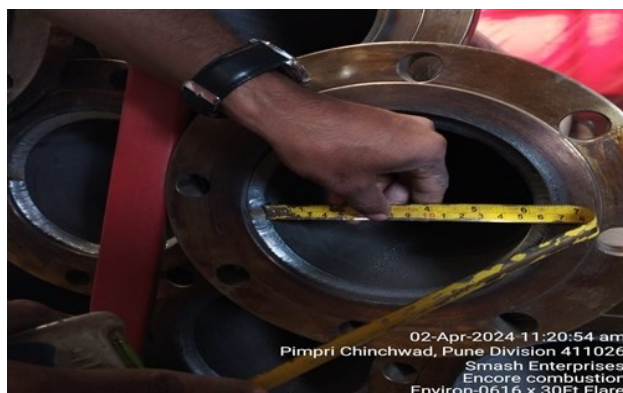
- i) Dimension inspection carried out for offered Air flare Risers checked Total length ,lifting lug orientation and elevation , flange OD, Thickness,hole size,P.C.D etc. as per drawing found within acceptable limit.
- ii) Fillet sizes & visual inspection of welds carried out found satisfactory. for detail refer vendor's inspection report.
- iii) Assembly of HP-LP and Air Flair along with track was done. Pilot was moved through the track,pilot to tip distance observed within 2" hence assembly found satisfactory.

Dimension Inspection

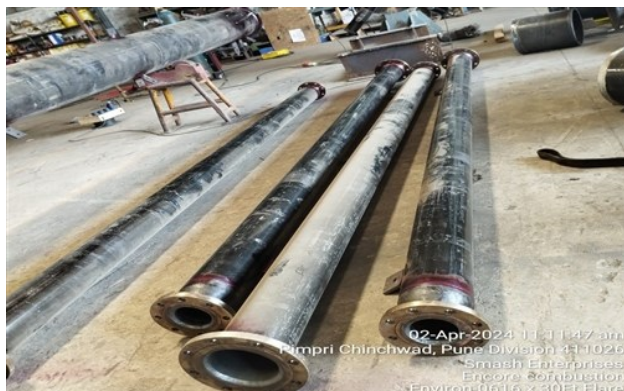
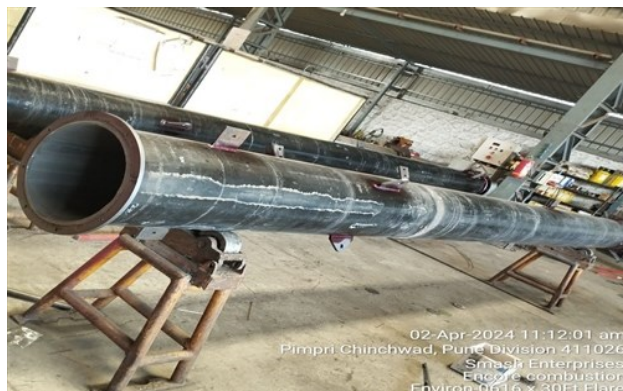
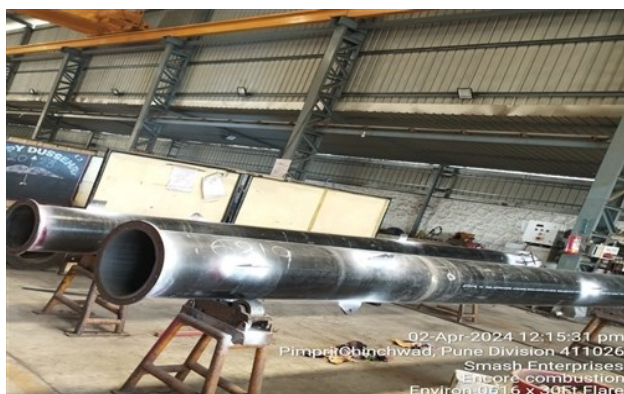
Item Description:						
PO Item No.	Item Code	Item Description / Identification / MTC Number	UOM	P.O. Quantity	Offered Quantity	Acceptable Quantity
-	-	[STD-ENV061630-FS2XX-SF01] Subcontract Fabrication-ENV0616X30 Air LP/HP Tandem Risers and Support Legs Fabrication	each	12	12	Refer Conclusion
Reference Documents:						
Sr. No.	Document Name	Client Document Number	Vendor Document Number	Approval Status		
1	PR/MR/ARM	NA	NA	NA		
2	QAP/ITP/QCP	NA	QAP/ENC/02 Rev.00	Approved by client through Mail Dated on 18.03.24		
3	Drawing(s)	NA	STD-ENV061630-FS200B Rev.00	Approved by client through Mail Dated on 18.03.24		
4	Datasheet(s)	NA	NA	NA		
5	Procedure(s)	NA	NA	NA		
6	Others(Specify)	NA	NA	NA		
Inspection Activities Carried Out:						
Stages Witnessed:						
1	offered Items ENV-0616 X 30 FT QAH Air Flare Risers--12 Nos. As per QAP Stage No. 2.0 - NDE (DP Test of accessible Weld) i) DP test random witnessed for Air flare risers & support lugs found satisfactory.

DP Test checked

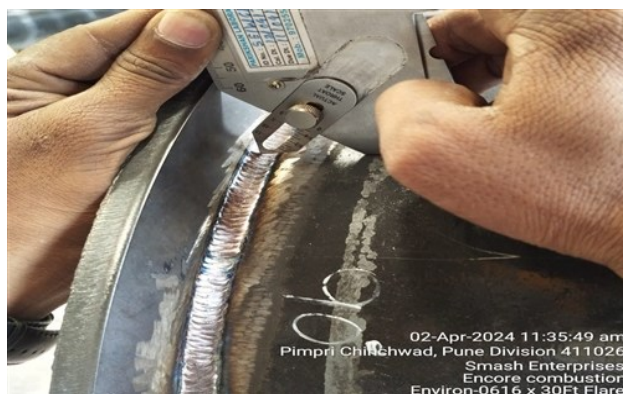
Fillet size verification
