Imaging of Anterior Cruciate Ligament Repair and Its Complications

OBJECTIVE. This article provides a review of anterior cruciate ligament (ACL) reconstruction procedures and their normal postoperative appearance. Then, we review commonly encountered complications: those associated with decreased range of motion (impingement, arthrofibrosis, intraarticular bodies, ganglion cysts) and those associated with laxity (graft tearing, graft stretching). Finally, we review some miscellaneous complications.

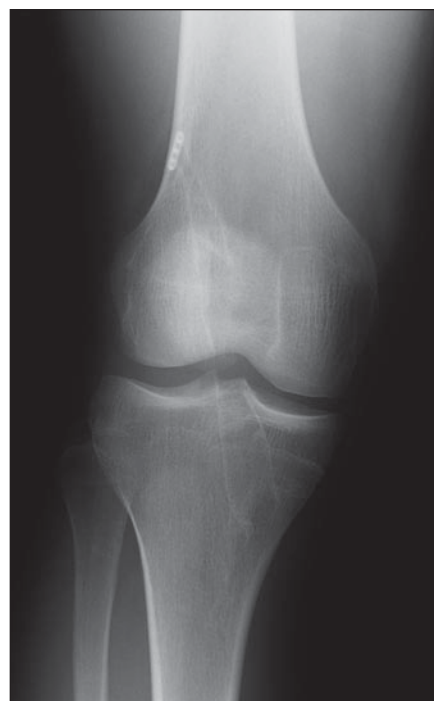
Fig. 3—Anteroposterior radiograph of 21-year-old man who presented for follow-up evaluation after reconstruction of right anterior cruciate ligament using doubled semitendinosus and gracilis tendon graft. Endobutton (Smith & Nephew) fixation device is seen at superior aspect of femoral tunnel.

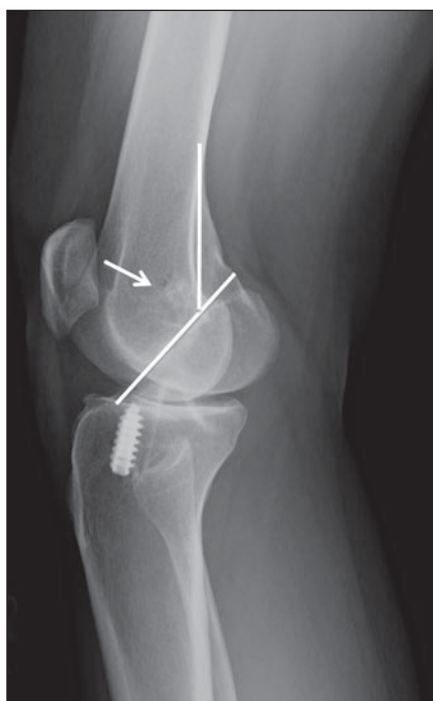
Fig. 4—Normal position of tunnel in 35-year-old man who presented for follow-up radiography after anterior cruciate ligament reconstruction.

A, Lateral radiograph shows first line drawn along posterior cortex of femur and second line along intercondylar notch. Inferior portion of femoral tunnel is located at intersection of these two lines (arrow). Opening of tibial tunnel is positioned posterior to intersection of Blumensaat line and tibia.

B, Anteroposterior radiograph shows that femoral tunnel can be seen as lucency (arrow) between 10- and 11-o'clock positions.

The positioning of the femoral tunnel is the primary factor in maintaining graft isometry [13]. Femoral tunnel positioning must be assessed in both the sagittal and coronal planes. The position of the tunnel can be assessed in the sagittal plane by drawing a line along the posterior cortex of the femur and another line along the roof of the intercondylar notch. The inferior portion of the tunnel should be located at the intersection of these two lines [12, 14] (Figs. 4A and 5A).

On an anteroposterior radiograph or a coronal MR image, the intraarticular portion of the femoral tunnel should open at the superolateral posterior margin of the intercondylar notch. If a clock face is superimposed on an anteroposterior radiograph or a coronal MR image with the center at the intercondylar notch, the tunnel should be oriented between 10- and 11-o'clock

on the right knee or between 1- and 2-o'clock on the left knee [12, 14] (Figs. 4B and 5B). We should note that the use of a clock face for evaluating tunnel positioning has significant limitations, particularly when evaluating an ACL repaired using the double-bundle technique, because the orientations of the insertion sites of the AMB and PLB change depending on the degree of flexion of the knee. This is important because imaging is performed with the knee extended, whereas surgery is performed with the knee in flexion. Therefore, if a clock face is used to describe the orientation of the femoral tunnel, the degree of flexion of the knee should be noted [15].

The positioning of the tibial tunnel is the primary factor in preventing impingement of the graft against the roof of the intercondylar notch [16]. On sagittal images, the tibial tunnel should be oriented parallel to the Blumensaat line. The Blumensaat line is a line drawn on conventional radiographs along the intercondylar roof. The distal portion of the tunnel should start near the tibial tuberosity, and the intraarticular opening of the tunnel should be completely posterior to where the Blumensaat line, or the Blumensaat line equivalent on MRI, intersects the tibia [12, 14] (Figs. 4A and 5C).

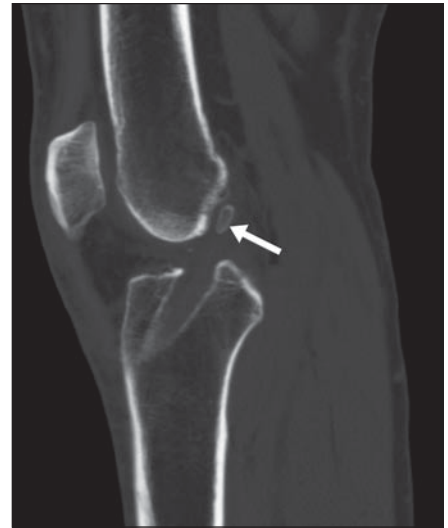
Fig. 14—Displaced femoral bone plug in 40-year-old man who presented with laxity after anterior cruciate ligament reconstruction.

A and B, Sagittal T1-weighted image (**A**) and sagittally reconstructed image from unenhanced CT scan (**B**) show femoral bone plug (*arrow*) has become inferiorly displaced and is within intracondylar notch.

Fixation site—Failure of fixation hardware can occur at several places. Bone plug fractures, bone plug dislocations, bone reabsorption around bone plugs, interference screw fractures, and interference screw migration have all been reported [14, 17–19] (Figs. 13–15). Fractures can also occur in the femur or tibia during graft placement [6].

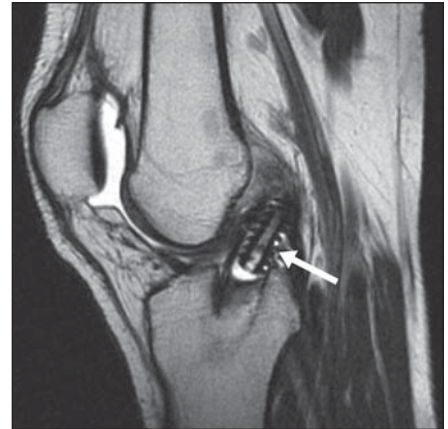
Fig. 15—Sagittal T1-weighted MR arthrogram in 24-year-old man who presented for follow-up imaging after anterior cruciate ligament reconstruction shows that interference screw (*arrow*) anchoring tibial portion of graft has migrated superiorly out of tibial tunnel.
