Helene Pavlov, M.D.
Joseph S. Torg, M.D.
Robert H. Freiburger, M.D.

Tarsal Navicular Stress Fractures: Radiographic Evaluation¹

Radiology 148: 641-645, September 1983

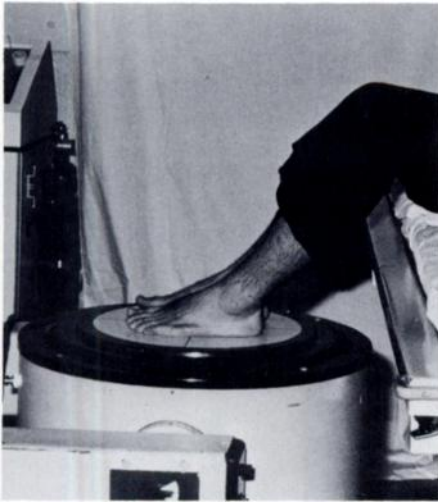
Figure 1

Plantar views are obtained with the soles of the patient's feet positioned on the face of the gamma camera. The patient leans posteriorly so that the isotope uptake from the body pool does not contribute to the uptake in the feet.

Radionuclide bone scanning was performed 1½ hours following the injection of 15 mCi (555 MBq) Tc-99m MDP (Osteolite technetium Tc-99m medronate sodium) and using an all-purpose collimator (5-7). Scans were obtained in 14 patients (16 feet) and included the standard frontal, medial, and/or lateral views and, in 10 of these feet, plantar views. Plantar views were obtained with the soles of both feet on the face of the gamma camera (Fig. 1).

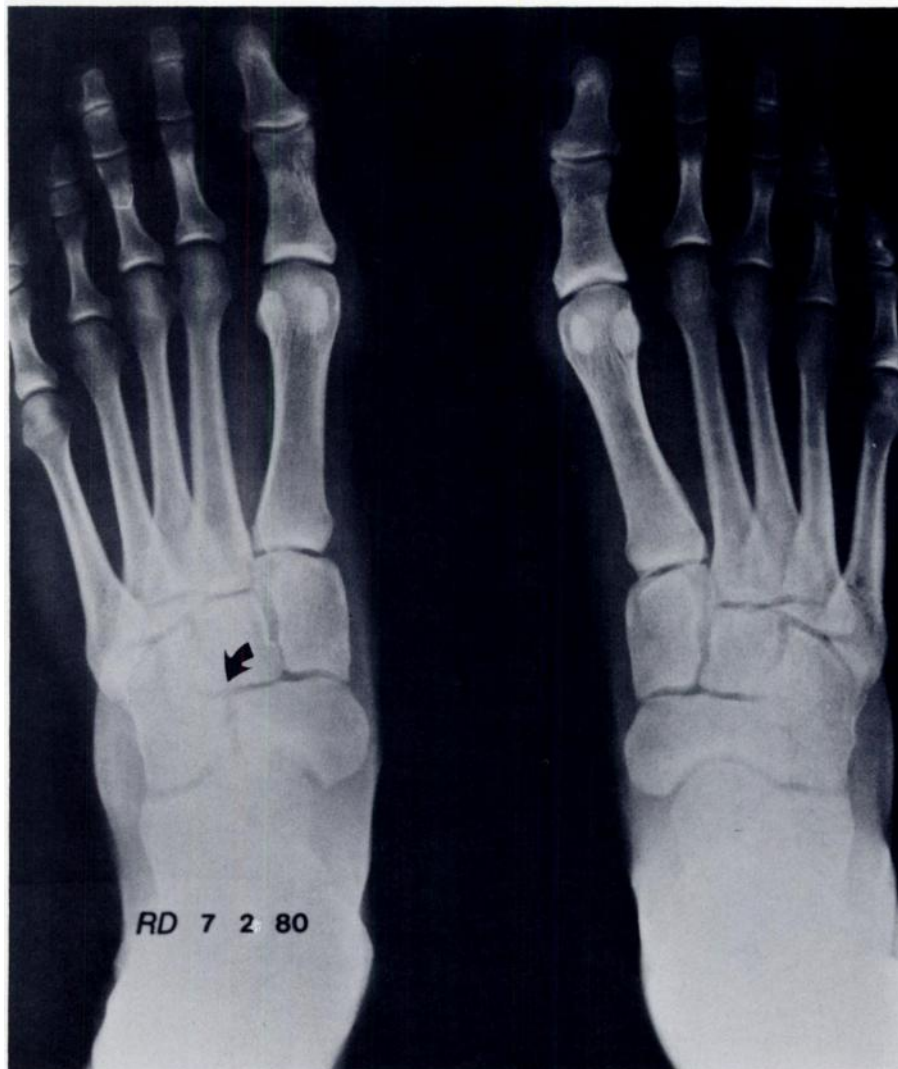
Figure 4

AP views of both feet demonstrate a complete vertical fracture in the left tarsal navicular (arrow). The fracture is linear and in the sagittal plane. The lateral fracture fragment must not be misinterpreted as a separate tarsal bone. Note that the area is underpenetrated, which is not unusual on the standard AP radiograph.

Only five fractures had been diagnosed based on the radiographs that the patients brought with them. Retrospectively, the fracture could be diagnosed on the routine AP radiographs in 9 of the 23 symptomatic feet (Fig. 4). In the remaining 14 feet, the tarsal navicular appeared intact even on collimated and direct magnification views. The fracture was never evident on the oblique or lateral views.

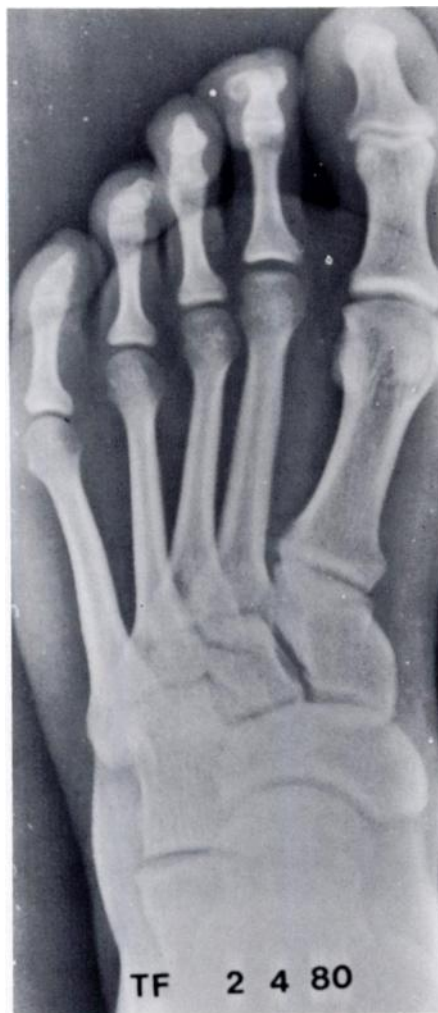
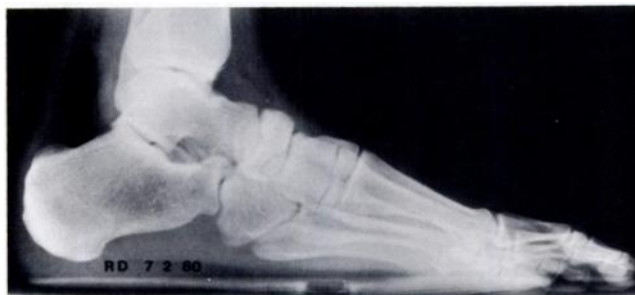
Figure 5

- a. AP view of the foot exhibiting the following foot characteristics: metatarsal adductus of the first three rays, a short first metatarsal with respect to the remaining metatarsals, and thickening of the medial cortex of the second metatarsal.
- b. Lateral view of the foot obtained with the patient standing. The dorsal surfaces of the talus and the navicular are malaligned with those of the cuneiforms and the metatarsals; the cuneiforms and metatarsals are displaced plantarward. In this patient the navicular is completely dense, although more commonly the sclerosis is confined to the proximal articular surface.

Multiple minor foot abnormalities observed on the routine radiographs are detailed in TABLE I. To summarize, on the AP view, the major findings were sclerosis of the proximal articular border of the tarsal navicular, a short first metatarsal, metatarsus adductus of the first through fourth rays, and hyperostosis or stress fractures of the second, third, and/or fourth metatarsals (Fig. 5a). On the lateral view, especially in the standing position, there is a tarsal malalignment with the talus and navicular dorsal to the cuneiforms (Fig. 5b). Proliferative changes on the dorsum of the talus and

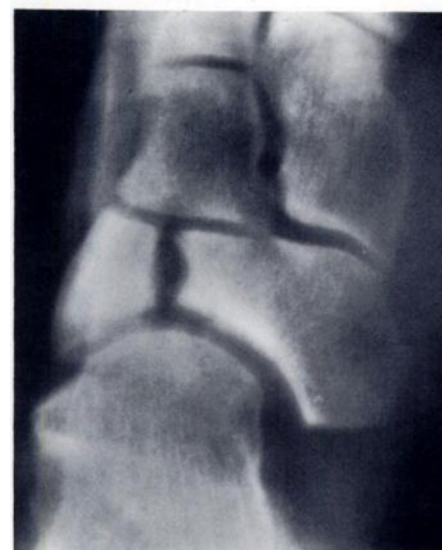
Figure 8

An anatomic AP tomogram demonstrating a complete fracture in which the medial fracture fragment is displaced medially. The lateral fragment is dense, indicating avascular necrosis; there is fracture nonunion. (Figure courtesy of the Journal of Bone and Joint Surgery.)

placed fractures (Fig. 8). Three of the fractures, one partial and two complete, were associated with a separate transverse fracture fragment paralleling the proximal articular border.
