DAMAGE CHART (DENT & BUCKLE)

Learjet 60

Aircraft registration: FAC-1216

Aircraft Serial number: 317

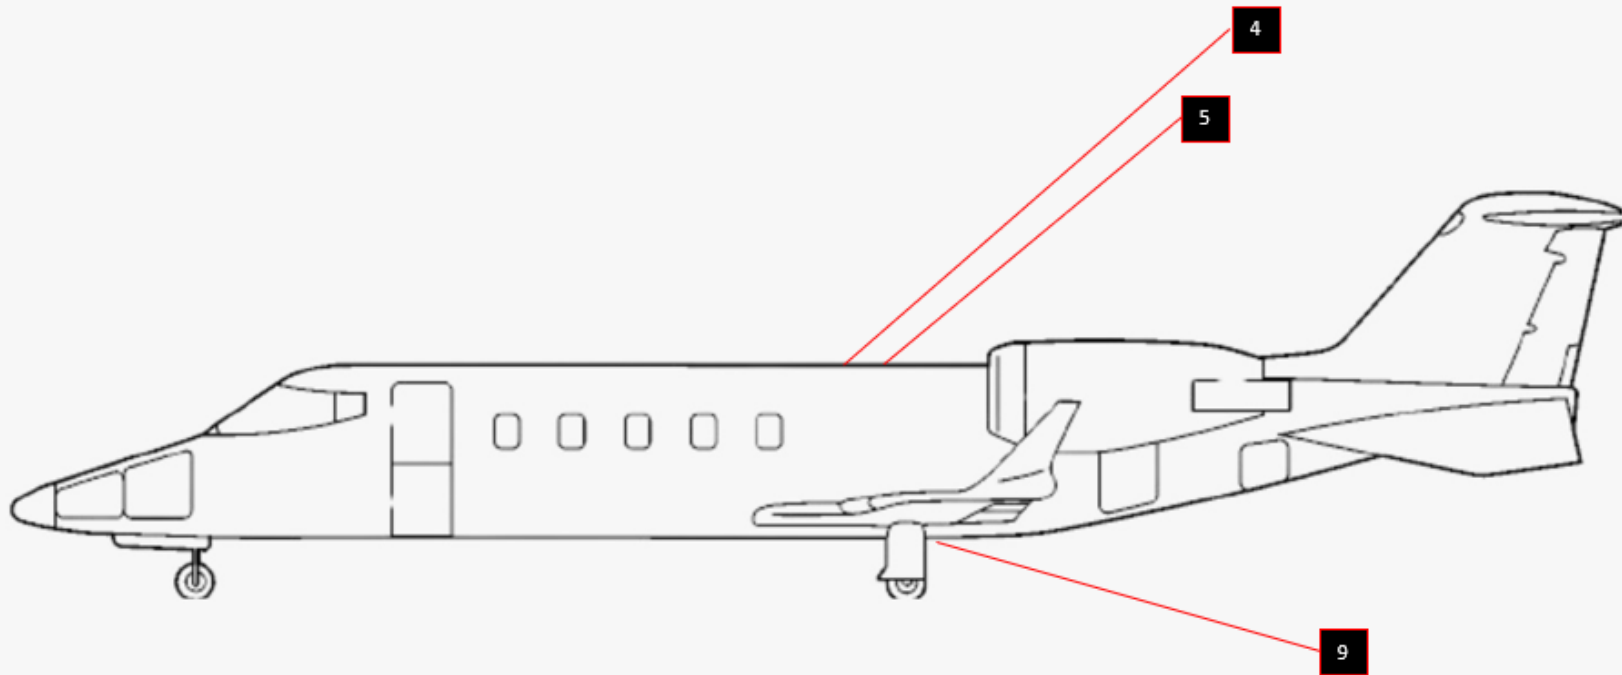
Left View.

ITEM	TYPE OF DAMAGE	DESCRIPTION	LOCATION			DIMENSIONS	REFERENCE	LIMITATIONS	ACCOMPLISHMENT DATA	STATUS	NEXT DUE
			FRAME	STRINGER	OTHER						
1	DENT	Dent in Flap upper area	Flap ST (86,50-95,30)	Spar 9R	Flap	L=9,3 H=9,3 D= 0,9 DR=90	SRM 57-50-00	N/A	N/A	CLOSED	N/A
2	DENT	Dent in Flap lower area	Flap ST R (104,2)	Spar (9-10) R	Flap	L=8,1 H=7,0 D= 0,57 DR=72	SRM 57-50-00	N/A	N/A	CLOSED	N/A
3	OTHER	Missing rivet in low wing area	WS 53,040	Spar 8-7R	Wing	N/A	N/A	N/A	N/A	Operator controlled	N/A
4	DENT	Upper fuselage dent in oxygen duct	FR (25-27)	STR 1R-1L	Center Fuselage	L=6,8 H=4,6 D=0,37 DR=65	SRM 53-23-00	N/A	N/A	CLOSED	N/A
5	DENT	Upper fuselage dent in oxygen duct	FR (25-27)	STR 1R-1L	Center Fuselage	L=10,4 H=6,4 D=0,69 DR=58	SRM 53-23-00	N/A	N/A	CLOSED	N/A
6	DENT	Upper fuselage dent in oxygen duct	FR (33-34)	STR 1R-1L	Center Fuselage	L=16,4 H=11,8 D=0,97 DR=30	SRM 53-23-00	N/A	N/A	CLOSED	N/A
7	DENT	Upper fuselage dent in oxygen duct	FR (33-34)	STR 1R-1L	Center Fuselage	L=7,6 H=5 D=0,23 DR=26	SRM 53-23-00	N/A	N/A	CLOSED	N/A

8	DENT	Upper fuselage dent in oxygen duct	FR (33-34)	STR 1R-1L	Center Fuselage	L= 8,9 H=7,6 D=0,47 DR=16	SRM 53-23-00	N/A	N/A	CLOSED	N/A
9	DENT	Dent in the lower fuselage area	FR (28-27)	STR 22L	Center Fuselage	L=6,4 H=5,2 D=0,8	SRM 53-23-00	N/A	N/A	CLOSED	N/A
10	DENT	Dent in Upper Flap zone	Flap ST 77,70L	Spar 9L	Flap	L=8,9 H=7,8 D=0,33 DR=16,2	SRM 57-50-00	N/A	N/A	CLOSED	N/A
11	DENT	Dent in Bottom area of the flap	Flap ST (42,15-31,35)L	Spar 9L	Flap	L=10,3 H= 8,4 D=0,77 DR=11,4	SRM 57-50-00	N/A	N/A	Operator controlled	N/A
