Complex Valve-in-Valve TAVI in High-Risk Coronary Anatomy

Chimney Stenting Technique Long-Term Outcomes

RODRIGUEZ Andres MD; PAOLANTONIO Franco, MD; PIRE Lelio, MD;
MENENDEZ Marcelo MD; PAOLANTONIO Daniel, MD

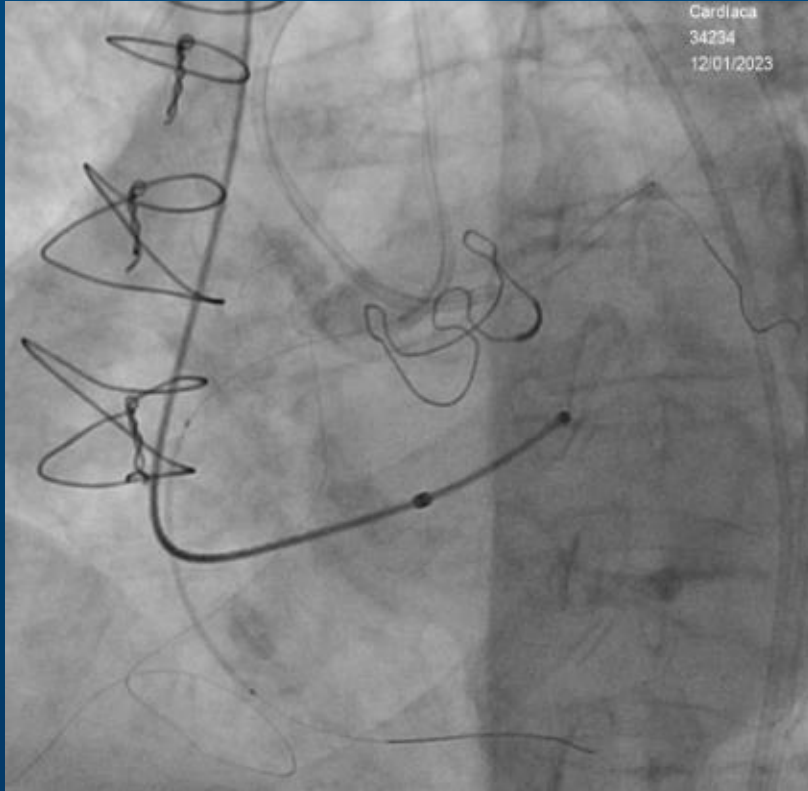
- ViV-TAVI under conscious sedation
- A temporary pacemaker was placed in the right ventricle through jugular access.
- Right radial access for pigtail placement in non-coronary sinus, for angiographic control.
- Guide catheters were positioned in right and left coronary arteries, via the left femoral and left radial access.
- Preventive positioning of guidewires and stents in both, LM and RCA, for coronary protection.
