# WOOD DESTROYING PESTS AND ORGANISM INSPECTION REPORT

Building No. <b>16513</b>	Street <b>Bonnie Lane</b>	City <b>Los Gatos</b>	ZIP <b>95032</b>	Date of Inspection <b>5/3/2024</b>	Number of Pages <b>Page 1 of 9</b>
<div style="display: flex; align-items: center;"> <div> <b>510 Madera Avenue</b>  <b>San Jose, CA 95112</b>  <b>(855) 331-1900 • Fax (925) 294-1818</b> </div> </div>					
Registration #: <b>PR1452</b>		HomeGuard #: <b>635652</b>		Escrow #:	
Ordered By: <b>Shannon Susick</b> <b>Coldwell Banker Real Estate</b> <b>410 N. Santa Cruz Avenue</b> <b>Los Gatos, CA 95030</b>		Property Owner/Party in Interest: <b>Ginny Lamb</b> <b>16513 Bonnie Lane</b> <b>Los Gatos, CA 95032</b>		Report Sent to:	
COMPLETE REPORT <input type="checkbox"/> LIMITED REPORT <input checked="" type="checkbox"/> SUPPLEMENTAL REPORT <input type="checkbox"/> REINSPECTION REPORT <input type="checkbox"/>					
General Description: <b>This is a one story single family dwelling with wood and stucco exterior, excluding the attached deck.</b>				Inspection Tag Posted: <b>Garage</b>

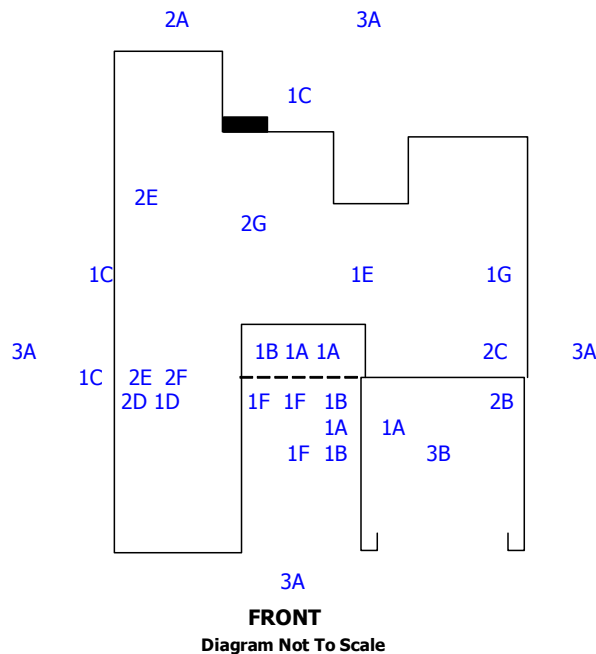
**1A.** FINDING: The roof sheathing has been damaged by fungus and/or drywood termites where indicated on the diagram. Refer to item(s) 1E for recommendations to control contributing moisture source and or infestation. (See Photo 4) (See Photo 5) (See Photo 6)

**1B.** FINDING: The rafter tail(s) as indicated on the diagram are damaged by fungus and/or drywood termites. Refer to item(s) 1E for recommendations to control contributing moisture source and or infestation. (See Photo 4) (See Photo 5) (See Photo 7)

**1C.** FINDING: The window trims have been damaged by fungus at the left and rear exterior as indicated on the diagram. The contributing moisture source appears to be exposure to the weather. (See Photo 8) (See Photo 9) (See Photo 10)

**2A.** FINDING: Minor stress cracks were noted in the exterior stucco as indicated on the diagram.

**2B.** FINDING: Water stains are evident at the garage as indicated on the diagram. This could indicate leakage through the roof covering.

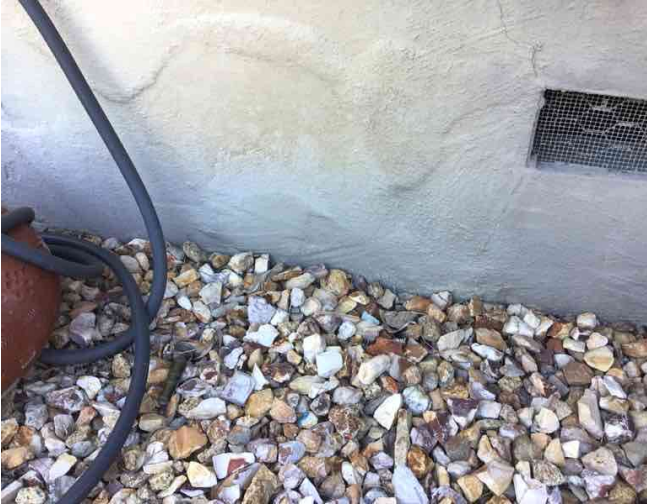
*Photo 01*

**3A.** FINDING: This home was constructed without the use of a weep screed at the base of the stucco. Although this was an accepted construction method it does create an area that can allow subterranean termites to access the home without being detected. This area can also allow condensation to build up and not drain properly. (See [Photo 1](#))

RECOMMENDATION: If further information is desired it will be necessary to install a series of test holes *Estimated Cost* to allow for further inspection. All findings, recommendations and bids will be issued in a supplemental report. If no additional damage is noted, the test holes in the stucco will be patched back up. We will attempt to match the texture as close as possible, however the texture may differ from the existing.

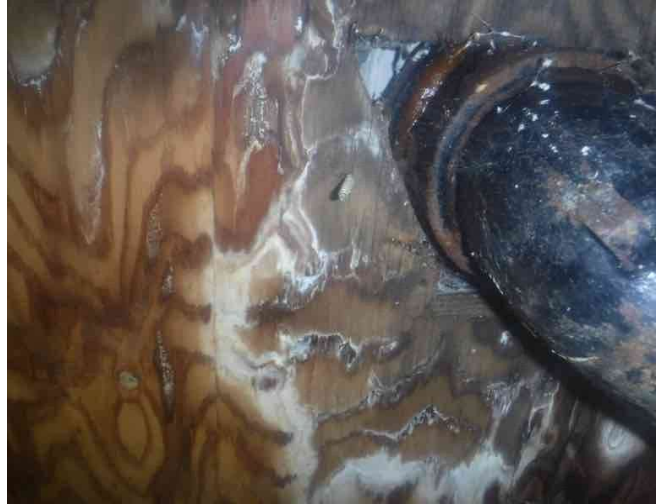
*Photo 03*

**1D.** FINDING: There is a surface fungus condition located at the subarea beneath the hall bathroom. The contributing moisture source appears to be a previous leak. (See Photo 3)

RECOMMENDATION: Scrape or wire brush this area and treat with a registered fungicide Timbor *Estimated Cost* (Disodium Octaborate Tetrahydrate). NOTE: In order to perform this treatment the property must be vacated for the treatment and three hours after the treatment has been completed.  
\*\*\*\*\* (SECTION 1 ITEM) \*\*\*\*\*

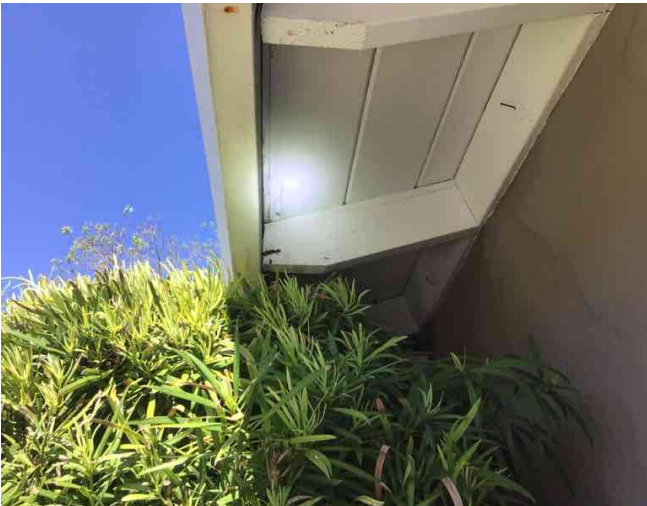
*Photo 04*

**1E.** FINDING: Infestation by Drywood Termites was noted at the exterior, interior garage. (See Photo 4) (See Photo 7) (See Photo 12)

RECOMMENDATION: Remove and replace the damaged sheathing to correct this condition. This bid *Estimated Cost* does not include replacement of the roof covering. After our repairs have been performed, the owner is advised to contact a licensed roofing contractor.  
\*\*\*\*\* (SECTION 1 ITEM) \*\*\*\*\*

RECOMMENDATION: Remove and replace the end of the damaged rafter tail(s) and install a new sister *Estimated Cost* section alongside for support.  
\*\*\*\*\* (SECTION 1 ITEM) \*\*\*\*\*

RECOMMENDATION: Due to the nature of these infestations, it will be necessary to seal the entire structure and fumigate it with Vikane (sulfuryl fluoride), using Chloropicrin as a warning agent. The entire structure must be vacant for this process. It is the owners responsibility to make any preparations required by the fumigators or to have someone to do so at a separate expense and to have the gas turned back on when the fumigation is complete. "NOTICE: The charge for service that this company subcontracts to another registered company may include the company's charges for arranging and administering such services that are in addition to the direct costs associated with paying the subcontractor. You may accept HomeGuard Incorporated's bid or you may contract directly with another registered company licensed to perform the work. If you choose to contract directly with another registered company, HomeGuard Incorporated will not in any way be responsible for any act or omission in the performance of work that you directly contract with another to perform." HomeGuard Incorporated guarantees all fumigations for a period of three years from the date of completion.

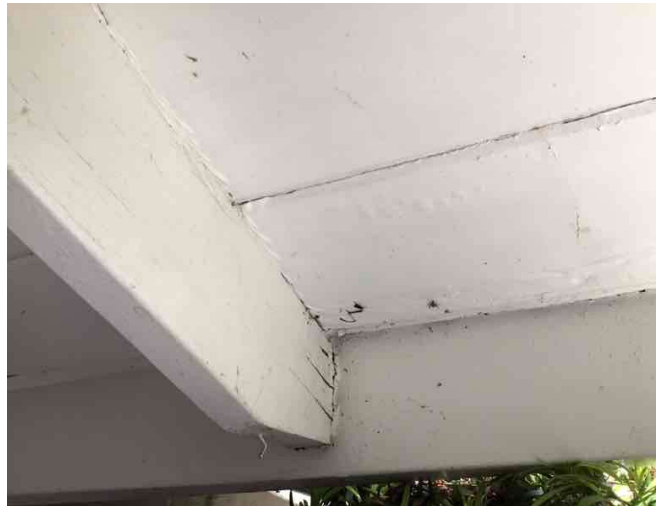
*Photo 05*

**1F.** FINDING: Drywood termite pellets were evident as noted in the above recommendation. (See Photo 5) (See Photo 7) (See Photo 12)

RECOMMENDATION: Remove and/or mask over all accessible termite pellets. It is possible for the drywood termite pellets to sift down or reappear in these areas where they have been masked over.

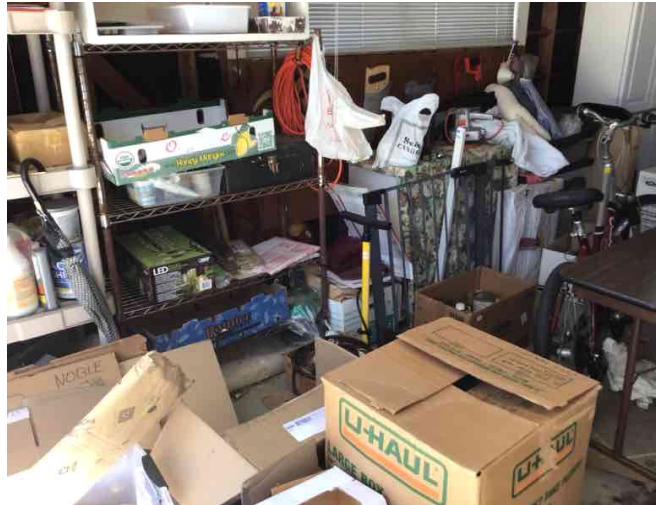
Photo 11

**3B.** FINDING: We were unable to inspect the interior of the garage due to stored personal property. (See [Photo 11](#))

RECOMMENDATION: The owner should move the storage away from the garage walls to allow for *Estimated Cost* further inspection. All findings, recommendations, and bids will be issued in a supplemental report.

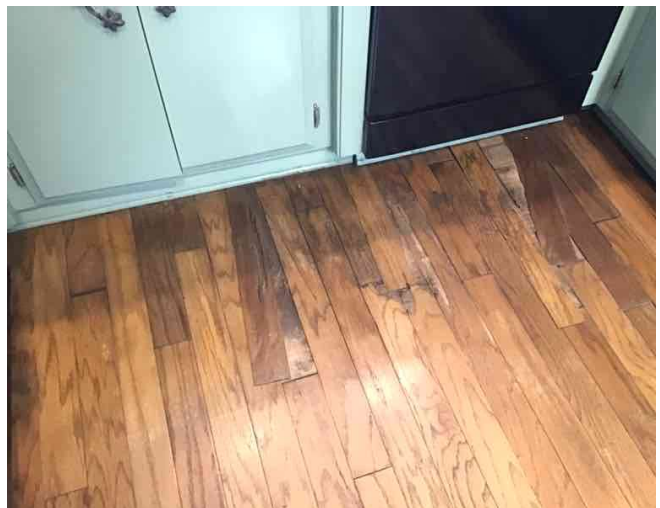
Photo 13

**1G.** FINDING: The hardwood flooring at the kitchen has been damaged by fungus. (See Photo 13)

RECOMMENDATION: Remove and replace the damaged hardwood flooring. Our bid does not include refinishing of the hardwood floor.
