Experimental Data Sharing for Structural Health Monitoring and Control

ASCE EMI Technical Committee on Structural Health
Monitoring and Control

July 15, 2024

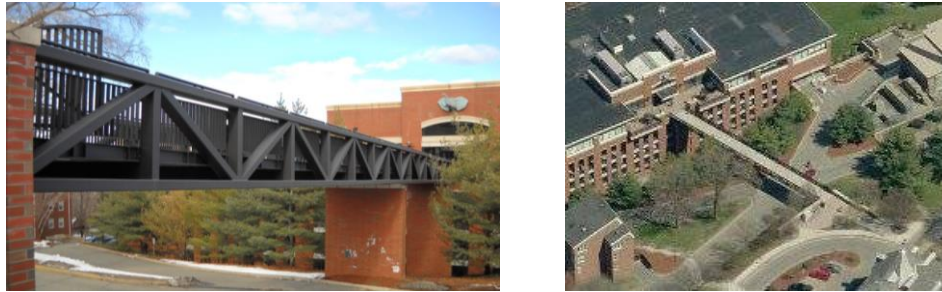
The Dowling Hall footbridge is a continuous two-span (22 m long for each span) steel frame bridge with a concrete deck (3.9 m wide) located at Tufts University campus, as shown below:

Figure 1. Dowling Hall Footbridge (photo on the right from www.maps.bing.com)

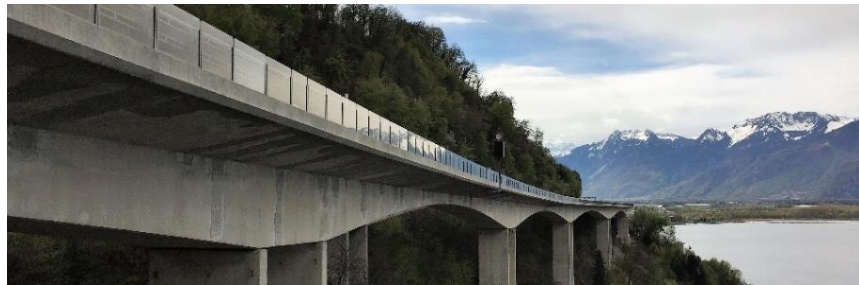
Test Structure. Constructed in 1969, the Chillon viaducts were strengthened in 2015 via a layer of Ultra High Performance Fiber Reinforced Cement-based Composite (UHPFRC) cast atop their decks. In order to assess the efficacy of this rehabilitation solution, and further evaluate its long-term performance, a Structural Health Monitoring (SHM) campaign was implemented by ETH Zurich. Three months of monitoring data have been shared with the community, with more to follow, allowing to study the influence of Operational and Environmental Conditions on the modal parameters and to further infer Performance Indicators (PIs) for assessing structural behavior [1].

Data Description A span of 98 m, in the central portion of the viaduct, has been instrumented with 11 accelerometers distributed along the span, as well as four strain gauges and environmental sensors (measuring temperature and humidity) installed at mid-span. The strain gauges were located directly on the rebar, aiming to capture fatigue effects in both the longitudinal and transverse direction.

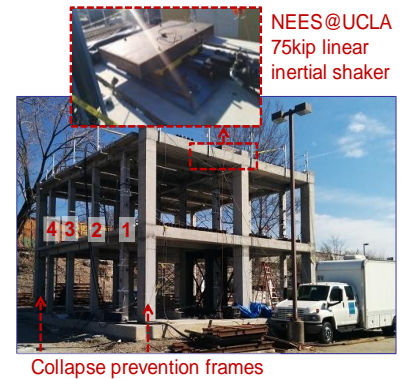
Test Structure Four identical concrete test frames were built at full scale outside the Structural Engineering and Materials Laboratory on Georgia Tech campus (Fig. 1). The frames are individually separate from each, with a gap between every two neighboring frames. Each frame consists of two bays and two stories and was meant to be representative of non-ductile reinforced concrete office buildings in the central and eastern United States built in the 1950s-1970s[1]. Frame #1 is an as-built bare frame as the reference structure, while different seismic retrofit measures are applied to the other three frames for comparison. This data sharing is for testing results from Frame #1.

Fig. 1. Full-scale frames and the 75-kip shaker on Frame #1 under test

Instrumentation and Test Procedures A 75-kip hydraulic linear inertial shaker provided by NEES@UCLA is mounted on the second elevated slab, i.e. roof top. Tens of shaker excitations were applied, with gradually increasing amplitude and causing damage to the concrete frame. The frame is first installed with 42 Kinometrics cabled accelerometers on columns and girders to capture the acceleration responses (Fig. 2a). Most of the cabled measurements are uniaxial, while a few are bi-axial or tri-axial; they provide a total number of 60 acceleration channels. To increase spatial resolution of the instrumentation, a total of 66 wireless accelerometers are interspersed between cabled accelerometers (Fig. 2b).

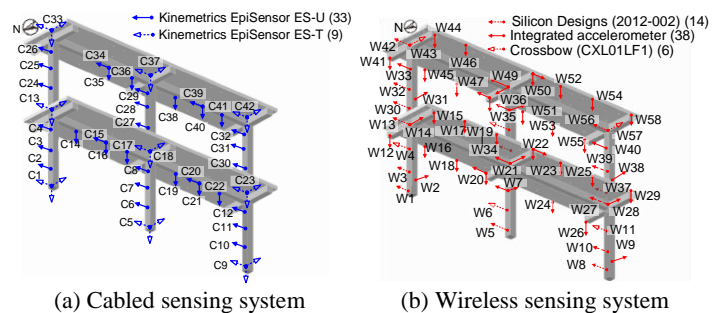
Fig. 2. Accelerometer instrumentation on Frame #1

Data Description There are a total of 126 acceleration channels installed on the structure, including both cabled and wireless channels [2]. Through the course of a few days, 61 sets of dynamic data sets are recorded. In addition, the cabled sensors recorded ambient vibration response of the structure, including vibrations of the mat foundation.

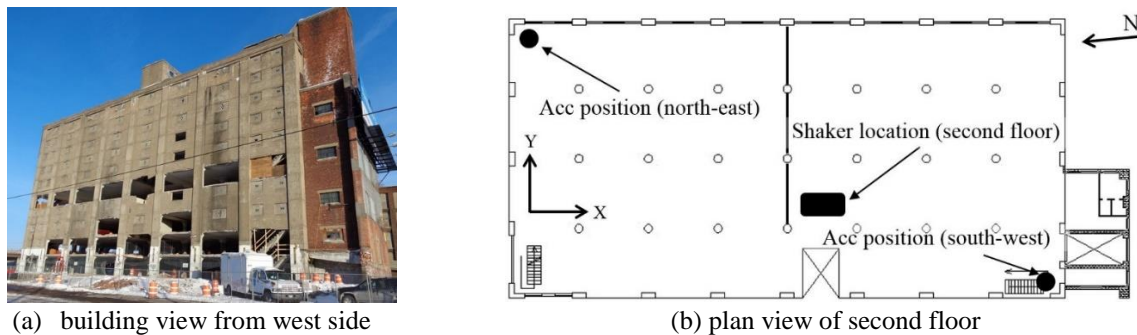
Test Structure Dynamic tests were performed on the ten-story warehouse building shown in Figure 1 to obtain its dynamic properties and their changes due to the damage introduced during the tests. The structure had a slab-column structural system and concrete infill walls in the exterior bays. In plan, the building was 24.4 m by 48.8 m (80 ft. by 160 ft.). A typical floor had the plan view shown in Figure 1 and a story height of 2.6 m (102 in.). More information about the test structure and the tests can be found in [1 and 2].

Fig. 1. Test structure and test setup.

Instrumentation and Test Procedures The test structure was instrumented with an array of 60 accelerometers installed at two opposite corners of each floor slab except for the roof, as shown in Figure 1b. An eccentric mass shaker was installed on the second story slab to introduce harmonic excitations along the two horizontal axes of the building, and at a 45-degree angle between those.

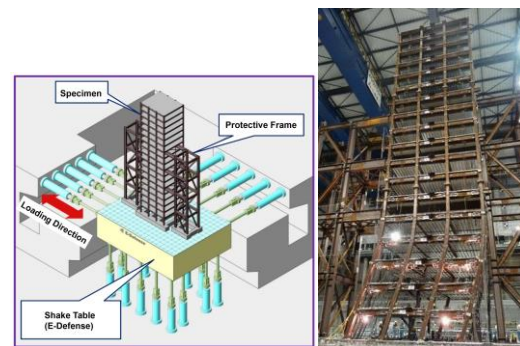
Test Structure(s) A one-third scale specimen of 18-storey steel hi-rise and a protective frame were rationally constructed and installed properly on the E-Defense shake table. The specimen represents the behavior of a typical steel high-rise and responds to earthquake as a steel moment-resisting-frame. The specimen is based on a steel high-rise constructed in 1980s to 90s where the column-to-beam strength ratio of 1.5 is provided to achieve a weak-beam strong-column mechanism. No inherent deficiencies are intentionally given.

Fig. 1 18-story specimen at the E-Defense

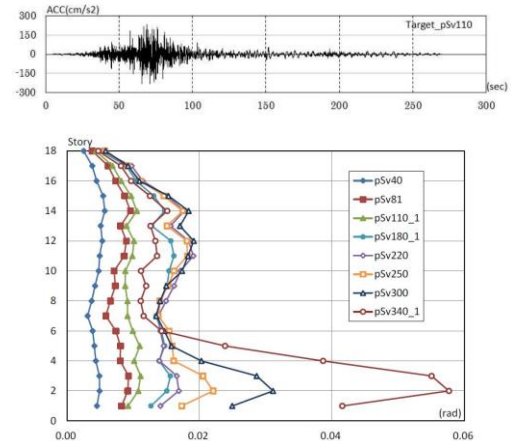
Instrumentation and Test Procedures The specimen was excited only in one direction. The input ground motion was a design synthetic ground motion with long-period characteristics for a Tokai-Tonankai-Nankai subduction-zone earthquake with the epicenter in the Nankai trough. The ground motion was synthesized assuming a building site and phase, and was processed properly for shake table use with the scaling law and a band-pass filter

Fig. 2 Input motion and story drift responses

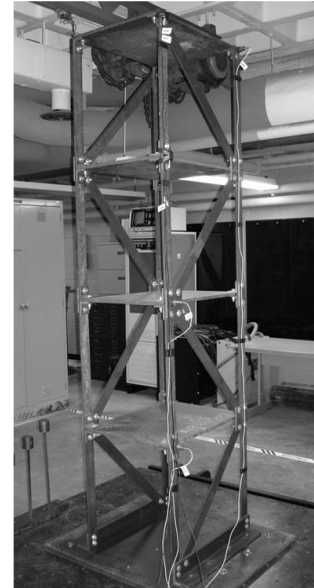
Test Structure Experimental data stems from a four-story structural steel model (Fig. 1), mounted on a uniaxial hydraulic shake table. The structure consists of four stories, with an interstory height of 533 mm and floor dimensions of 610 mm by 457 mm. The structure is braced to make it preferentially flexible in the direction of excitation, allowing for a clear spectrum of bending modes in this direction. All structural connections are bolted. The direction of excitation is referred to as the *weak* bending direction and the direction normal to excitation is referred to as the *strong* bending direction of the structure [1,2].

Instrumentation and Test Procedures The model is instrumented with piezoelectric accelerometers, with seven channels response on the structural model and one reference channel on the shake table's platform. The sensors are attached magnetically to the column connection plates at each floor.

Fig. 1 Structural model on shake table

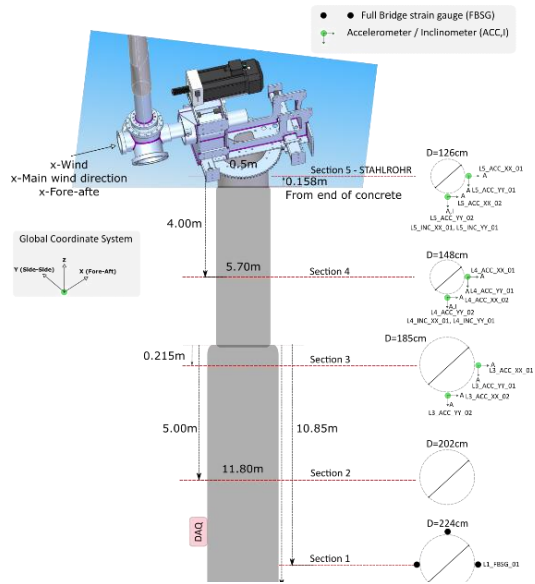
Instrumentation and Test Procedures The tower and nacelle are instrumented with 11 accelerometers distributed along the length of the tower, nacelle main frame, main bearing and generator. Two full bridge strain gauges, which can be converted to bending moments, are installed on the concrete tower. Temperature and humidity are measured at the base of the tower. In addition, operational performance data (SCADA) such as wind speed, nacelle yaw orientation, rotor speed, power output and turbine status can also be sampled [1].

Figure 1: Tower measurement layout [1].
